# COUNTY OF LOS ANGELES

**CONSOLIDATED SEWER MAINTENANCE DISTRICT  
CONDITION ASSESSMENT PROGRAM REPORT  
PROJECT NO. Y0TV1314A2**

**CONDITION ASSESSMENT REPORT  
LOS ANGELES COUNTY PUBLIC WORKS  
CONSOLIDATED SEWER MAINTENANCE DISTRICT**

PROJECT NAME:	Y0TV1314A2	PROJECT MGR:	ERIC LIU
PROJECT DATE:	02/24/15	CONTACT NO:	(626) 300-3369
SUP. DISTRICT(s):	3	MAP PAGE(S):	1090, 1091, 1118
Report By:	Jonathan Gonzalez	Report Date:	8/17/18

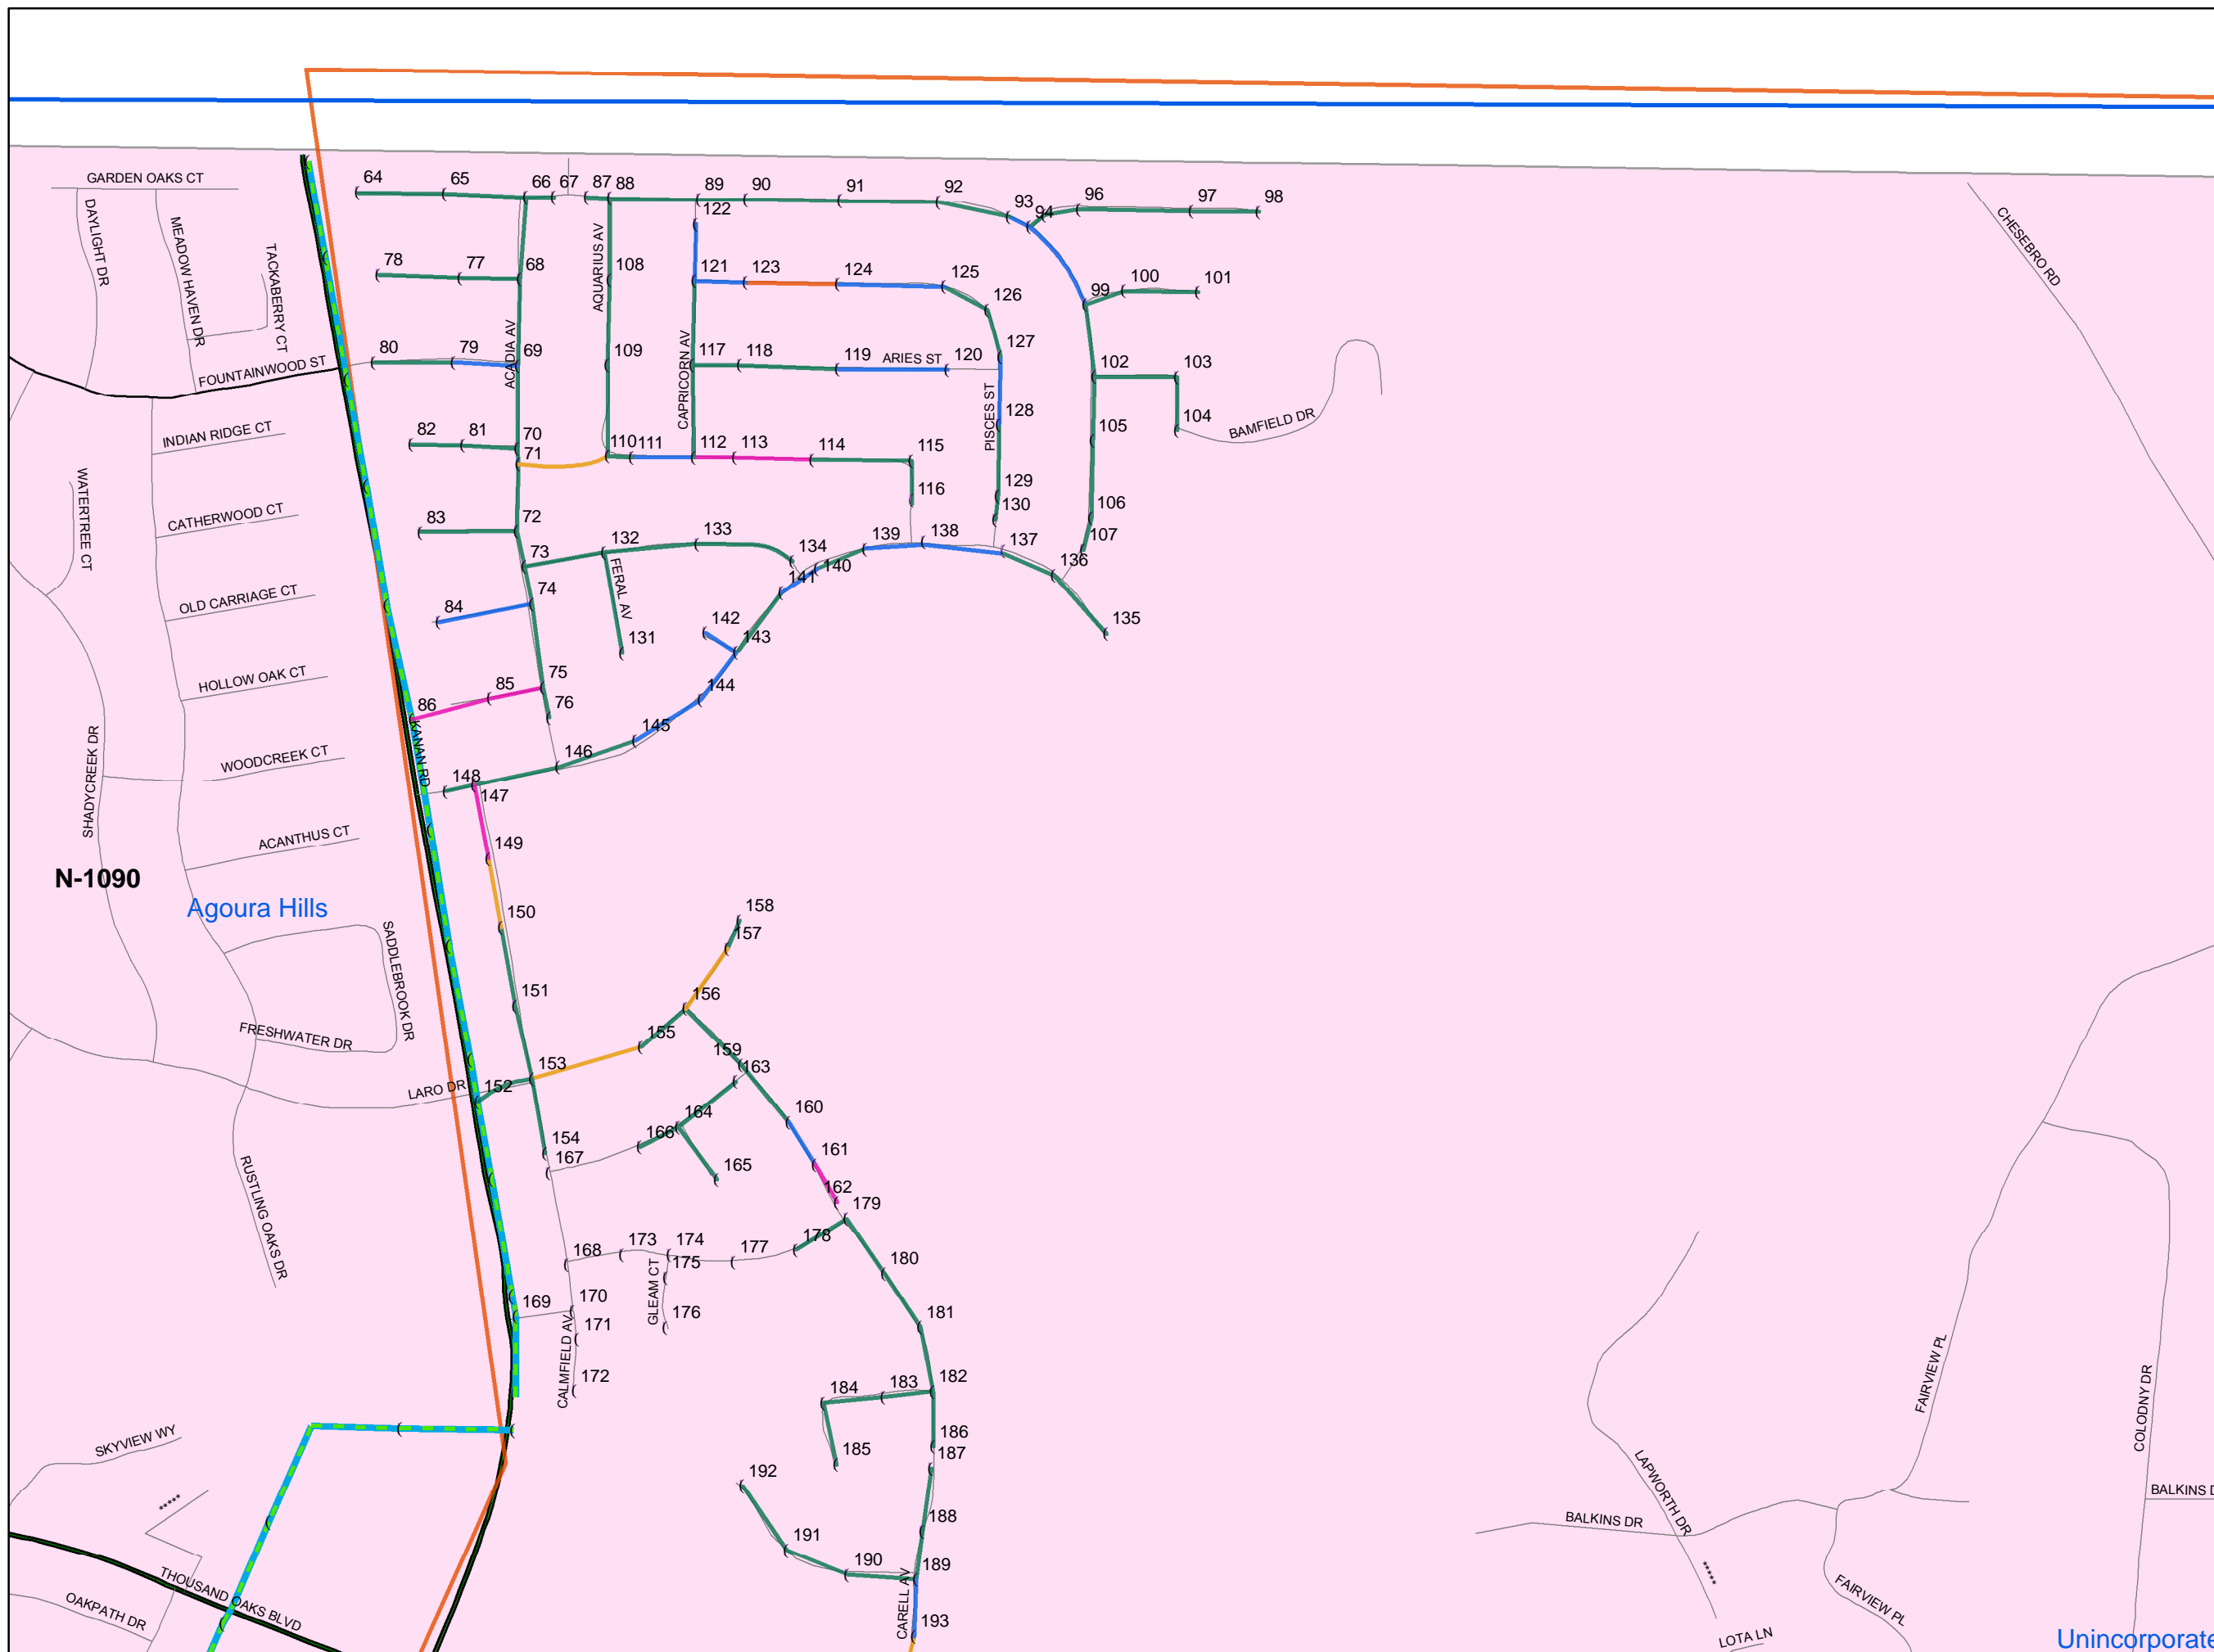
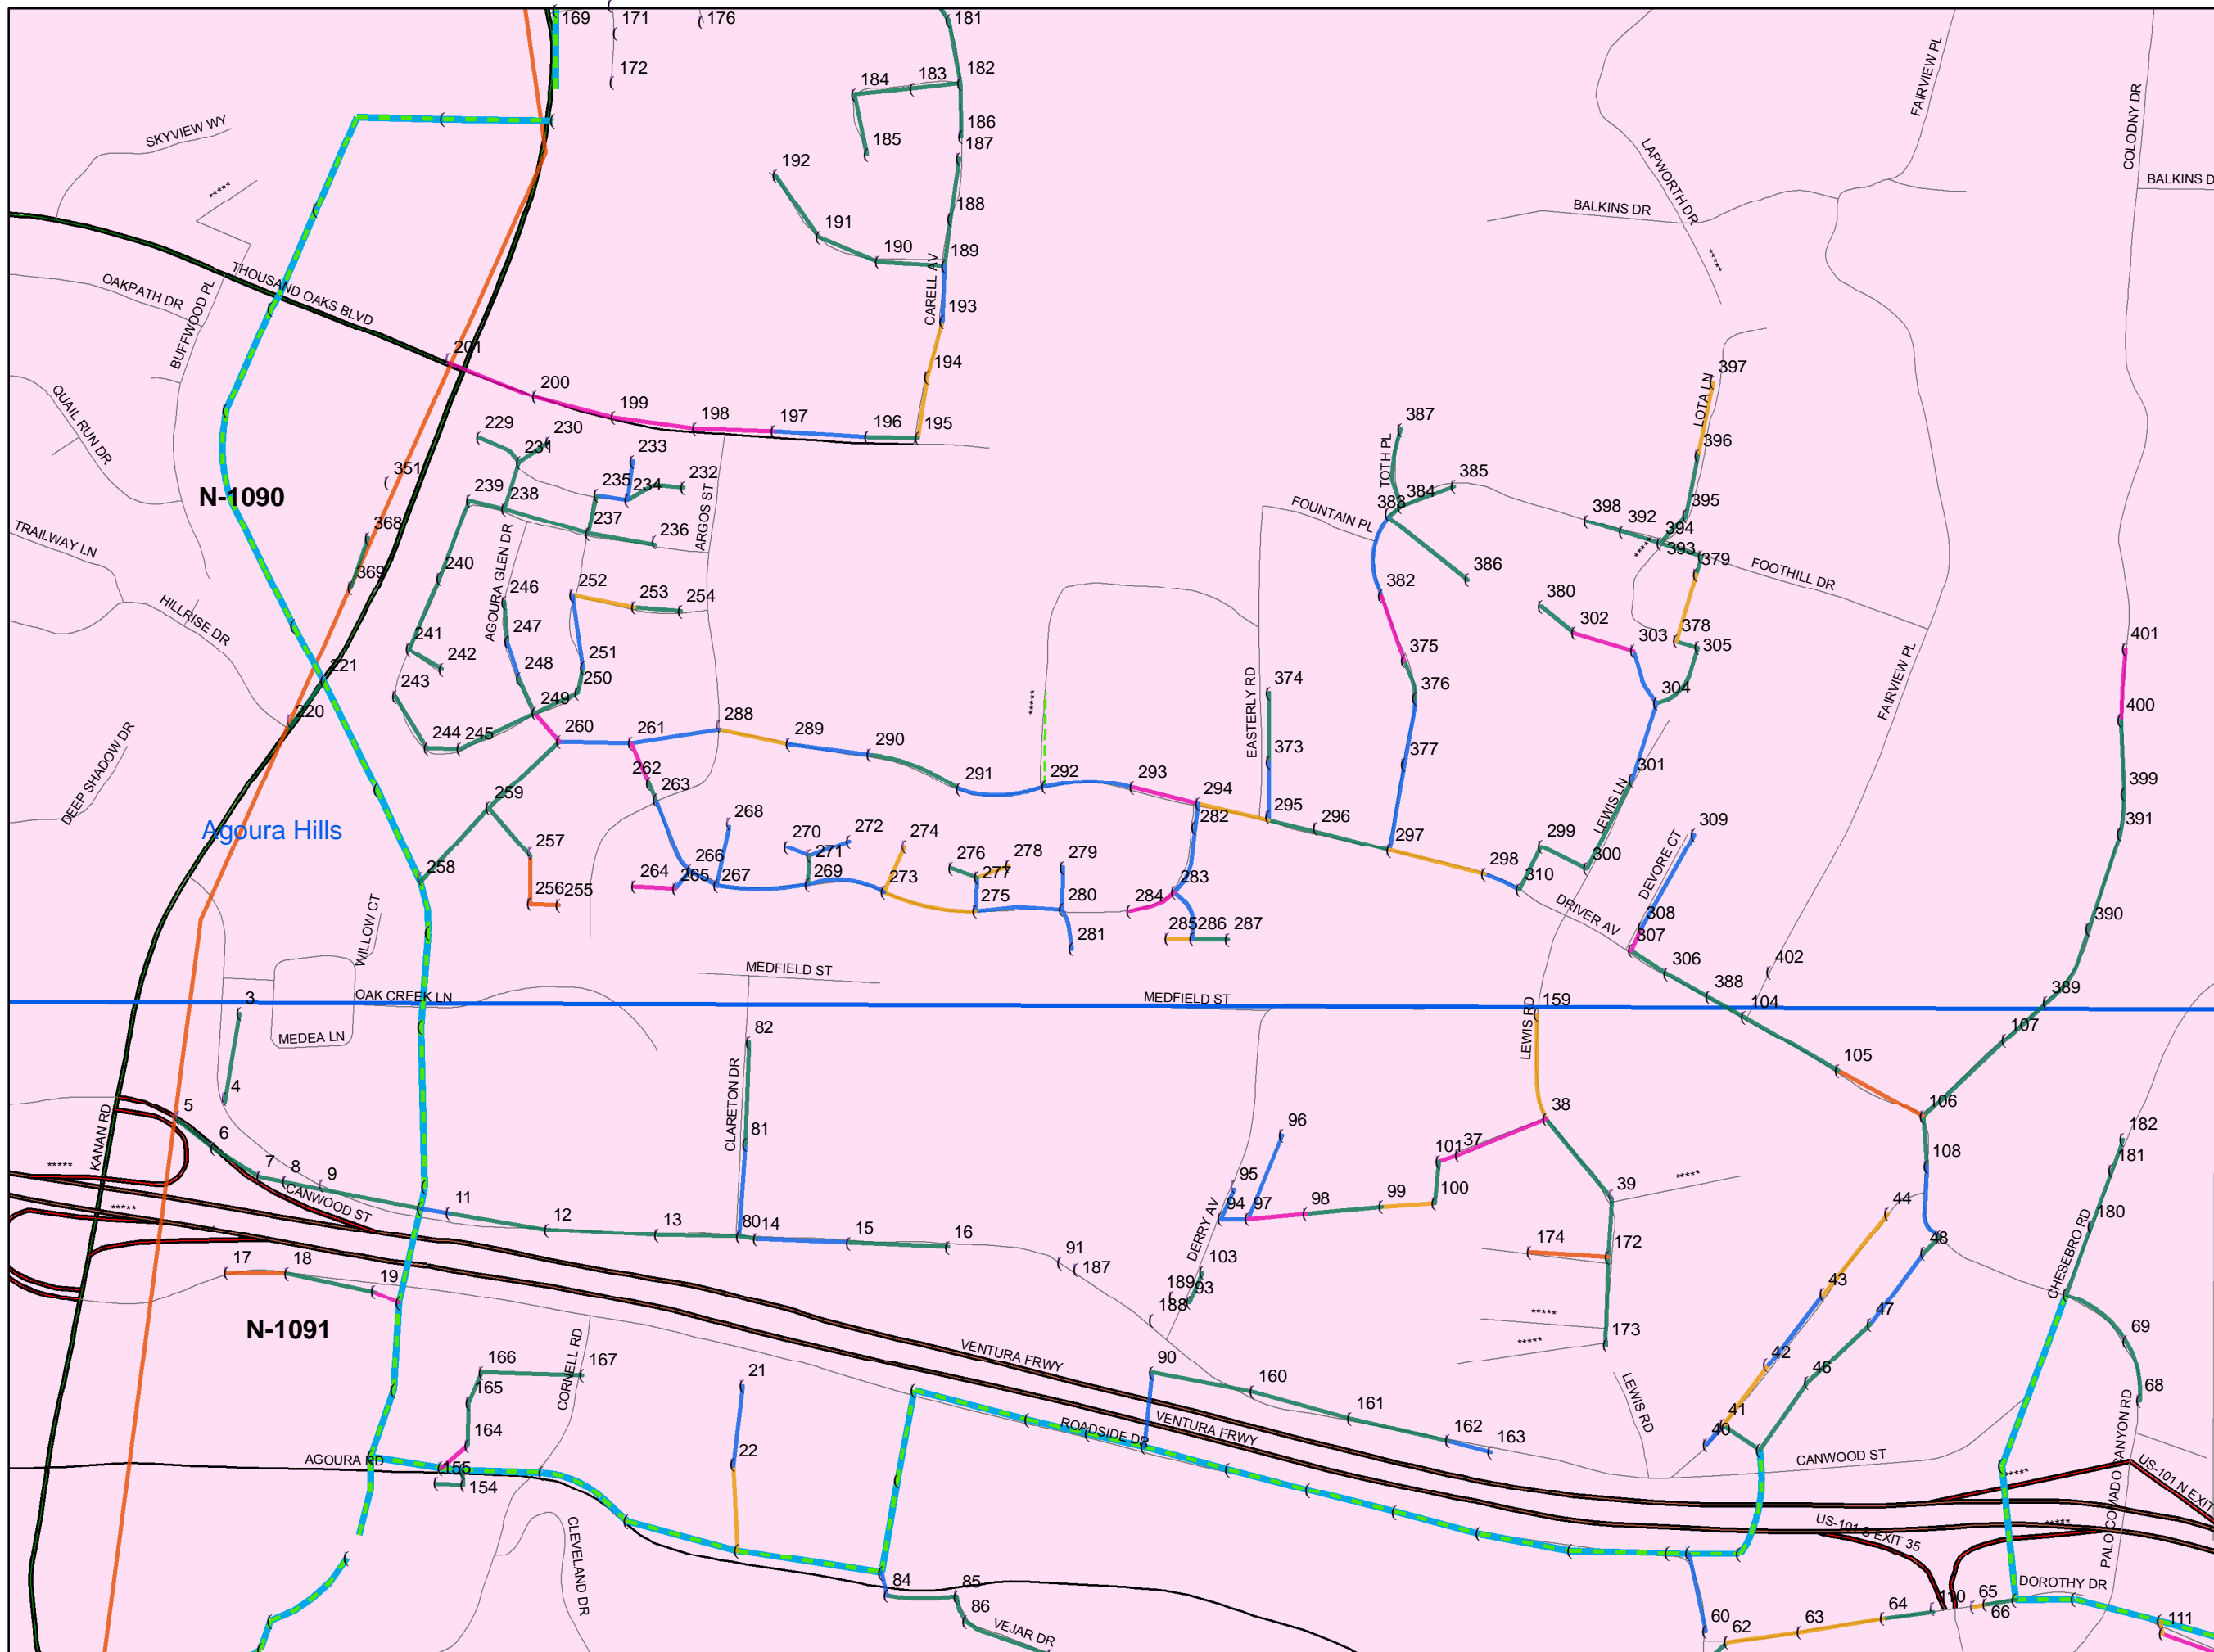
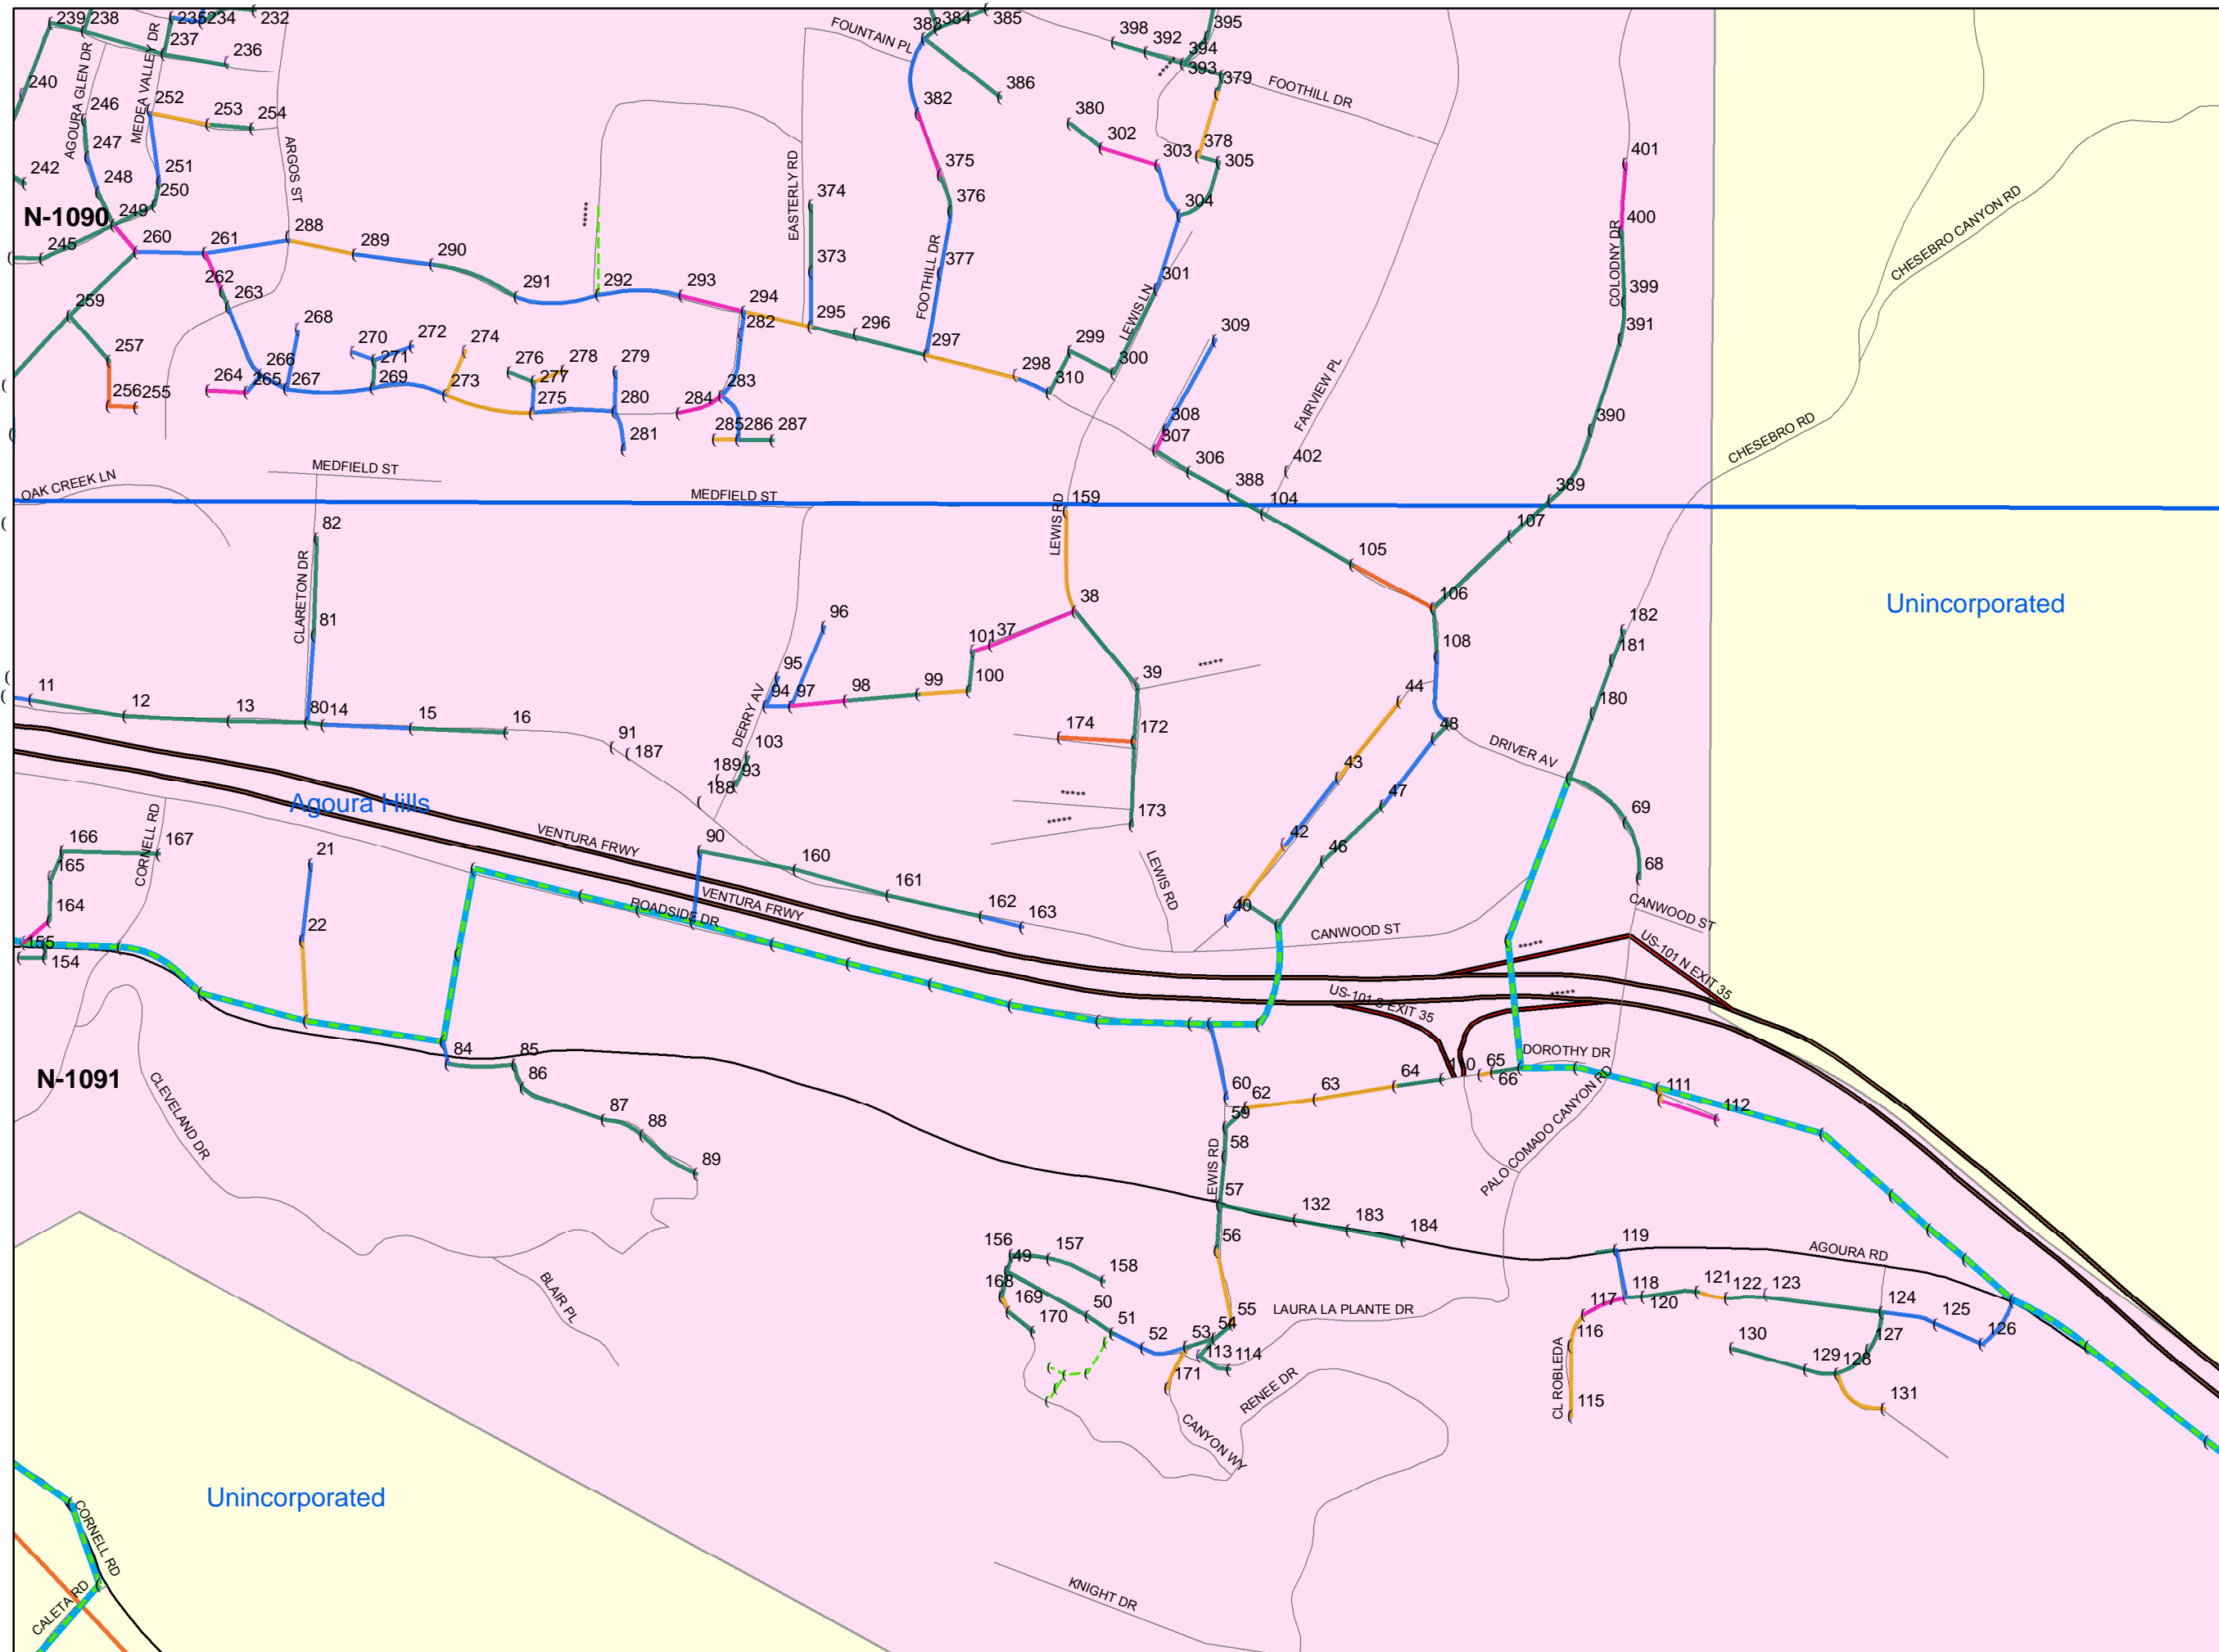
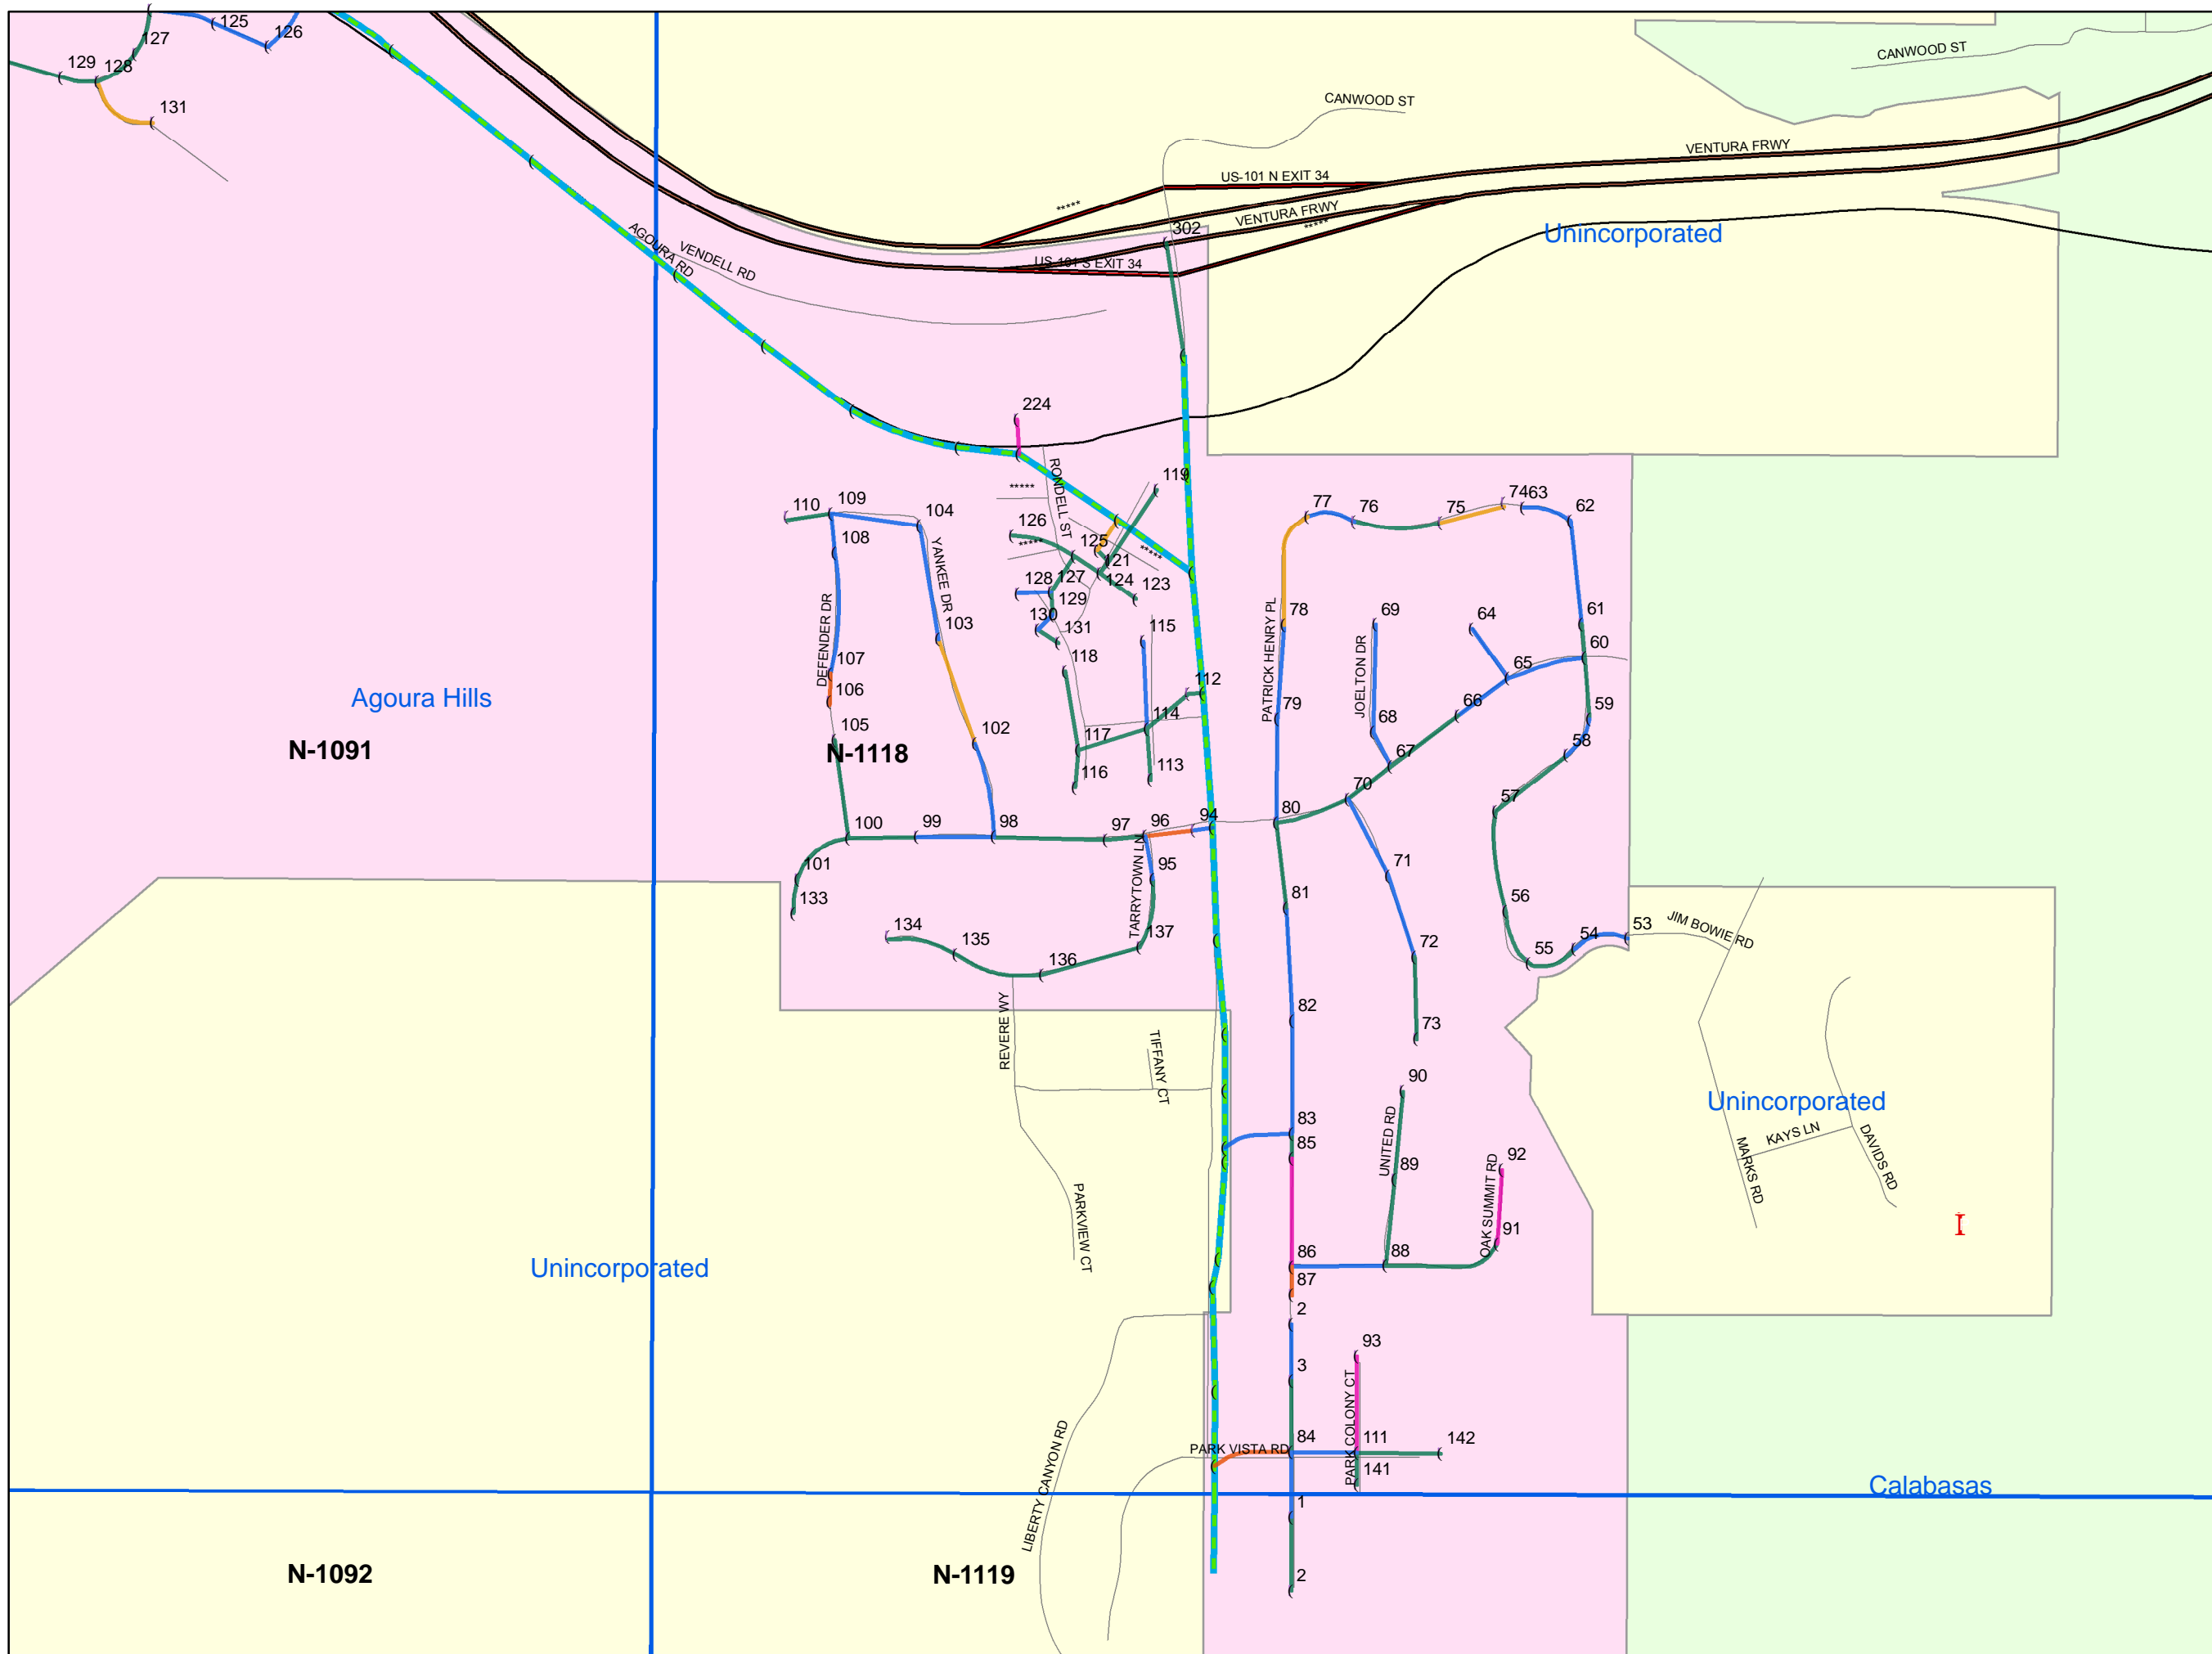
### QUICK MAINTENANCE RATING

Our inspection revealed that approximately 81.2 percent of the system televised in your City as part of Project No. Y0TV1314A2 was free of significant blockages or restrictions that would impede sewer flows. The remaining 18.8 percent of the pipe segments within the City had a PACP maintenance grade of 3, 4, or 5 as indicated in the Quick Maintenance Rating Table shown below. These segments have been incorporated into our periodic cleaning schedule with corrective action taken.

A color-coded map showing the quick maintenance rating for each pipe segment is provided in Enclosure 2.

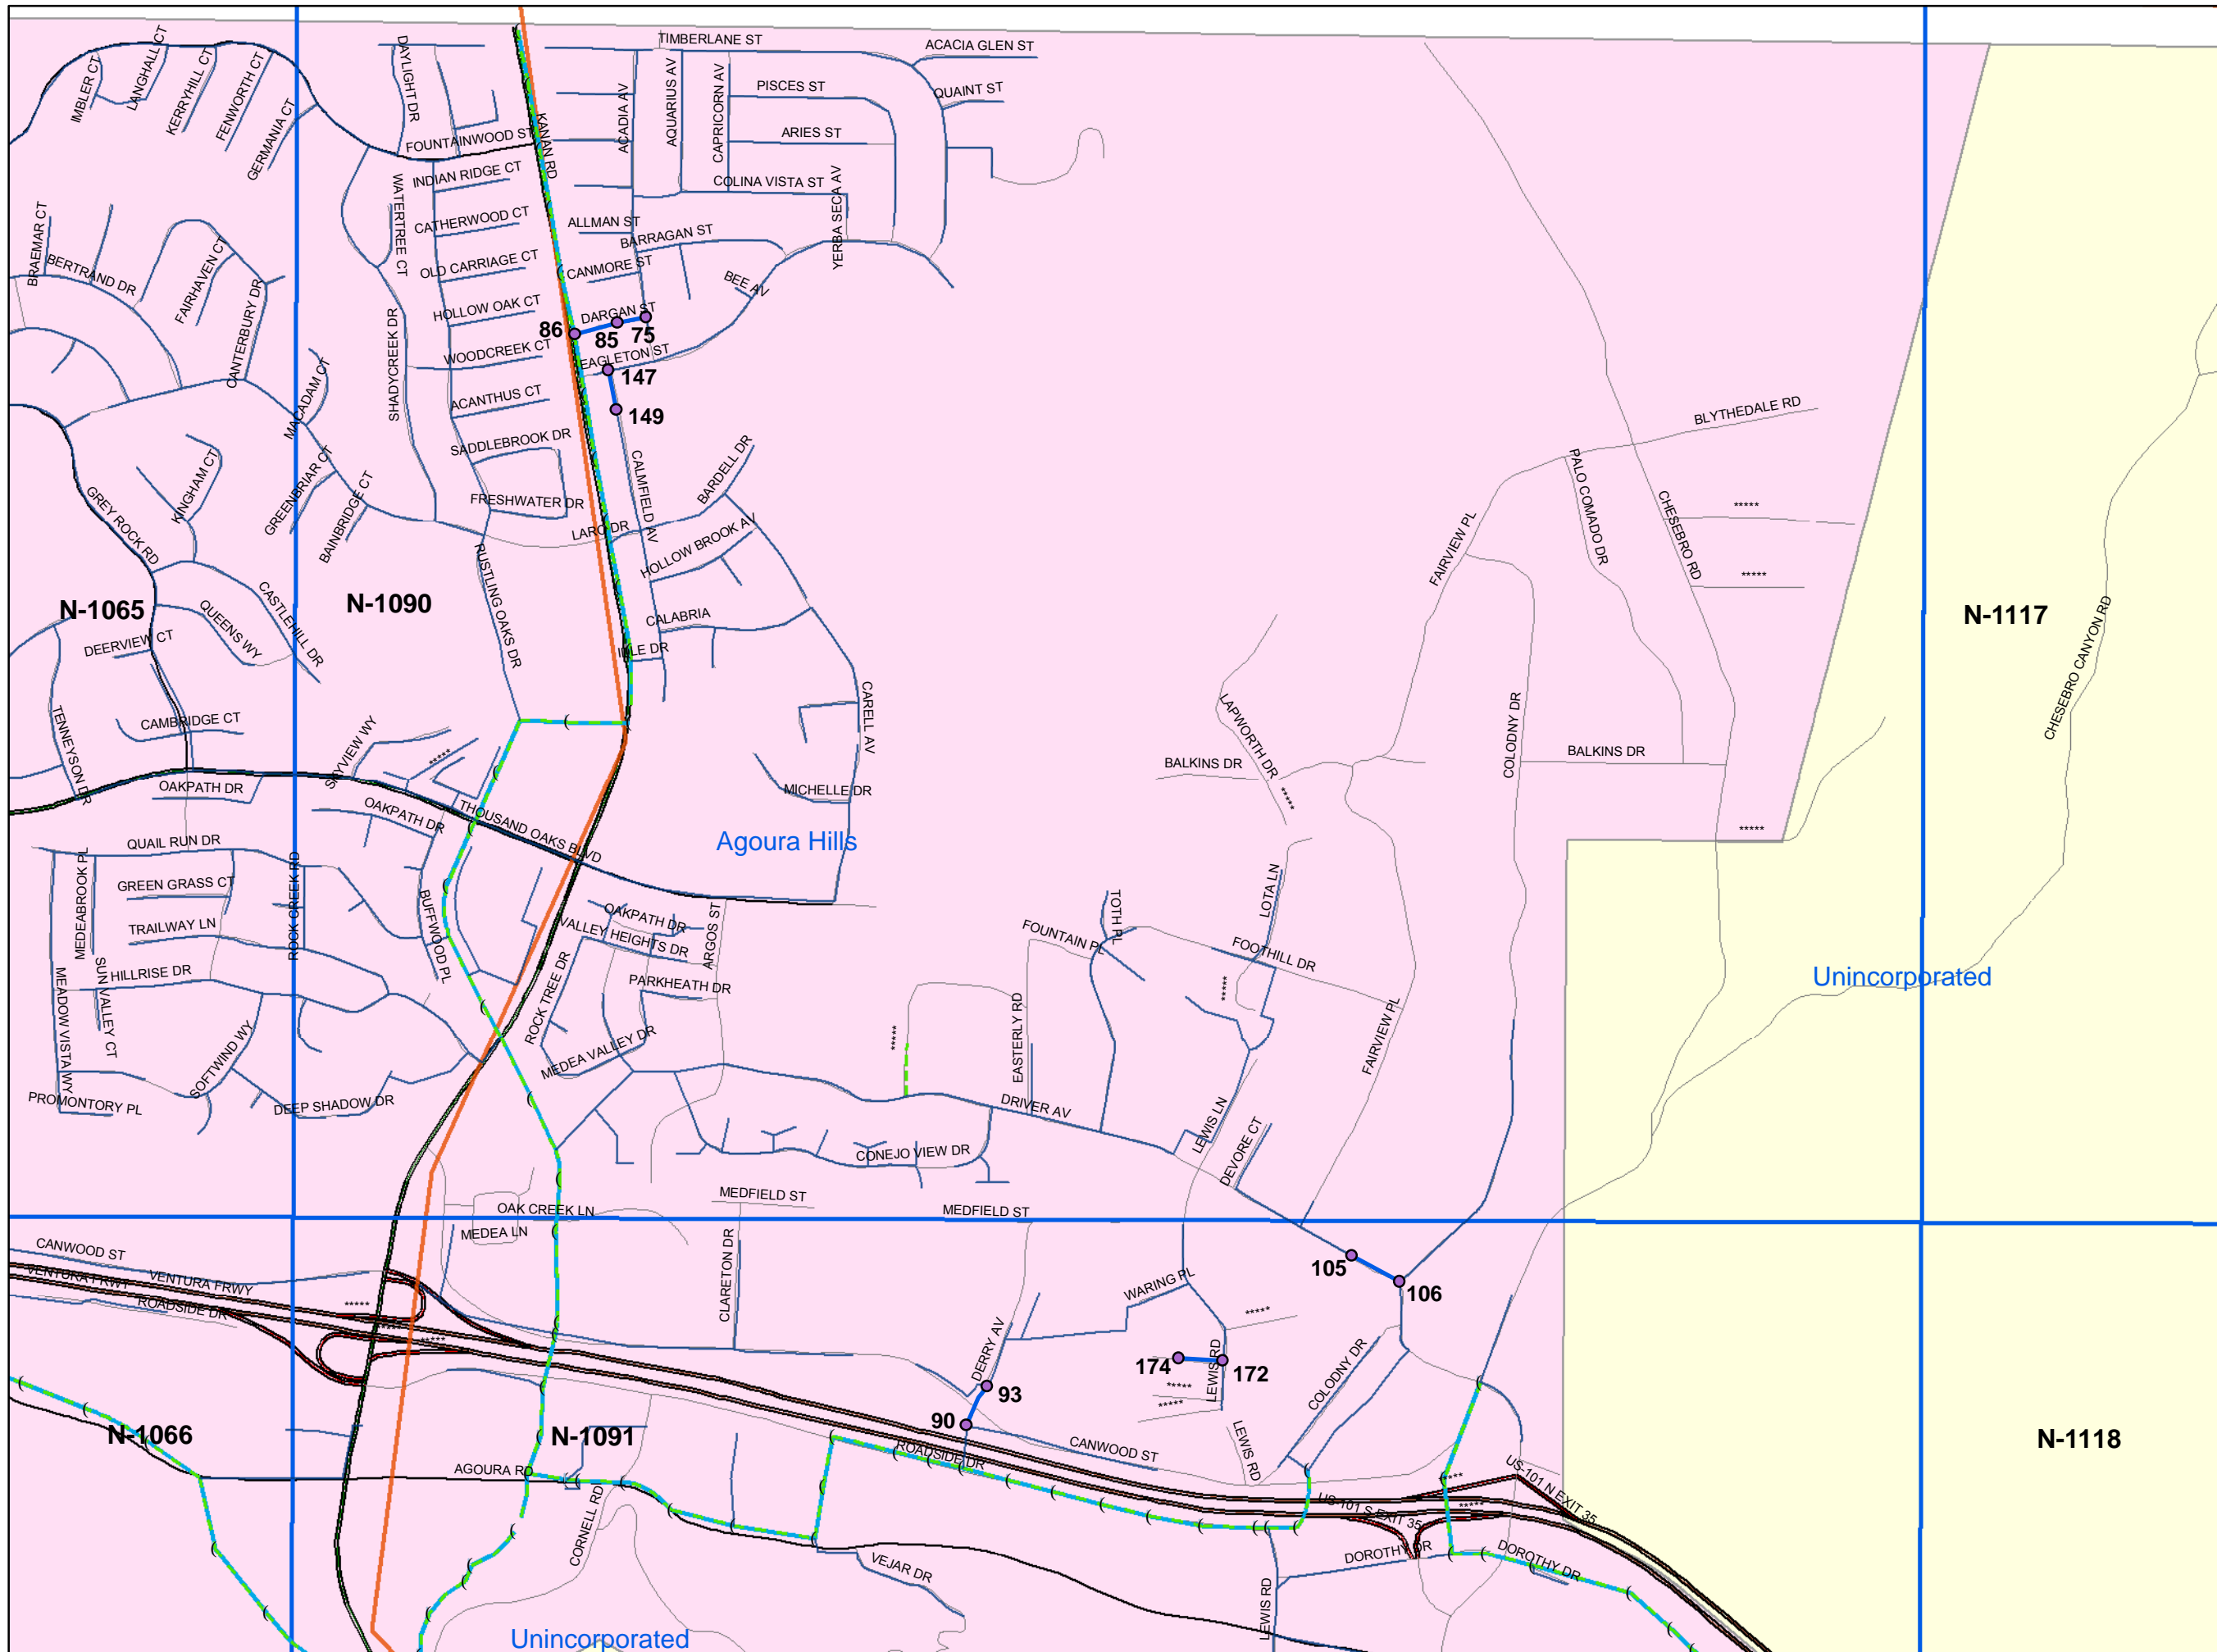
## HIGH WATER LEVEL

Our inspection revealed that approximately 99.4 percent of the system televised has adequate capacity. Approximately 0.6 percent of the segments inspected exhibited visual signs associated with high water levels. The capacity of the sewer pipe can be determined by analyzing several PACP codes, including Water Level, Water Mark, and miscellaneous remarks, which indicate the camera was underwater or there were sags in the line. A sewer pipe is considered at capacity when 50 percent of the diameter of the sewer pipe is full of water. However, there are conditions in which the Water Level or Water Mark has reached 50 percent or greater due to heavy flows in adjoining pipes, a temporary stoppage caused by debris in the sewer lines, or a sag in the line. Therefore, additional review of these pipe segments was conducted to determine if any capacity issues exist.

All sewer pipes where the Water Level, Water Mark, and miscellaneous remarks of camera underwater or sags in the line are at or above 50 percent capacity have been listed and analyzed on the High Water Level Table in Enclosure 2. The nature of these high water level conditions is also summarized on this table.

A map showing the sewer lines with high water levels is provided in Enclosure 2.

<b>ITEM NO.</b>	<b>QMR</b>	<b>START MH</b>	<b>END MH</b>	<b>STREET</b>	<b>OBSERVATION: LOCATION</b>	<b>CAPACITY</b>	<b>CORRECTIVE ACTION</b>
1	5141	1091-0172	1091-0174	TULARE LN	Water mark (80%)	YES	No action needed*
2	5121	1091-0105	1091-0106	DRIVER AV	Sag	NO	No action needed*
3	4232	1090-0147	1090-0149	CALMFIELD AV	Camera underwater	YES	No action needed*
4	4200	1090-0085	1090-0086	DARGAN ST	Camera underwater	YES	No action needed*
5	4100	1090-0075	1090-0085	DARGAN ST	Water level high (50%)	YES	No action needed*
6	4100	1091-0090	1091-0093	DERRY AV	Water mark (50%)	YES	No action needed*
