# COUNTY OF LOS ANGELES

**CONSOLIDATED SEWER MAINTENANCE DISTRICT  
CONDITION ASSESSMENT PROGRAM REPORT  
PROJECT NO. Y0TV1314A2**

**CONDITION ASSESSMENT REPORT  
LOS ANGELES COUNTY PUBLIC WORKS  
CONSOLIDATED SEWER MAINTENANCE DISTRICT**

PROJECT NAME:	Y0TV1314A2	PROJECT MGR:	ERIC LIU
PROJECT DATE:	02/24/15	CONTACT NO:	(626) 300-3369
SUP. DISTRICT(s):	3	MAP PAGE(S):	1090, 1091, 1118
Report By:	Jonathan Gonzalez	Report Date:	8/17/18

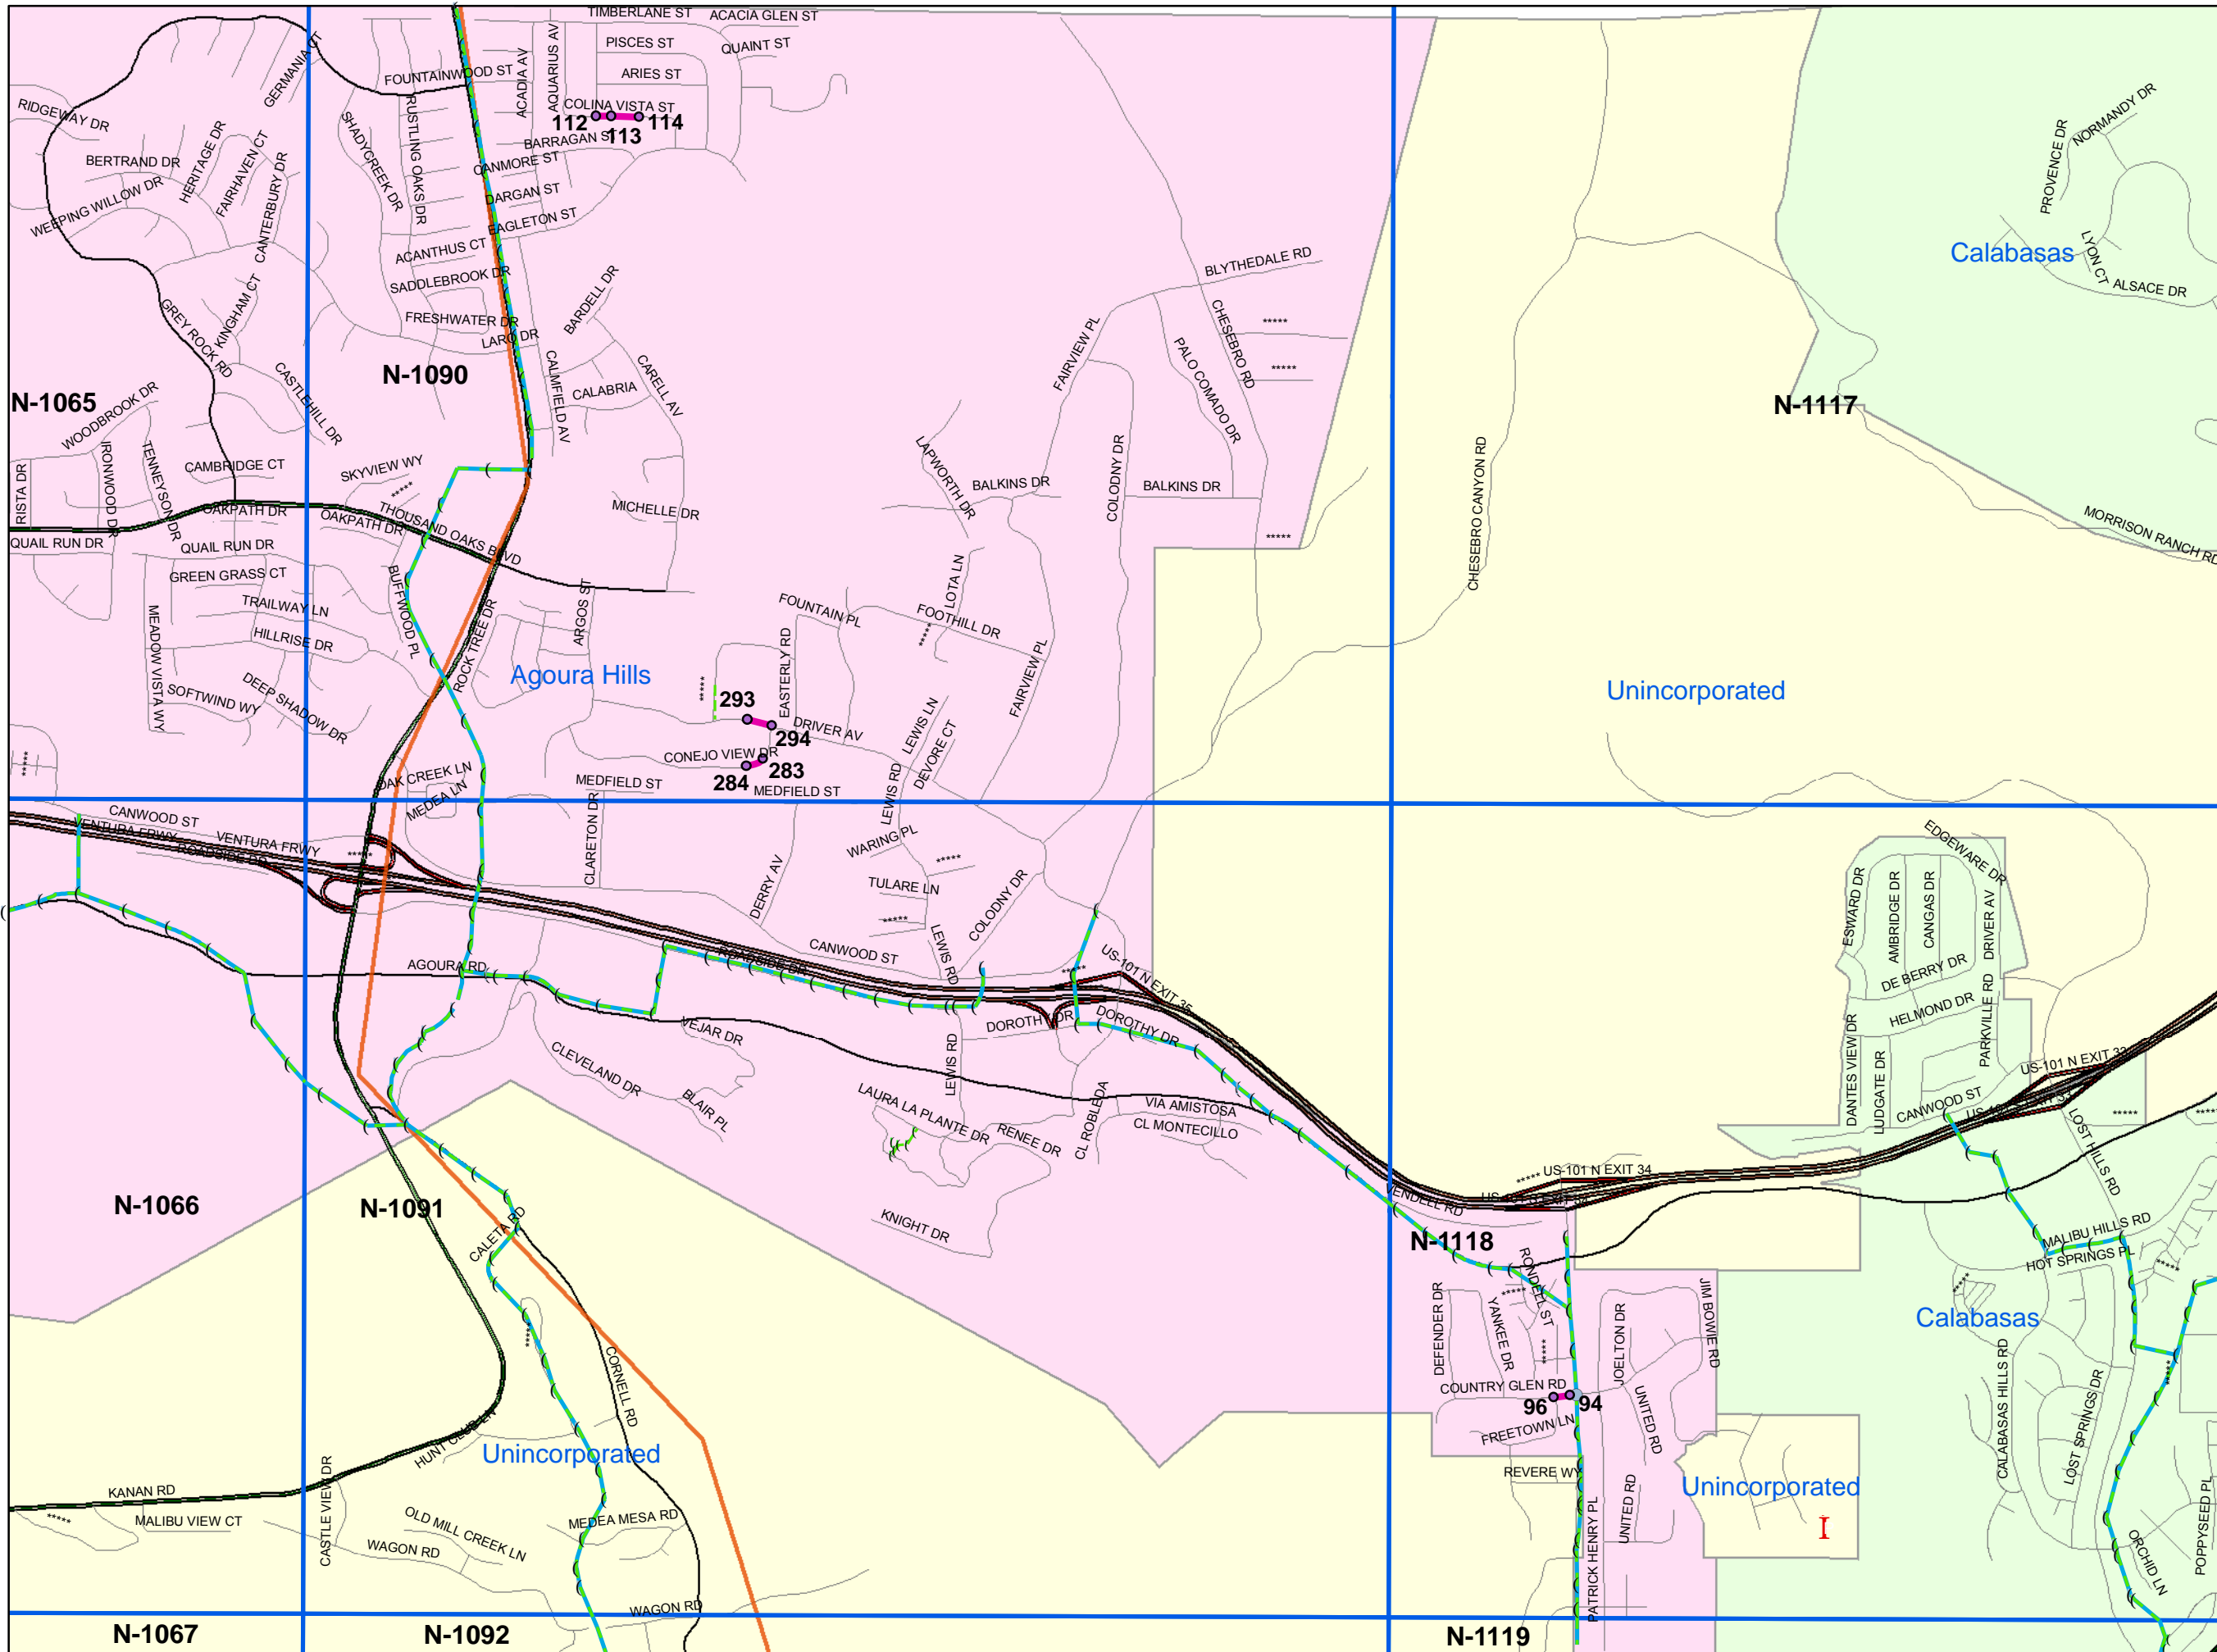
## INFILTRATION

Our inspection revealed that approximately 0.4 percent of the system included in your City as part of Project No. Y0TV1314A2 has infiltration within the pipe segments. Infiltration is the ingress of groundwater into the sewers through a defect or porous area of the pipe wall. All sewer pipes where infiltration was found are listed on the Infiltration Table in Enclosure 2. This table also provides the proposed corrective action for these impacted sewer segments. If a corrective action is proposed, the work will be programmed in the next 24 months as part of our ongoing Accumulative Capital Outlay Program.

A map showing the sewer lines with infiltration is provided in Enclosure 2.

<b>ITEM NO.</b>	<b>QMR</b>	<b>START MH</b>	<b>END MH</b>	<b>STREET</b>	<b>OBSERVATION: LOCATION</b>	<b>PROPOSED CORRECTIVE METHOD</b>
1	5141	1118-0094	1118-0096	COUNTRY GLEN RD	Infiltration	No action needed
2	4222	1090-0113	1090-0114	COLINA VISTA ST	Infiltration	No action needed
3	4123	1090-0293	1090-0294	DRIVER AV	Infiltration	No action needed
4	4100	1090-0112	1090-0113	COLINA VISTA ST	Infiltration	Injection Grout
5	4100	1090-0283	1090-0284	CONEJO DR	Infiltration	No action needed

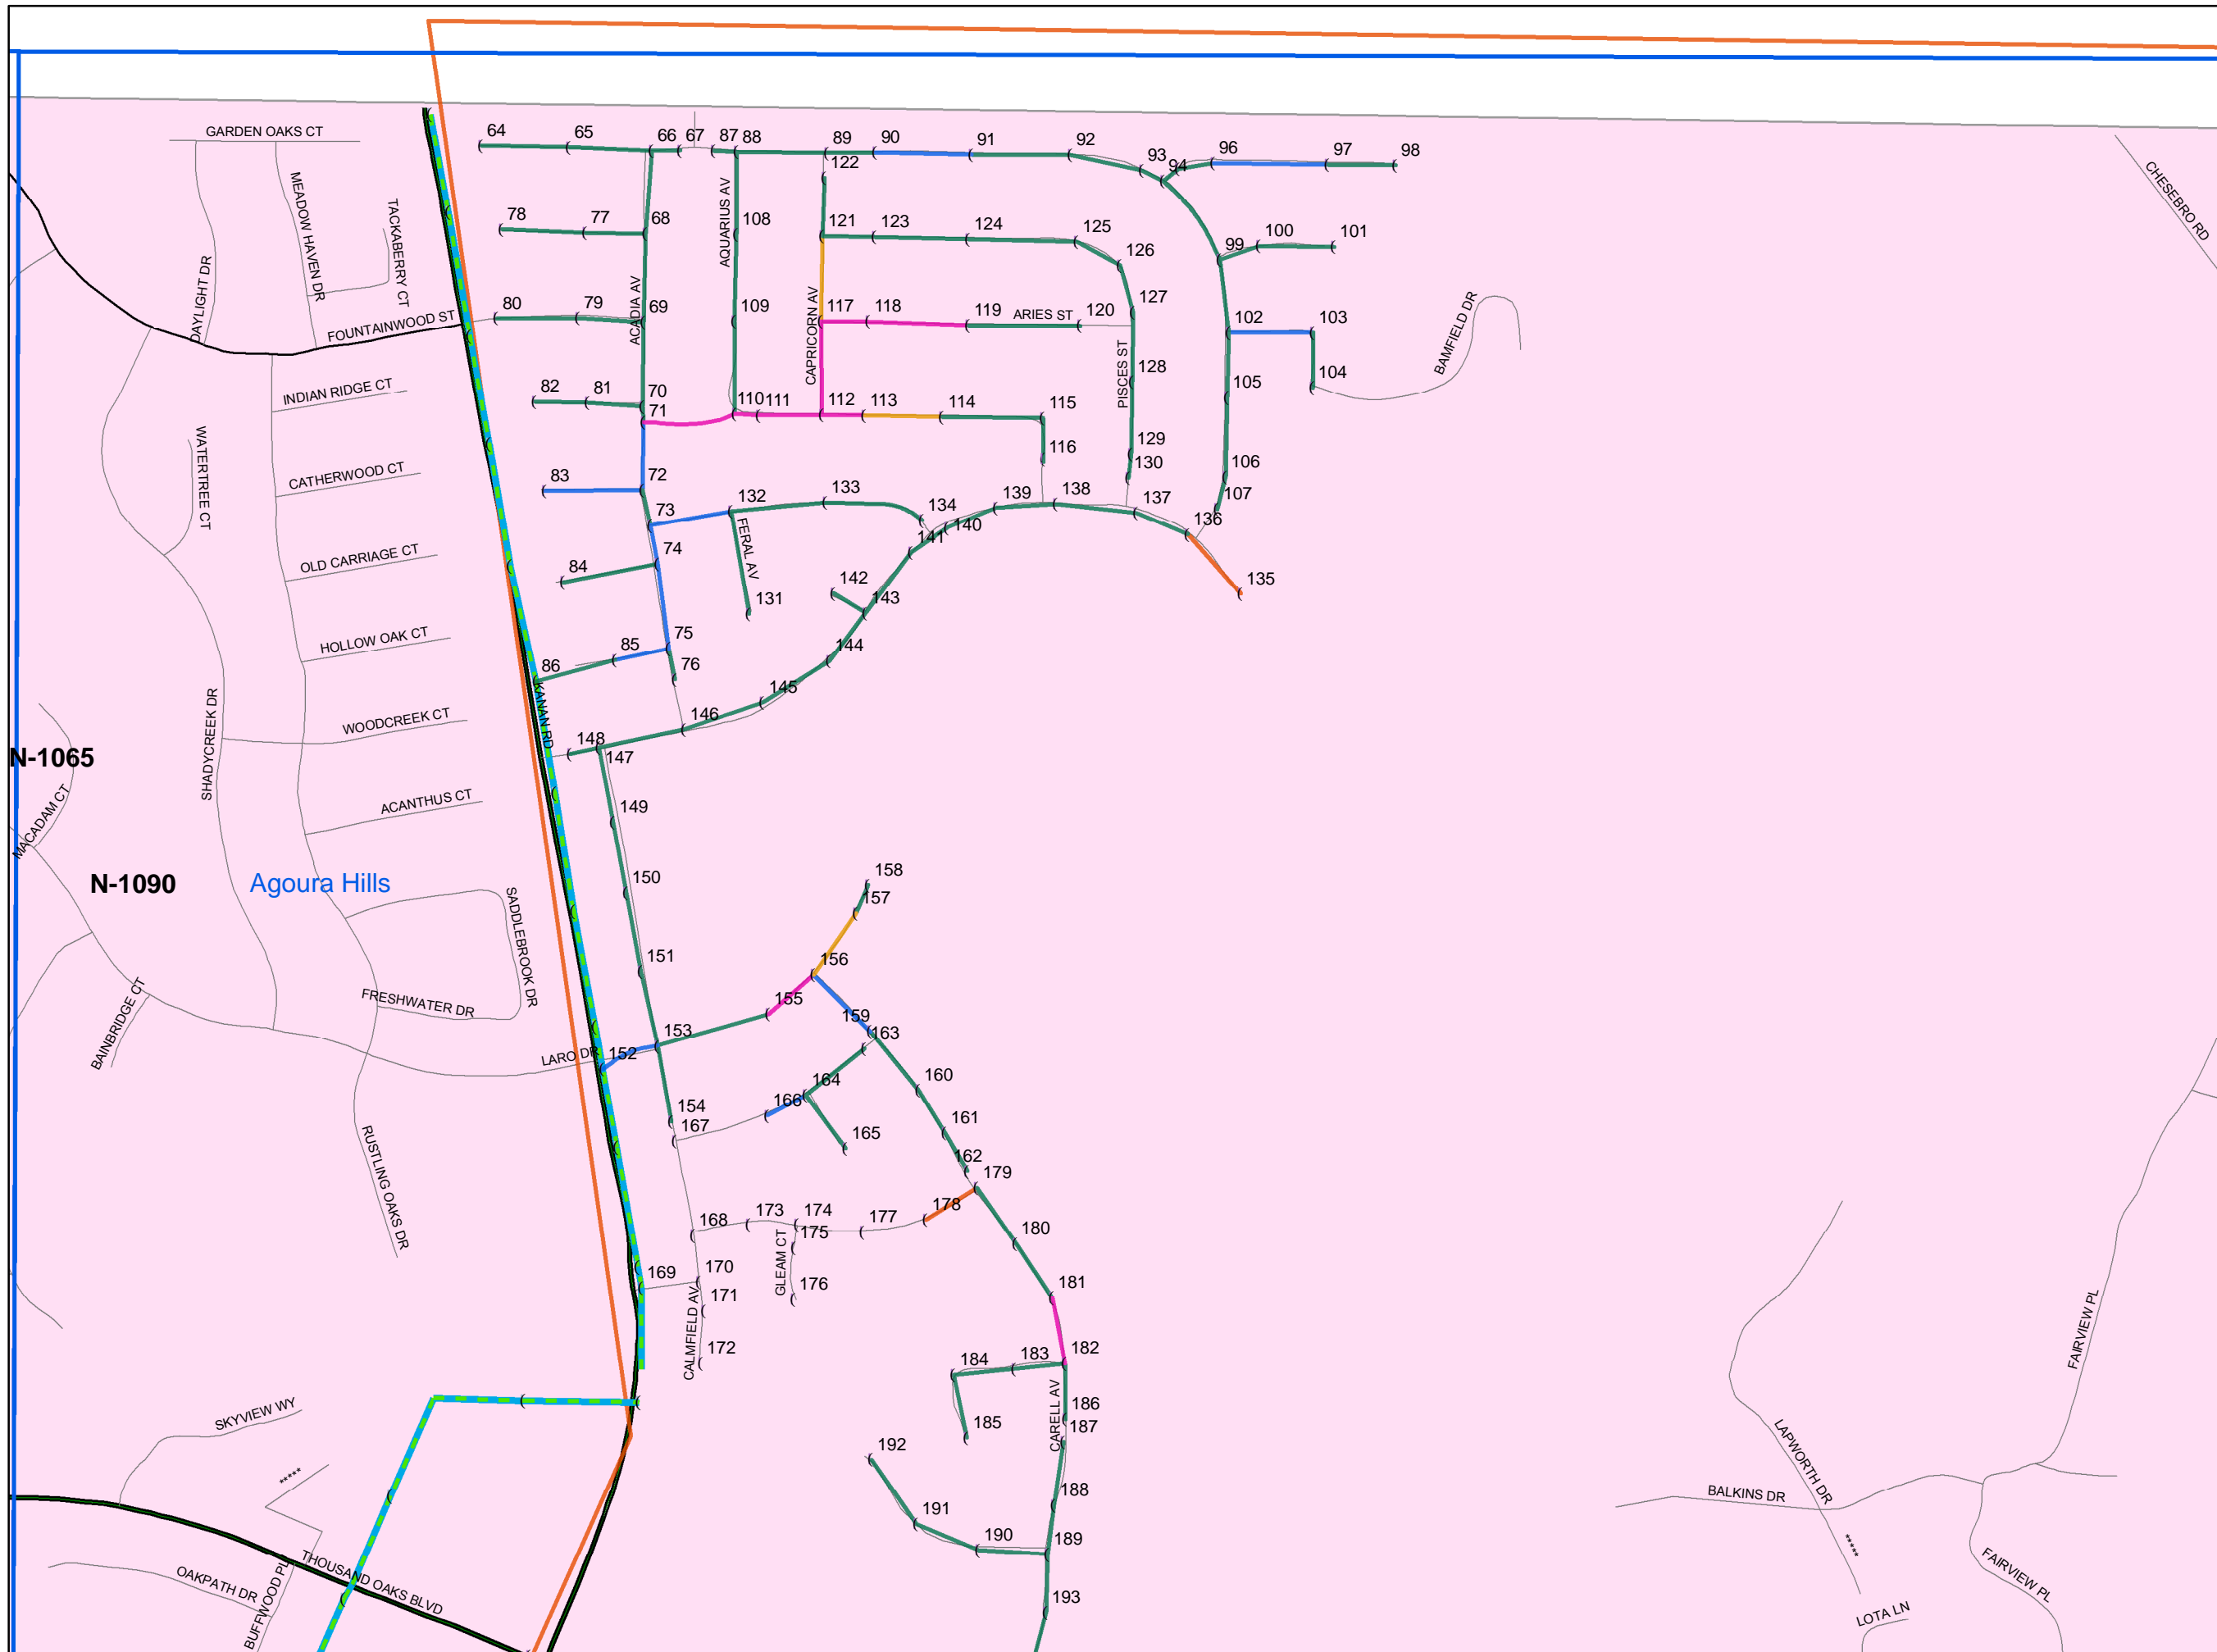
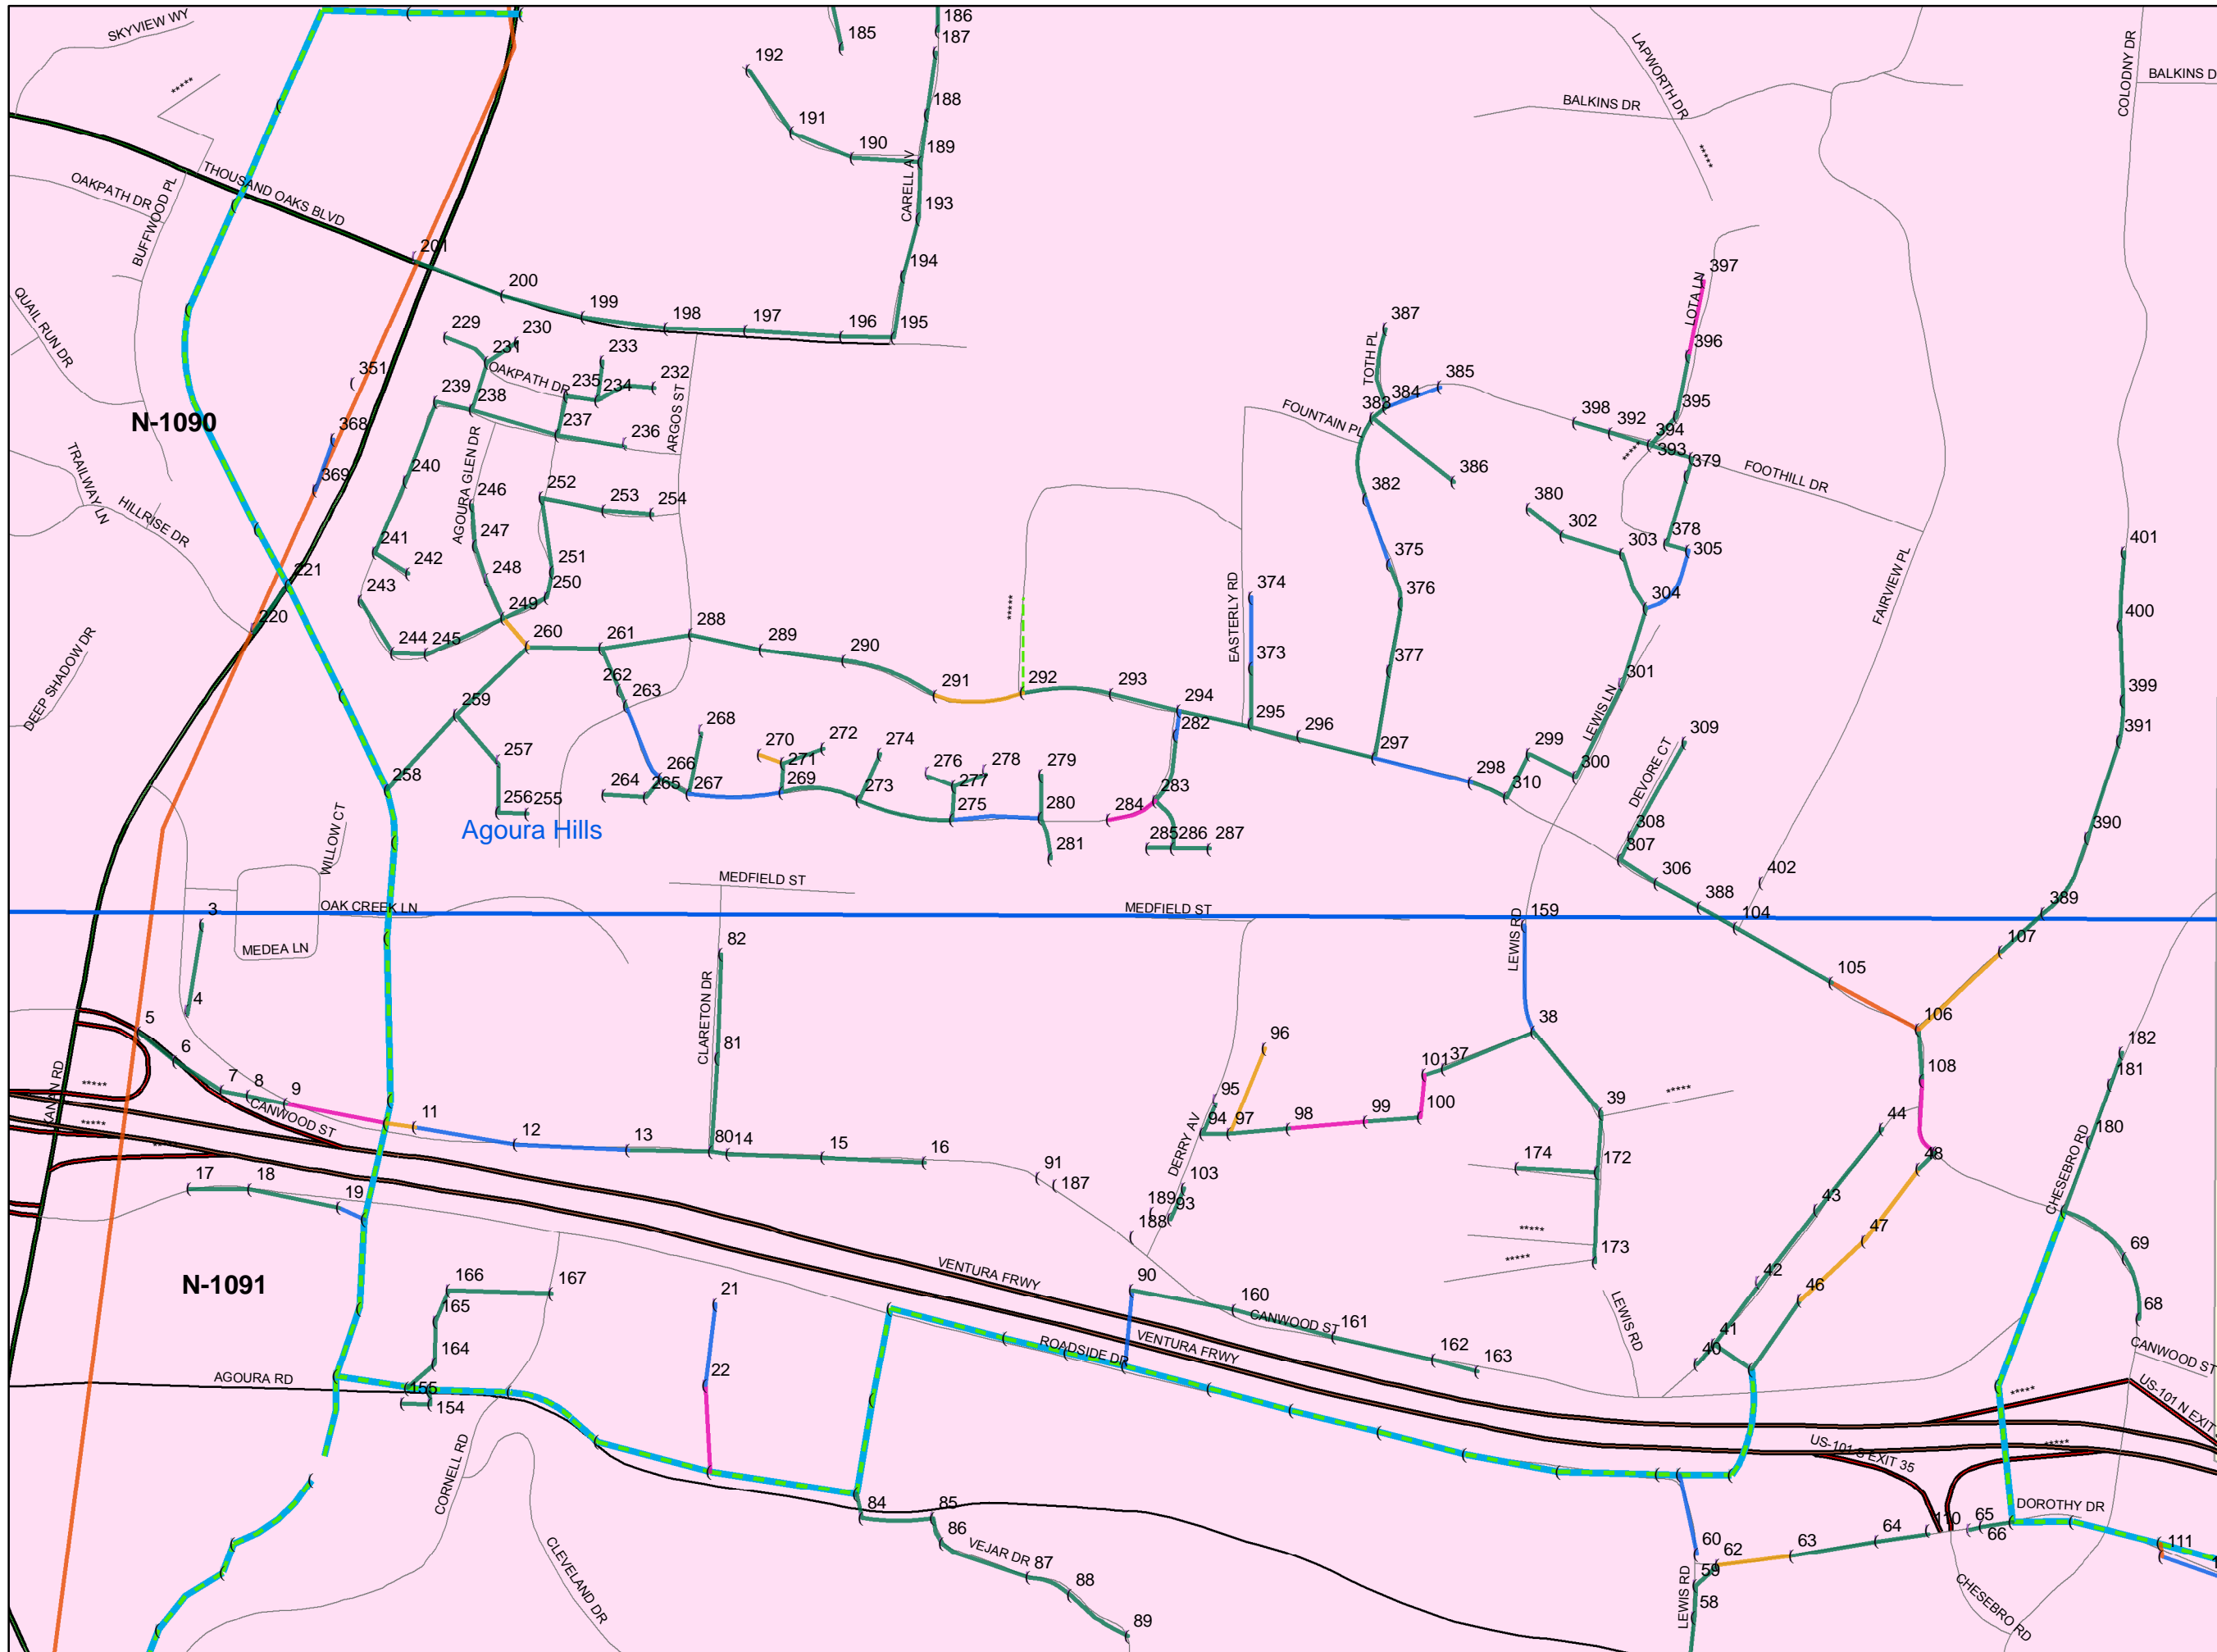
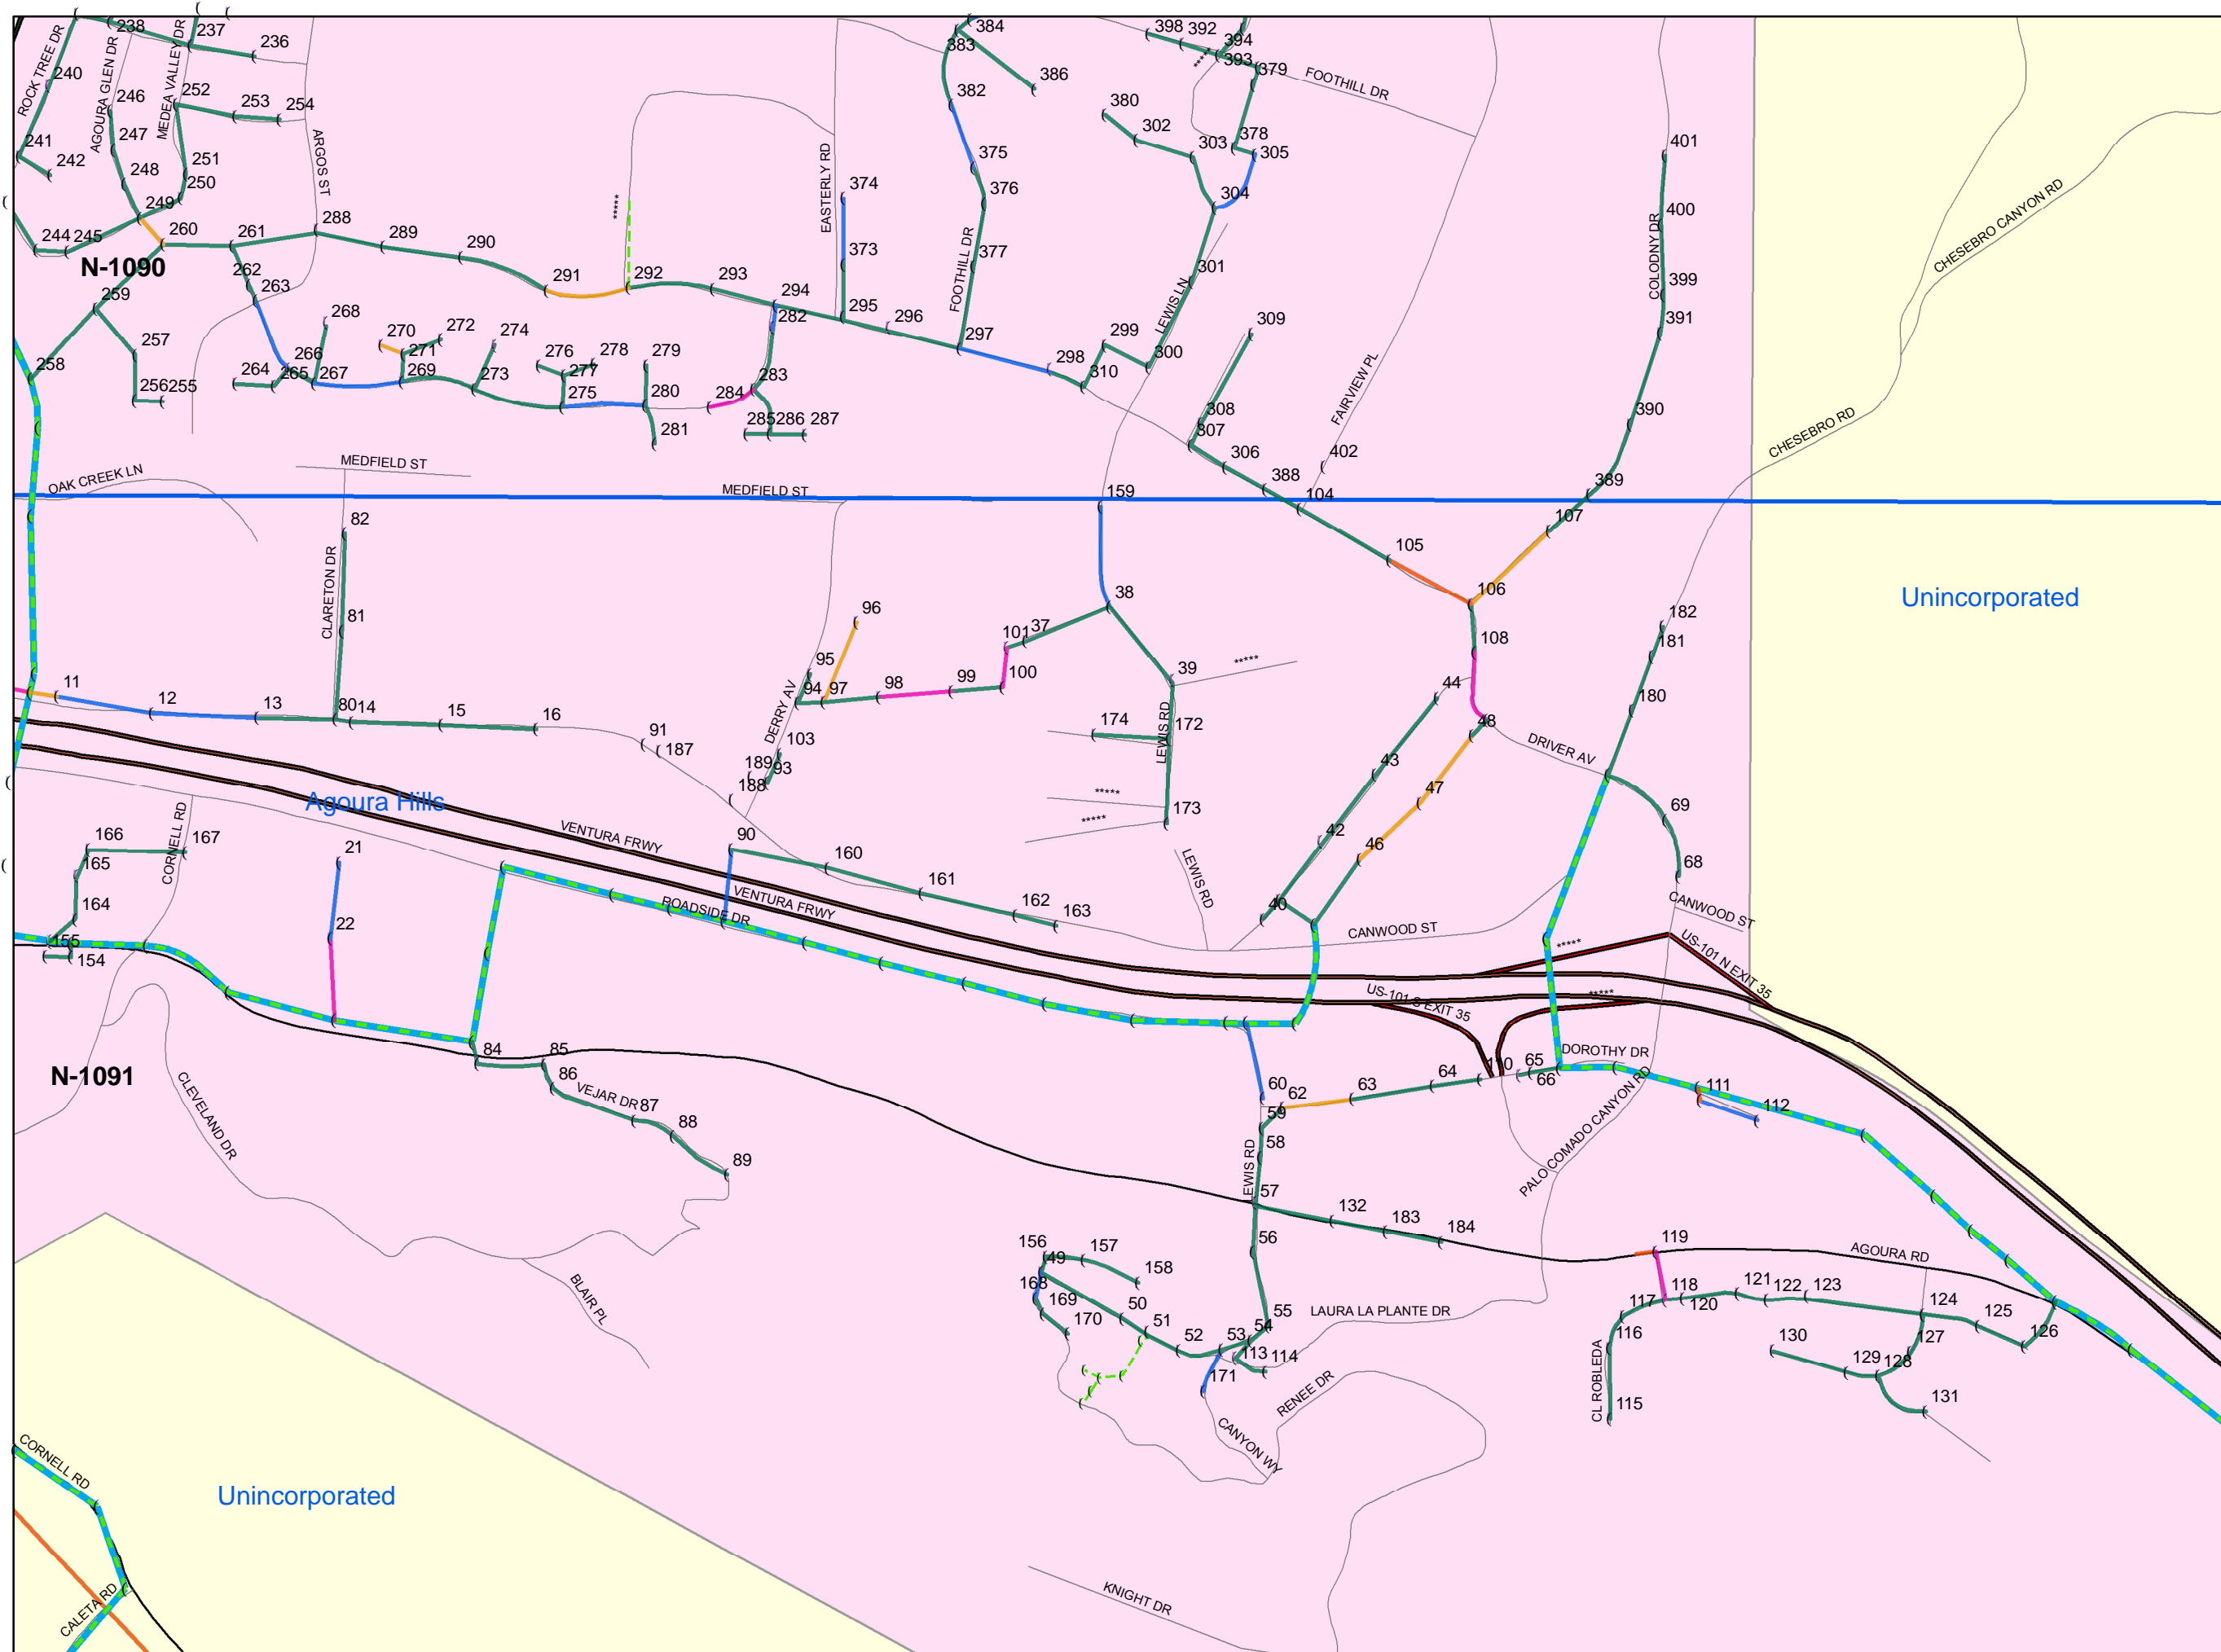
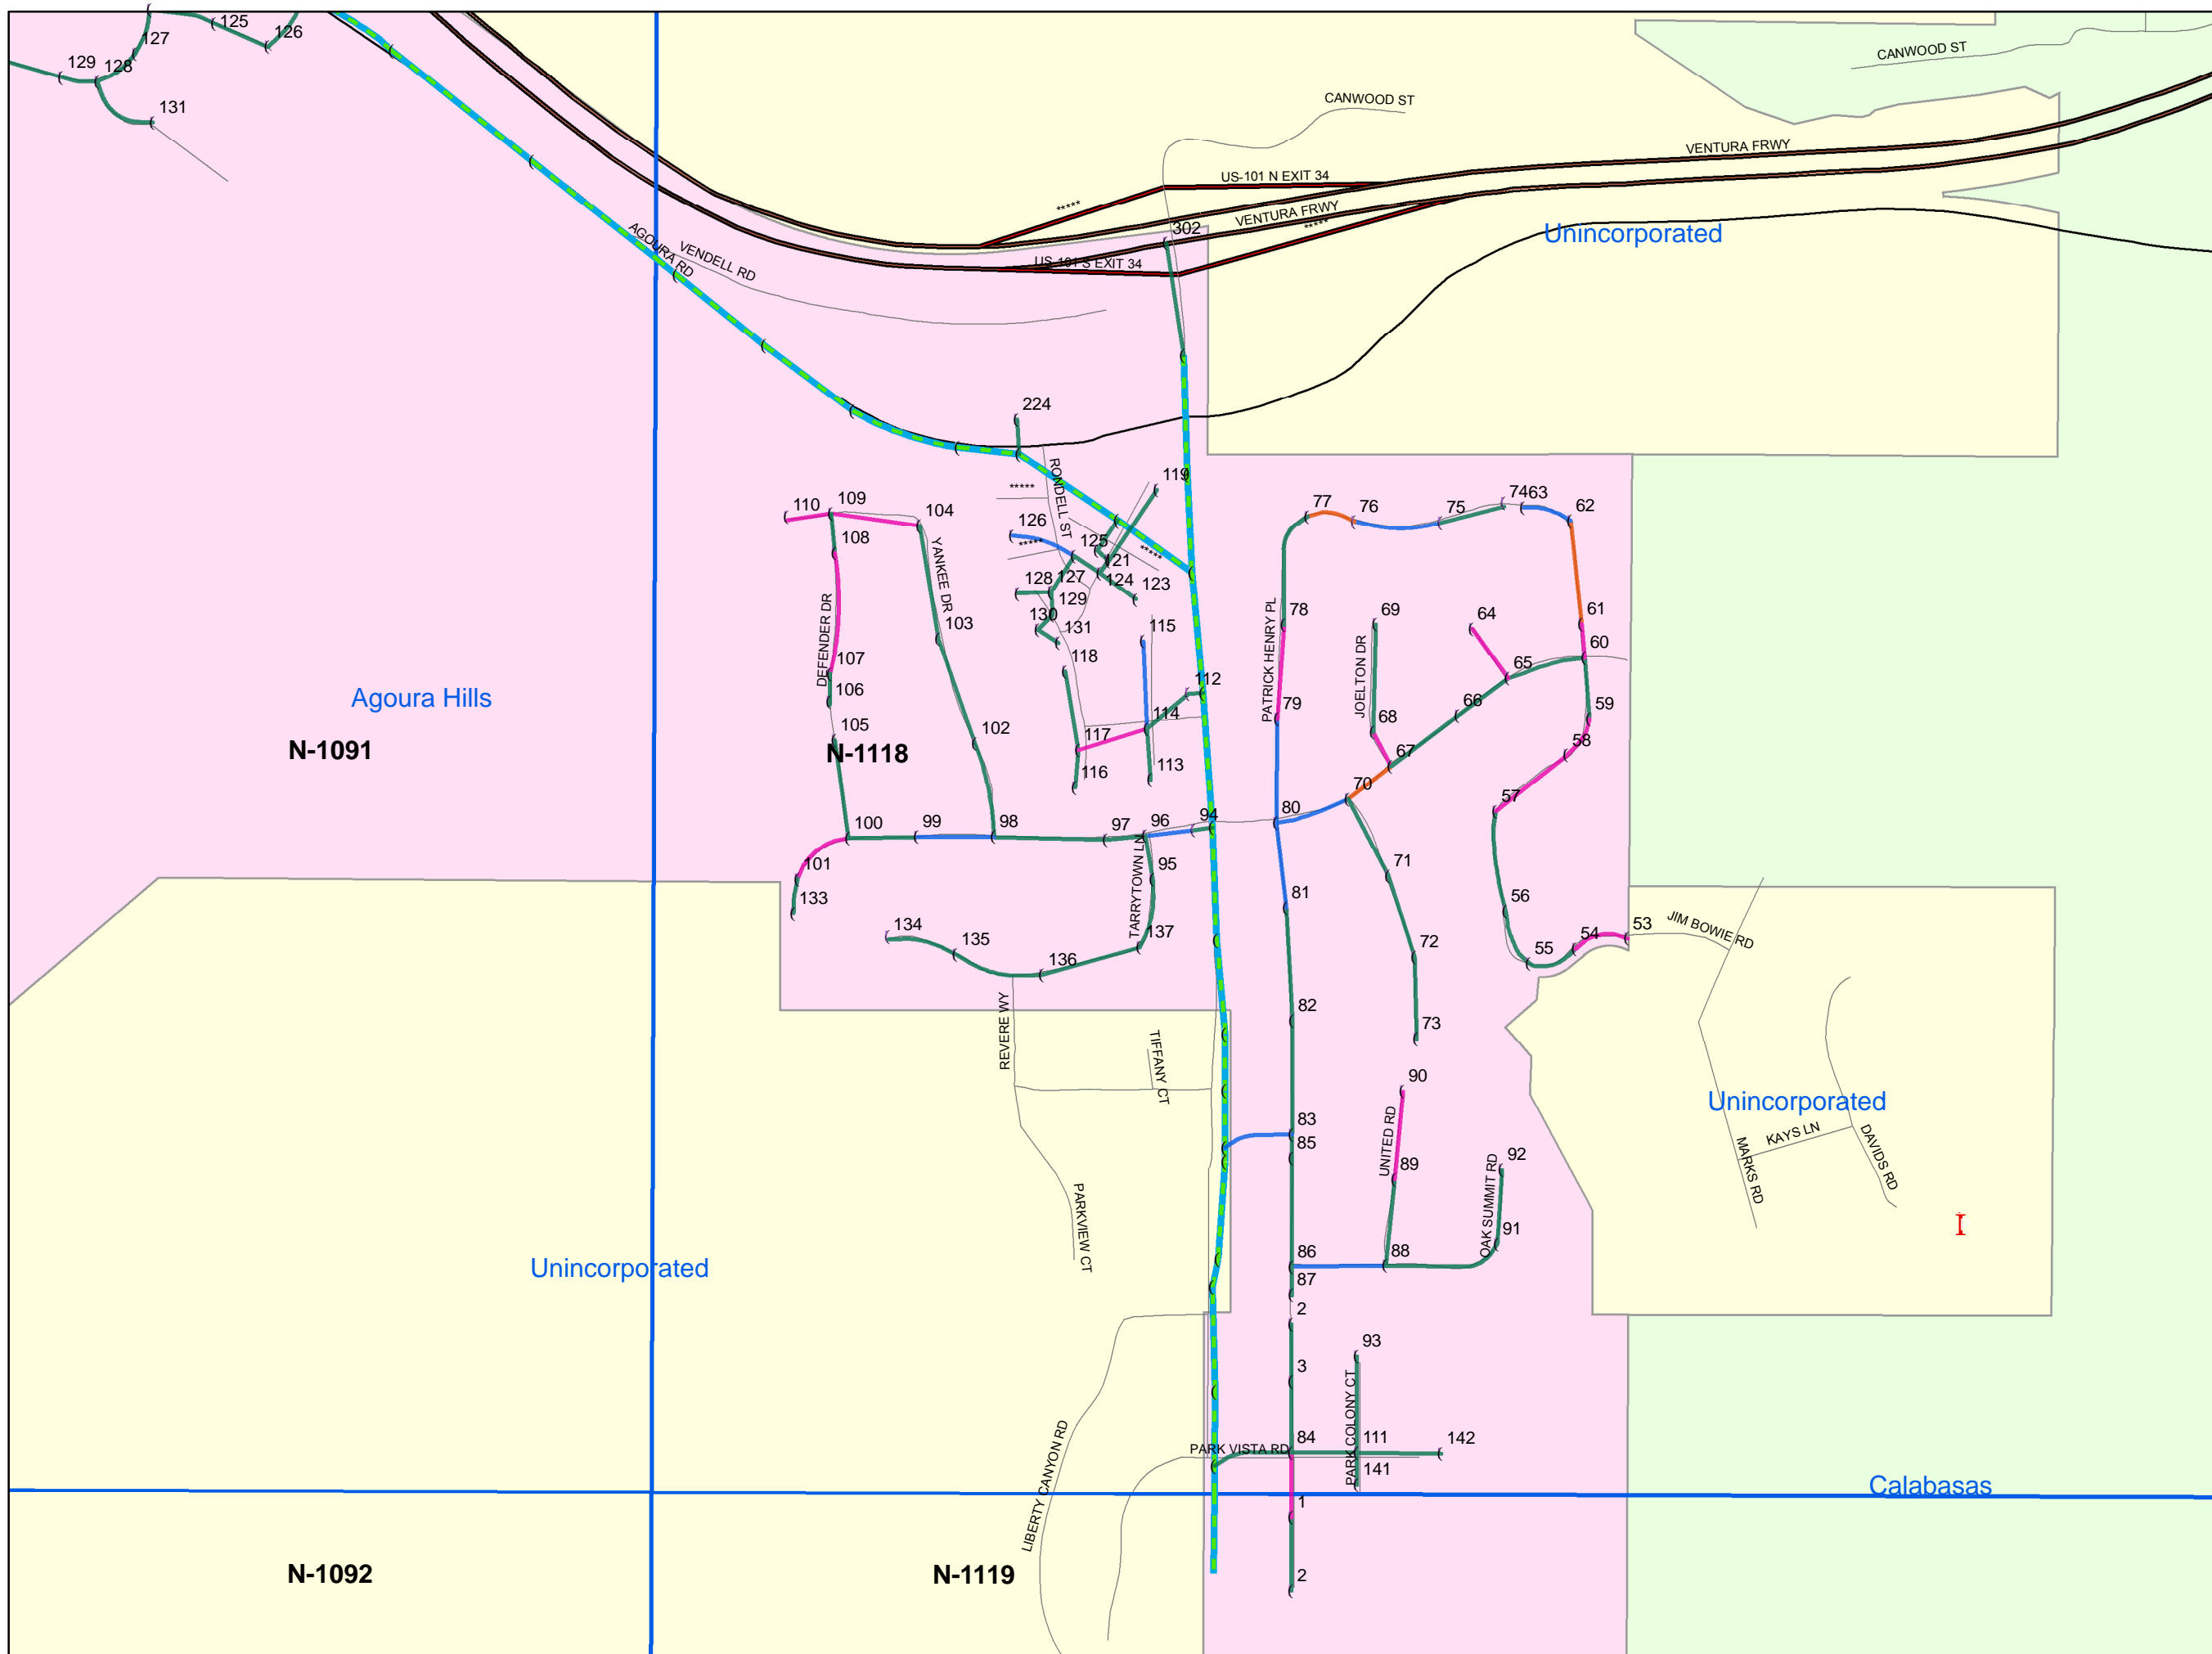
### QUICK STRUCTURAL RATING

Our inspection revealed that approximately 90.3 percent of the inspected pipe segments within the City were free of severe structural defects. The remaining 9.7 percent of the inspected pipe segments had a PACP structural grade of 4 or 5 as indicated in the Quick Structural Rating Table shown below. These segments have been placed on a priority list based on the severity and the need for action. For items 1 through 40 in the Quick Structural Rating Report Priority List (Enclosure 3), which warrant a corrective action, the proposed corrective action will be programmed in the next 24 months as part of the ongoing Accumulative Capital Outlay Program.

A color-coded map showing the Quick Structural Rating for each pipe segment is located in Enclosure 3.

<b>ITEM NO.</b>	<b>START MH</b>	<b>END MH</b>	<b>STREET</b>	<b>OBSERVATION</b>	<b>PROPOSED CORRECTIVE ACTION</b>
1	1118-0067	1118-0070	COUNTRY GLEN RD	Hole	Point Repair
2	1118-0076	1118-0077	PROVIDENT RD	Fracture, Hole	Point Repair
3	1091-0105	1091-0106	DRIVER AV	Deformed	No action needed*
4	1091-WEST	1091-0119	AGOURA RD	Broken	Lining
5	1091-0111	1091-TRNK	DOROTHY DR	Broken	Lining
6	1118-0062	1118-0061	JIM BOWIE RD	Hole	Point Repair
7	1090-0135	1090-0136	EAGLETON ST	Broken	Point Repair
8	1090-0178	1090-0179	CALABRIA DR	Broken	No action needed*
9	1118-0067	1118-0068	JOELTON DR	Fractures	No action needed*
10	1118-0060	1118-0061	JIM BOWIE RD	Fractures	No action needed*
11	1118-0064	1118-0065	GADSHILL LN	Fracture	No action needed*
12	1118-0058	1118-0059	JIM BOWIE RD	Fracture	No action needed*
13	1090-0112	1090-0117	CAPRICORN AV	Fracture	No action needed*
14	1091-0118	1091-0119	CALLE ROBLEDA	Joint offset	No action needed*

15	1118-0057	1118-0058	JIM BOWIE RD	Fractures	Point Repair
16	1118-0100	1118-0101	COUNTRY GLEN RD	Fractures	No action needed*
17	1091-0108	1091-0109	DRIVER AV	Sag	No action needed*
18	1090-0299	1090-0310	DRIVER AV EASEMENT	Fractures	No action needed*
19	1119-0001	1119-0084	PATRICK HENRY PL	Fractures	No action needed*
20	1091-0009	1091-TRNK	CANWOOD ST	Fractures	No action needed*
21	1091-0022	1091-TRNK	AGOURA RD EASEMENT	Fractures	No action needed*
22	1118-0053	1118-0054	JIM BOWIE RD	Broken	Point Repair

<b>ITEM NO.</b>	<b>START MH</b>	<b>END MH</b>	<b>STREET</b>	<b>OBSERVATION</b>	<b>PROPOSED CORRECTIVE ACTION</b>
23	1090-0071	1090-0110	AQUARIUS AV EASEMENT	Fractures	No action needed*
24	1118-0078	1118-0079	PATRICK HENRY PL	Fractures	No action needed*
25	1118-0089	1118-0090	UNITED RD	Fractures	No action needed*
26	1091-0098	1091-0099	DERRY AVE	Fractures	No action needed*
27	1091-0100	1091-0101	WARING PLEASMENT	Fractures	No action needed*
28	1118-0104	1118-0109	ENDEAVOR ST	Fractures	No action needed*
29	1118-0107	1118-0108	DEFENDER DR	Fractures	No action needed*
30	1118-0109	1118-0110	ENDEAVOR ST	Fractures	No action needed*
31	1090-0110	1090-0111	COLINA VISTA ST	Fractures	No action needed*
32	1090-0111	1090-0112	COLINA VISTA ST	Fractures	No action needed*
33	1090-0112	1090-0113	COLINA VISTA ST	Fractures	No action needed*
34	1118-0114	1118-0117	LIBERTY CANYON RD	Fractures	No action needed*
35	1090-0117	1090-0118	ARIES ST	Fractures	No action needed*

36	1090-0118	1090-0119	ARIES ST	Fractures	No action needed*
37	1090-0155	1090-0156	BARDELL DR	Fractures	No action needed*
38	1090-0182	1090-0181	CARELL AV	Fractures	No action needed*
39	1090-0283	1090-0284	CONEJO DR	Fractures	No action needed*
40	1090-0396	1090-0397	LOTA LN PVT RD	Fractures	No action needed*

\*Structural deficiencies are categorized into groups of defects or observations with a wide range of severity. Each of these deficiencies received additional post inspection review and some of these were determined not likely to interfere with the normal operation of the sewer line due to the severity, size, and/or location of the deficiency. These segments will be reviewed during the next cycle of CCTV inspections.
