### **CONSOLIDATED SEWER MAINTENANCE DISTRICT CONDITION ASSESSMENT PROGRAM REPORT PROJECT Y0TV0506D**

**CONDITION ASSESSMENT REPORT  
COUNTY OF LOS ANGELES DEPARTMENT OF PUBLIC WORKS  
CONSOLIDATED SEWER MAINTENANCE DISTRICT**

PROJECT NAME:	Y0TV0506D	PROJECT MGR:	Kari Eskridge
PROJECT DATE	4/17/06-8/14/06	CONTACT NO:	(626) 300-3390
SUP. DISTRICT(s):	5	MAP PAGE(S):	2212, 2166, and 2428
Report By	Colin McCarter	Report Date.	01/13/09

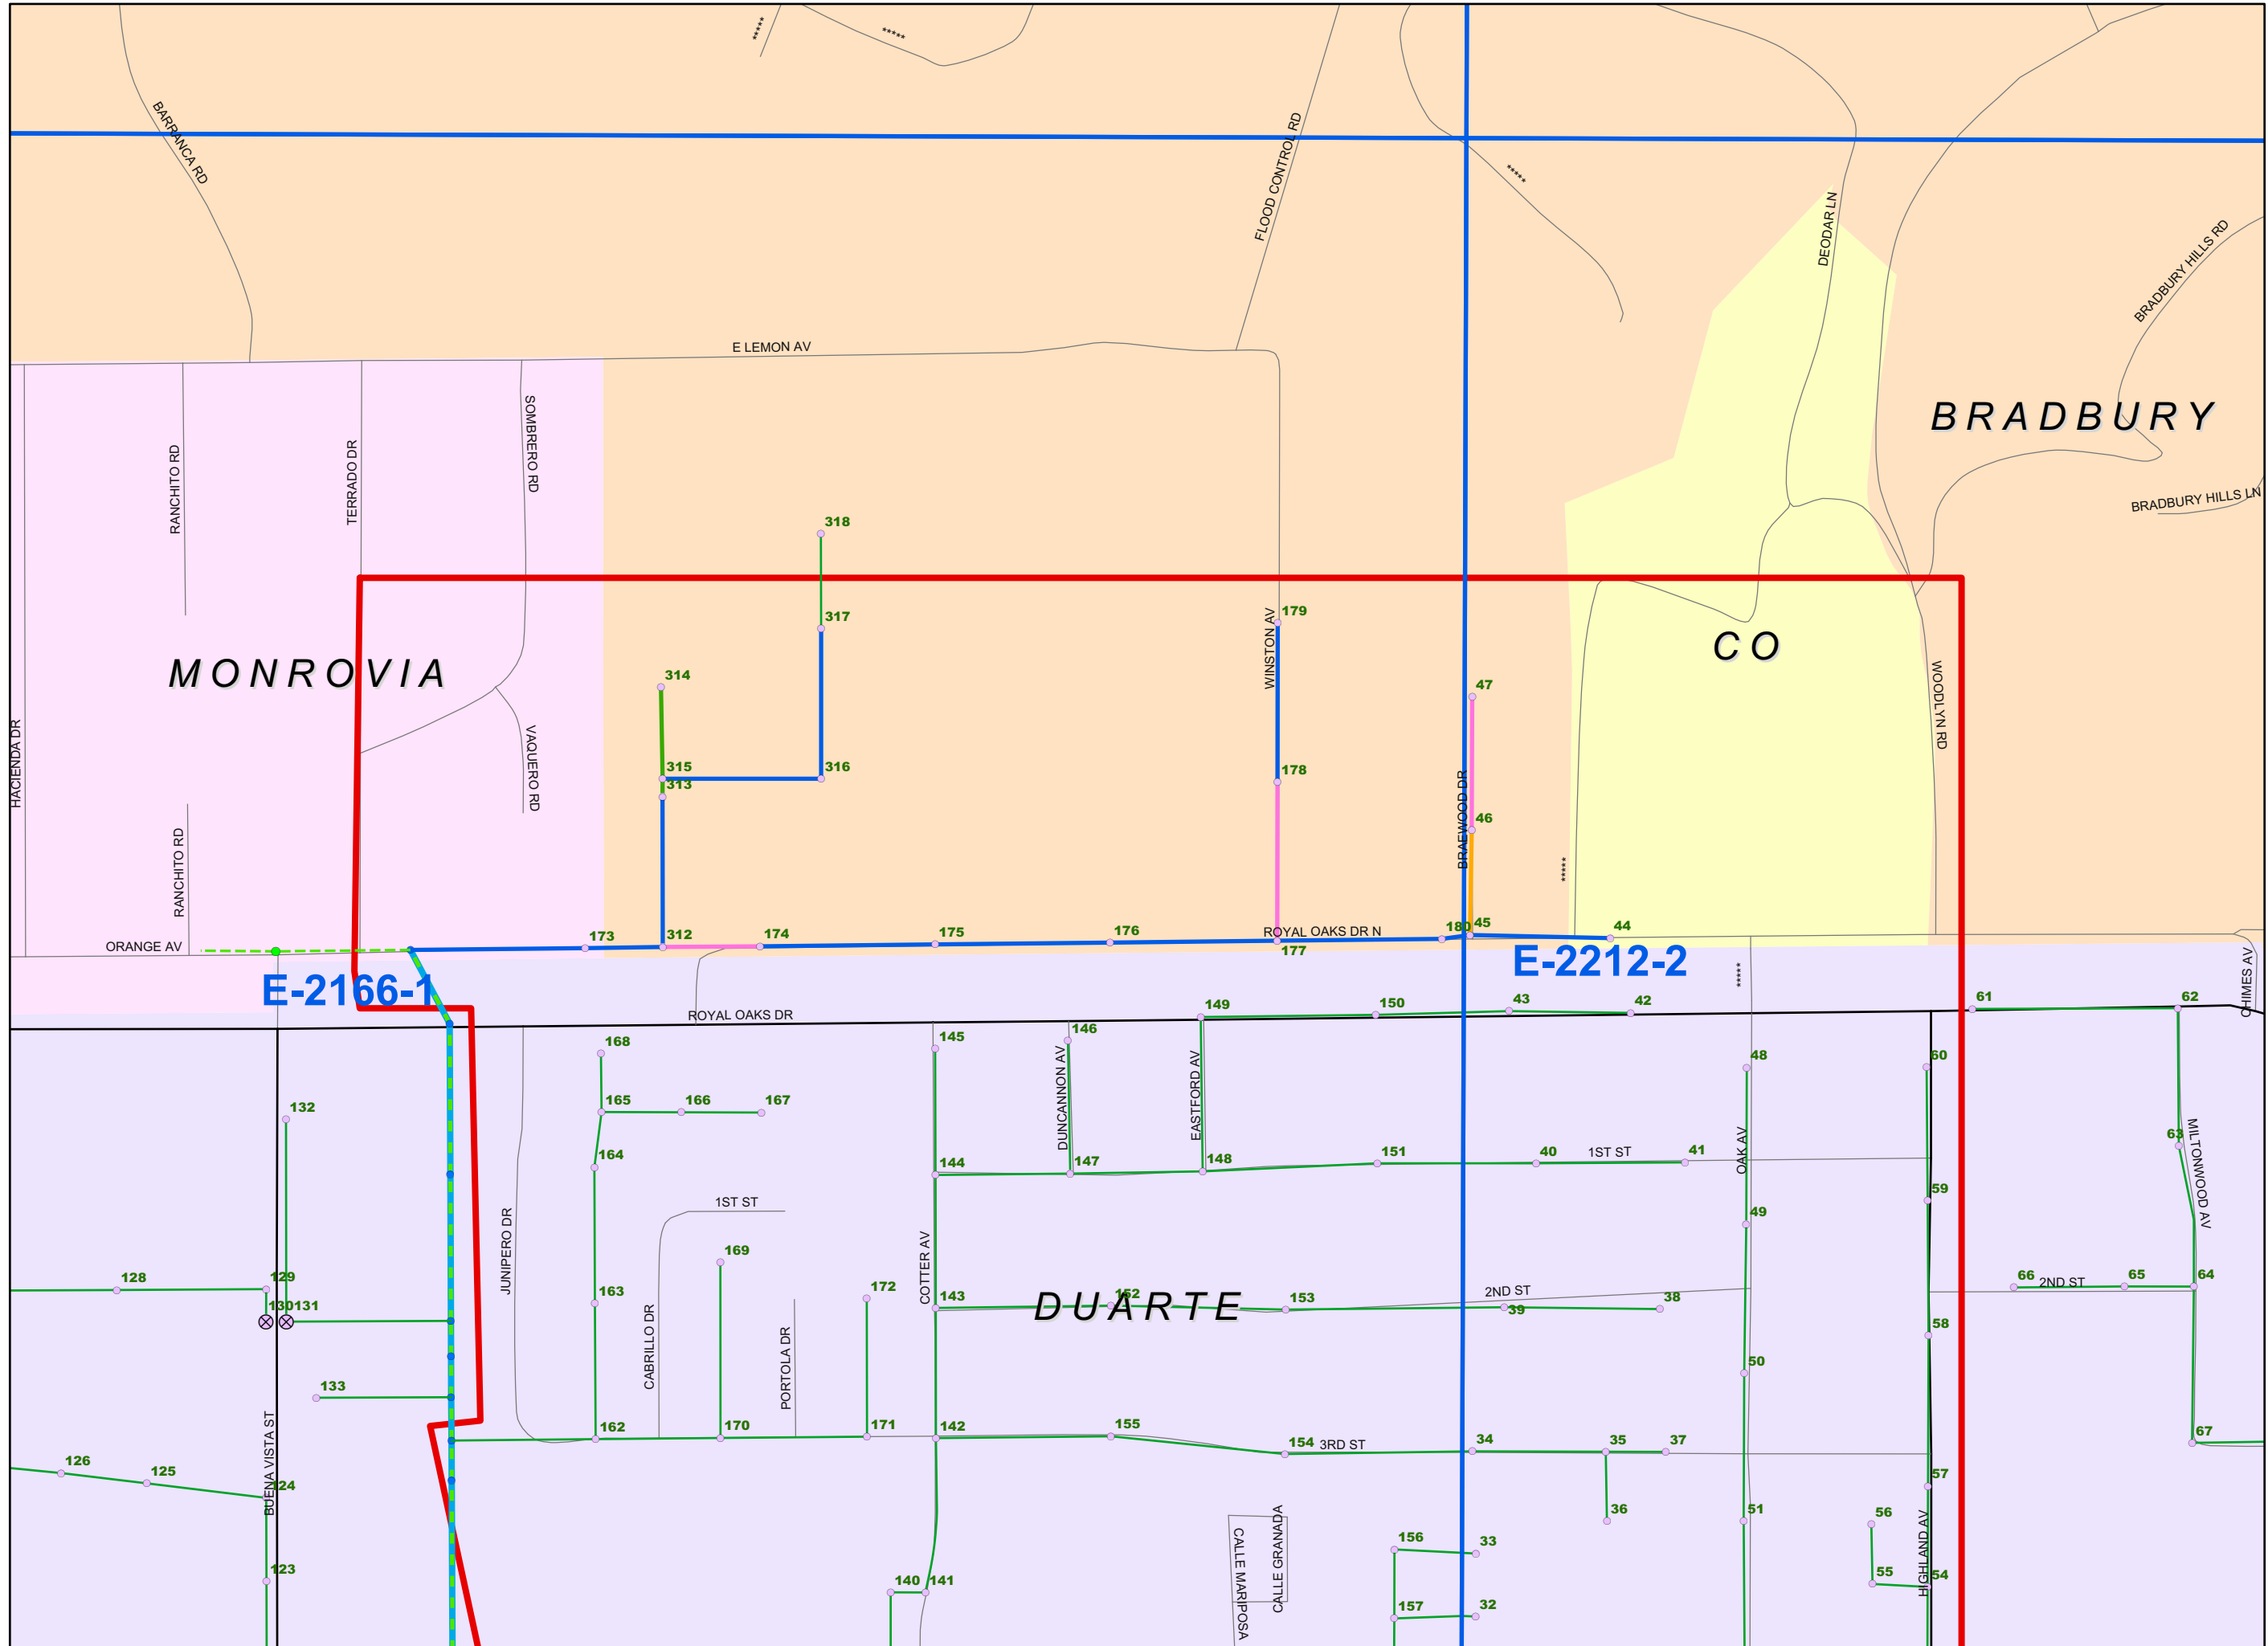
#### QUICK MAINTENANCE RATING (QMR)

Our inspection revealed that approximately 83.6 percent of the system televised was free of blockages or restrictions that would impede sewer flows. However, the remaining 16.4 percent of the inspected pipe segments within the City of Bradbury area had a PACP maintenance grade of 4 as indicated in the Quick Maintenance Rating Table shown below. These segments have been incorporated into our routine cleaning schedule with corrective action taken as noted on the Quick Maintenance Rating Report Priority List (Enclosure 2). Also included is a color-coded map showing the quick maintenance rating for each pipe segment.

<b>Item No.</b>	<b>QMR</b>	<b>Start MH</b>	<b>End MH</b>	<b>Street</b>	<b>Observation</b>	<b>Corrective Action Taken</b>
1	4121	2212-0047	2212-0046	BRAEWOOD DR	Roots	Rodder (Last Serviced: 7/29/08)
2	4131	2166-0178	2166-0177	WINSTON AV	Root ball	Rodder (Last Serviced: 7/25/08)
3	4121	2166-0174	2166-0312	ROYAL OAKS DR	Root ball	Rodder (Last Serviced: 7/25/08)

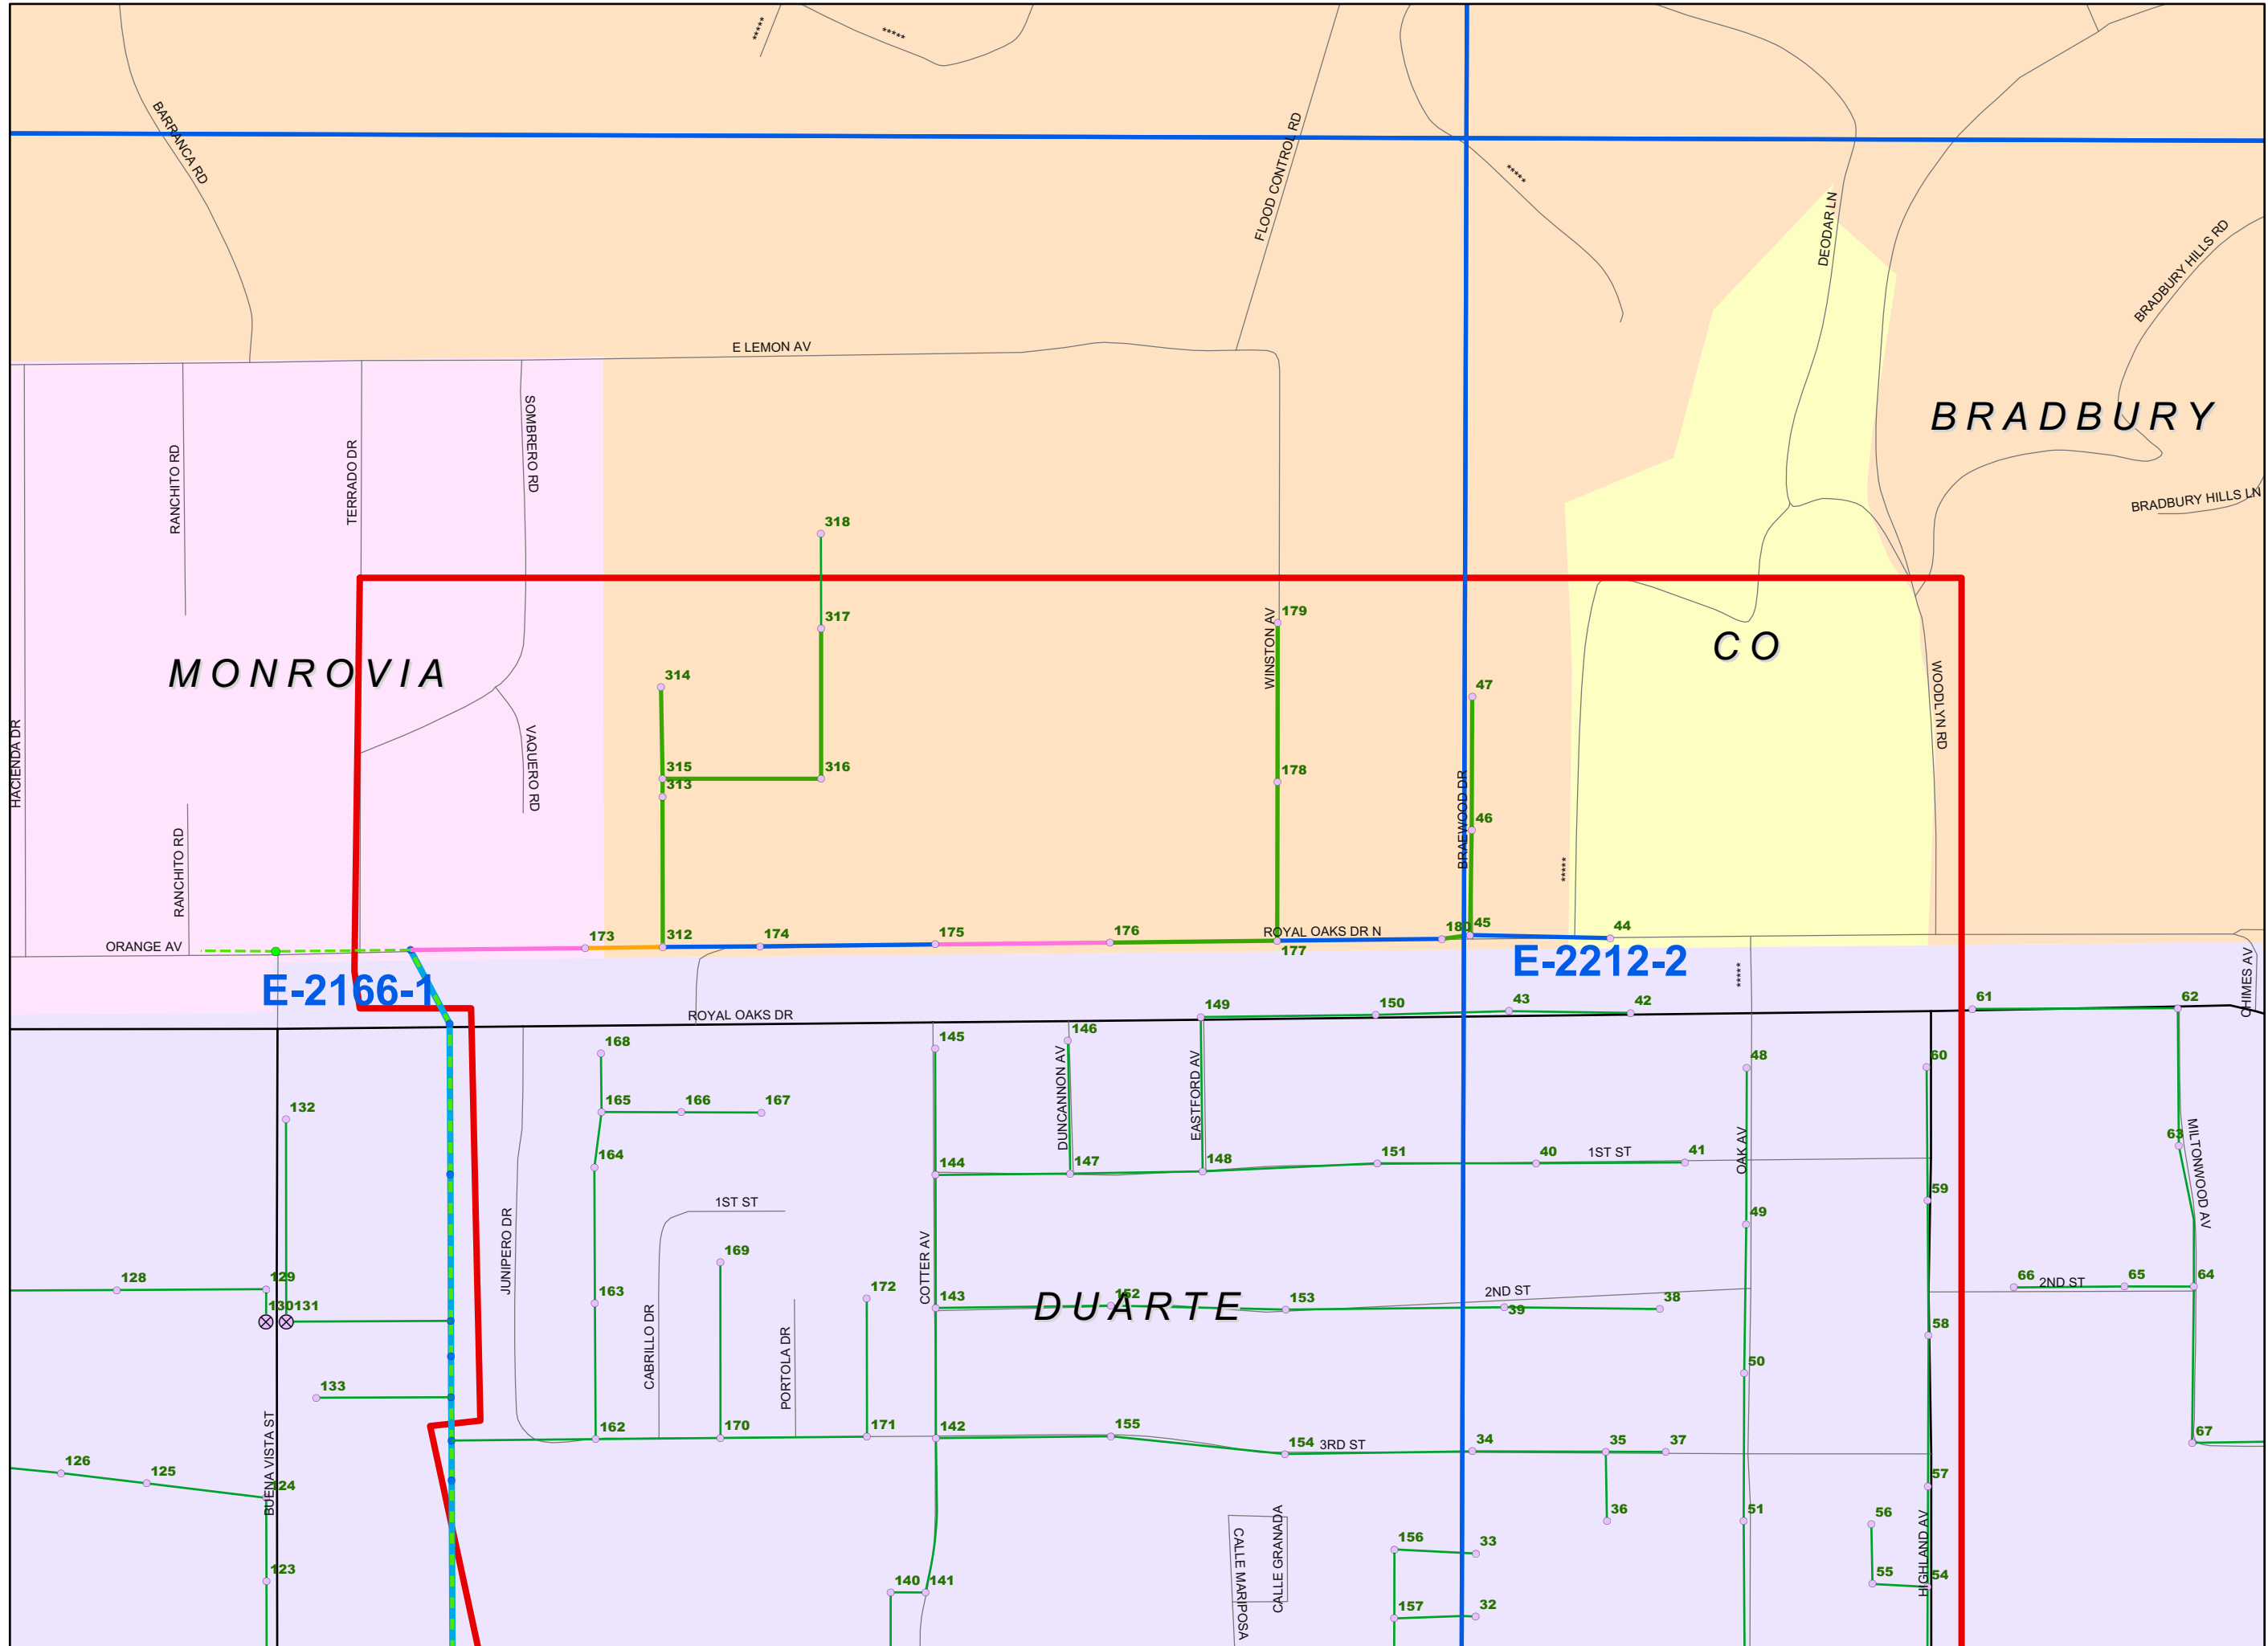
### QUICK STRUCTURAL RATING (QSR)

Our inspection revealed that approximately 92.8 percent of the inspected pipe segments within the City of Bradbury were free of severe structural defects. However, the remaining 7.2 percent of the inspected pipe segments had a PACP structural grade of 4 as indicated in the Quick Structural Rating Table shown below. These segments have been placed on a priority list based on the severity and the need for action. Item 1 in the Quick Structural Rating Report Priority List (Enclosure 3) includes defects that do not impact the structural integrity of the pipe. At this time, no action is recommended. A color-coded map showing the Quick Structural Rating for each pipe segment is located in Enclosure 3. A copy of the actual inspection reports for this segment is included in Enclosure 4.

<b>Item No.</b>	<b>QSR</b>	<b>Start MH</b>	<b>End MH</b>	<b>Street</b>	<b>Observation: Location</b>	<b>Proposed Corrective Method</b>
1	4221	2166-0176	2166-0175	ROYAL OAKS DR	Fractures: 201' and 241'	Structural integrity in tact. No action needed.
