**CONSOLIDATED SEWER MAINTENANCE DISTRICT
CONDITION-ASSESSMENT PROGRAM REPORT
PROJECT NO. Y0TV1314A2**

**CONDITION-ASSESSMENT REPORT
LOS ANGELES COUNTY PUBLIC WORKS
CONSOLIDATED SEWER MAINTENANCE DISTRICT**

CCTV PROJECT Y0TV1314A2

CITY OF CALABASAS

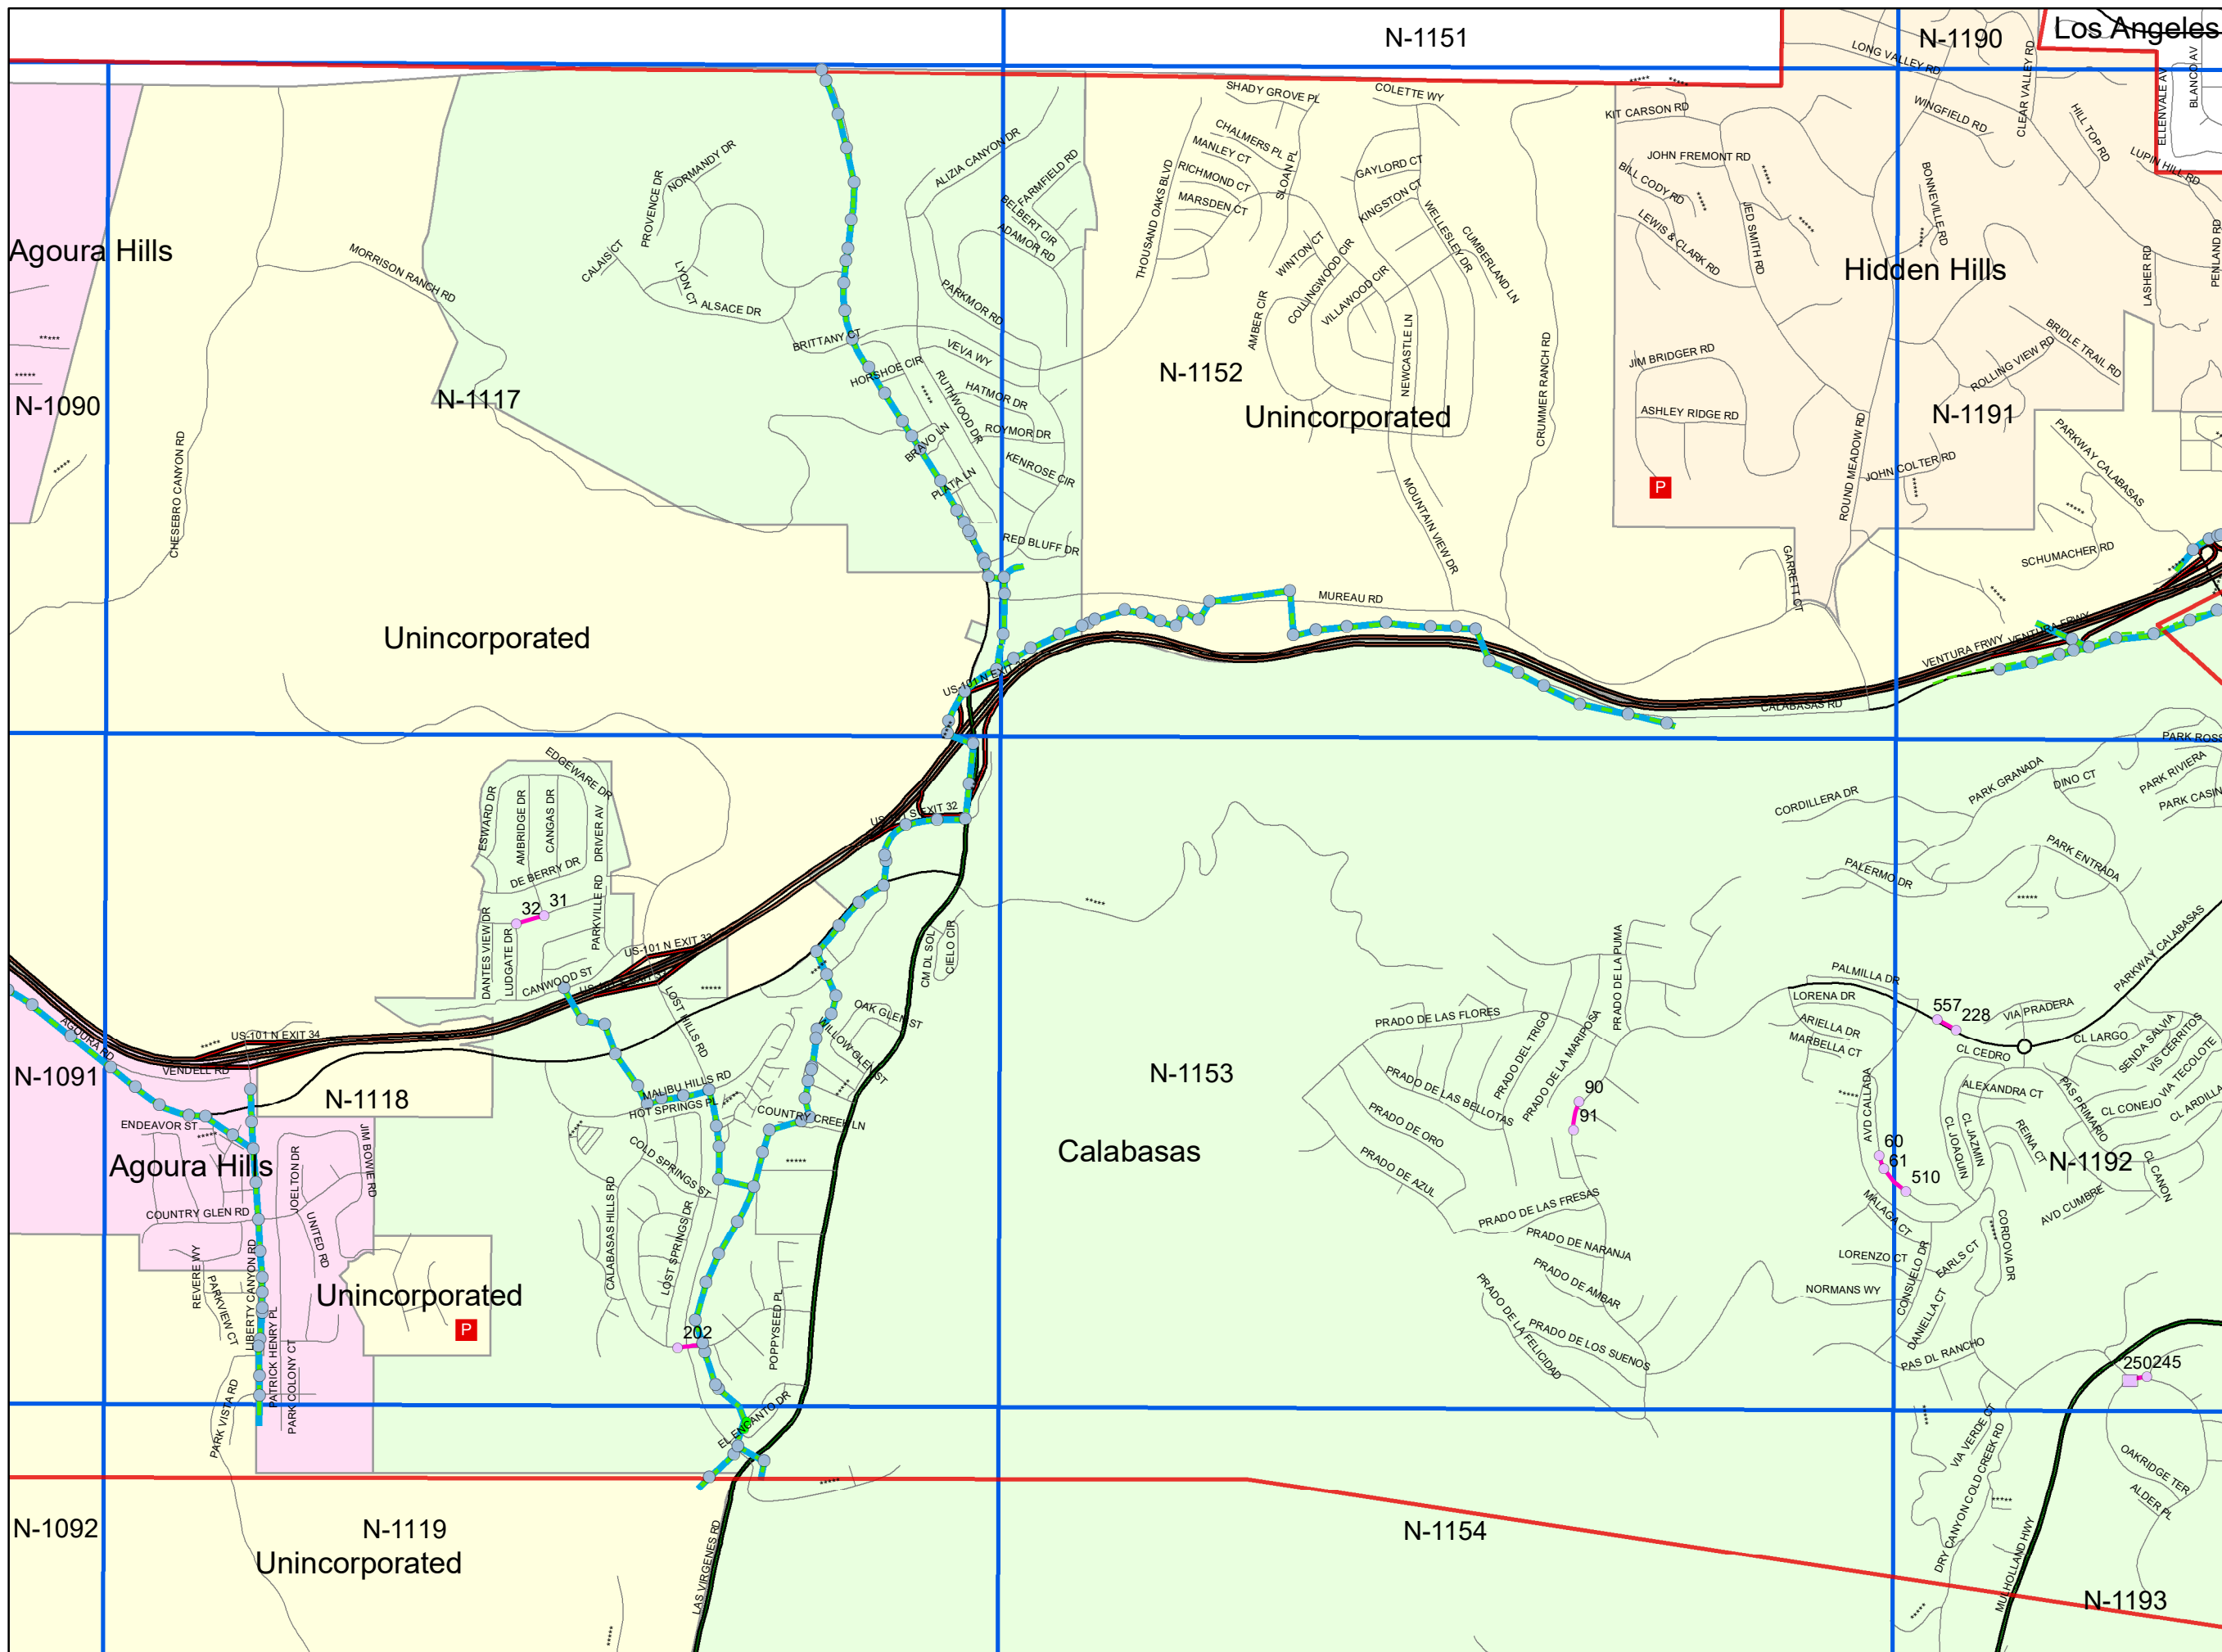
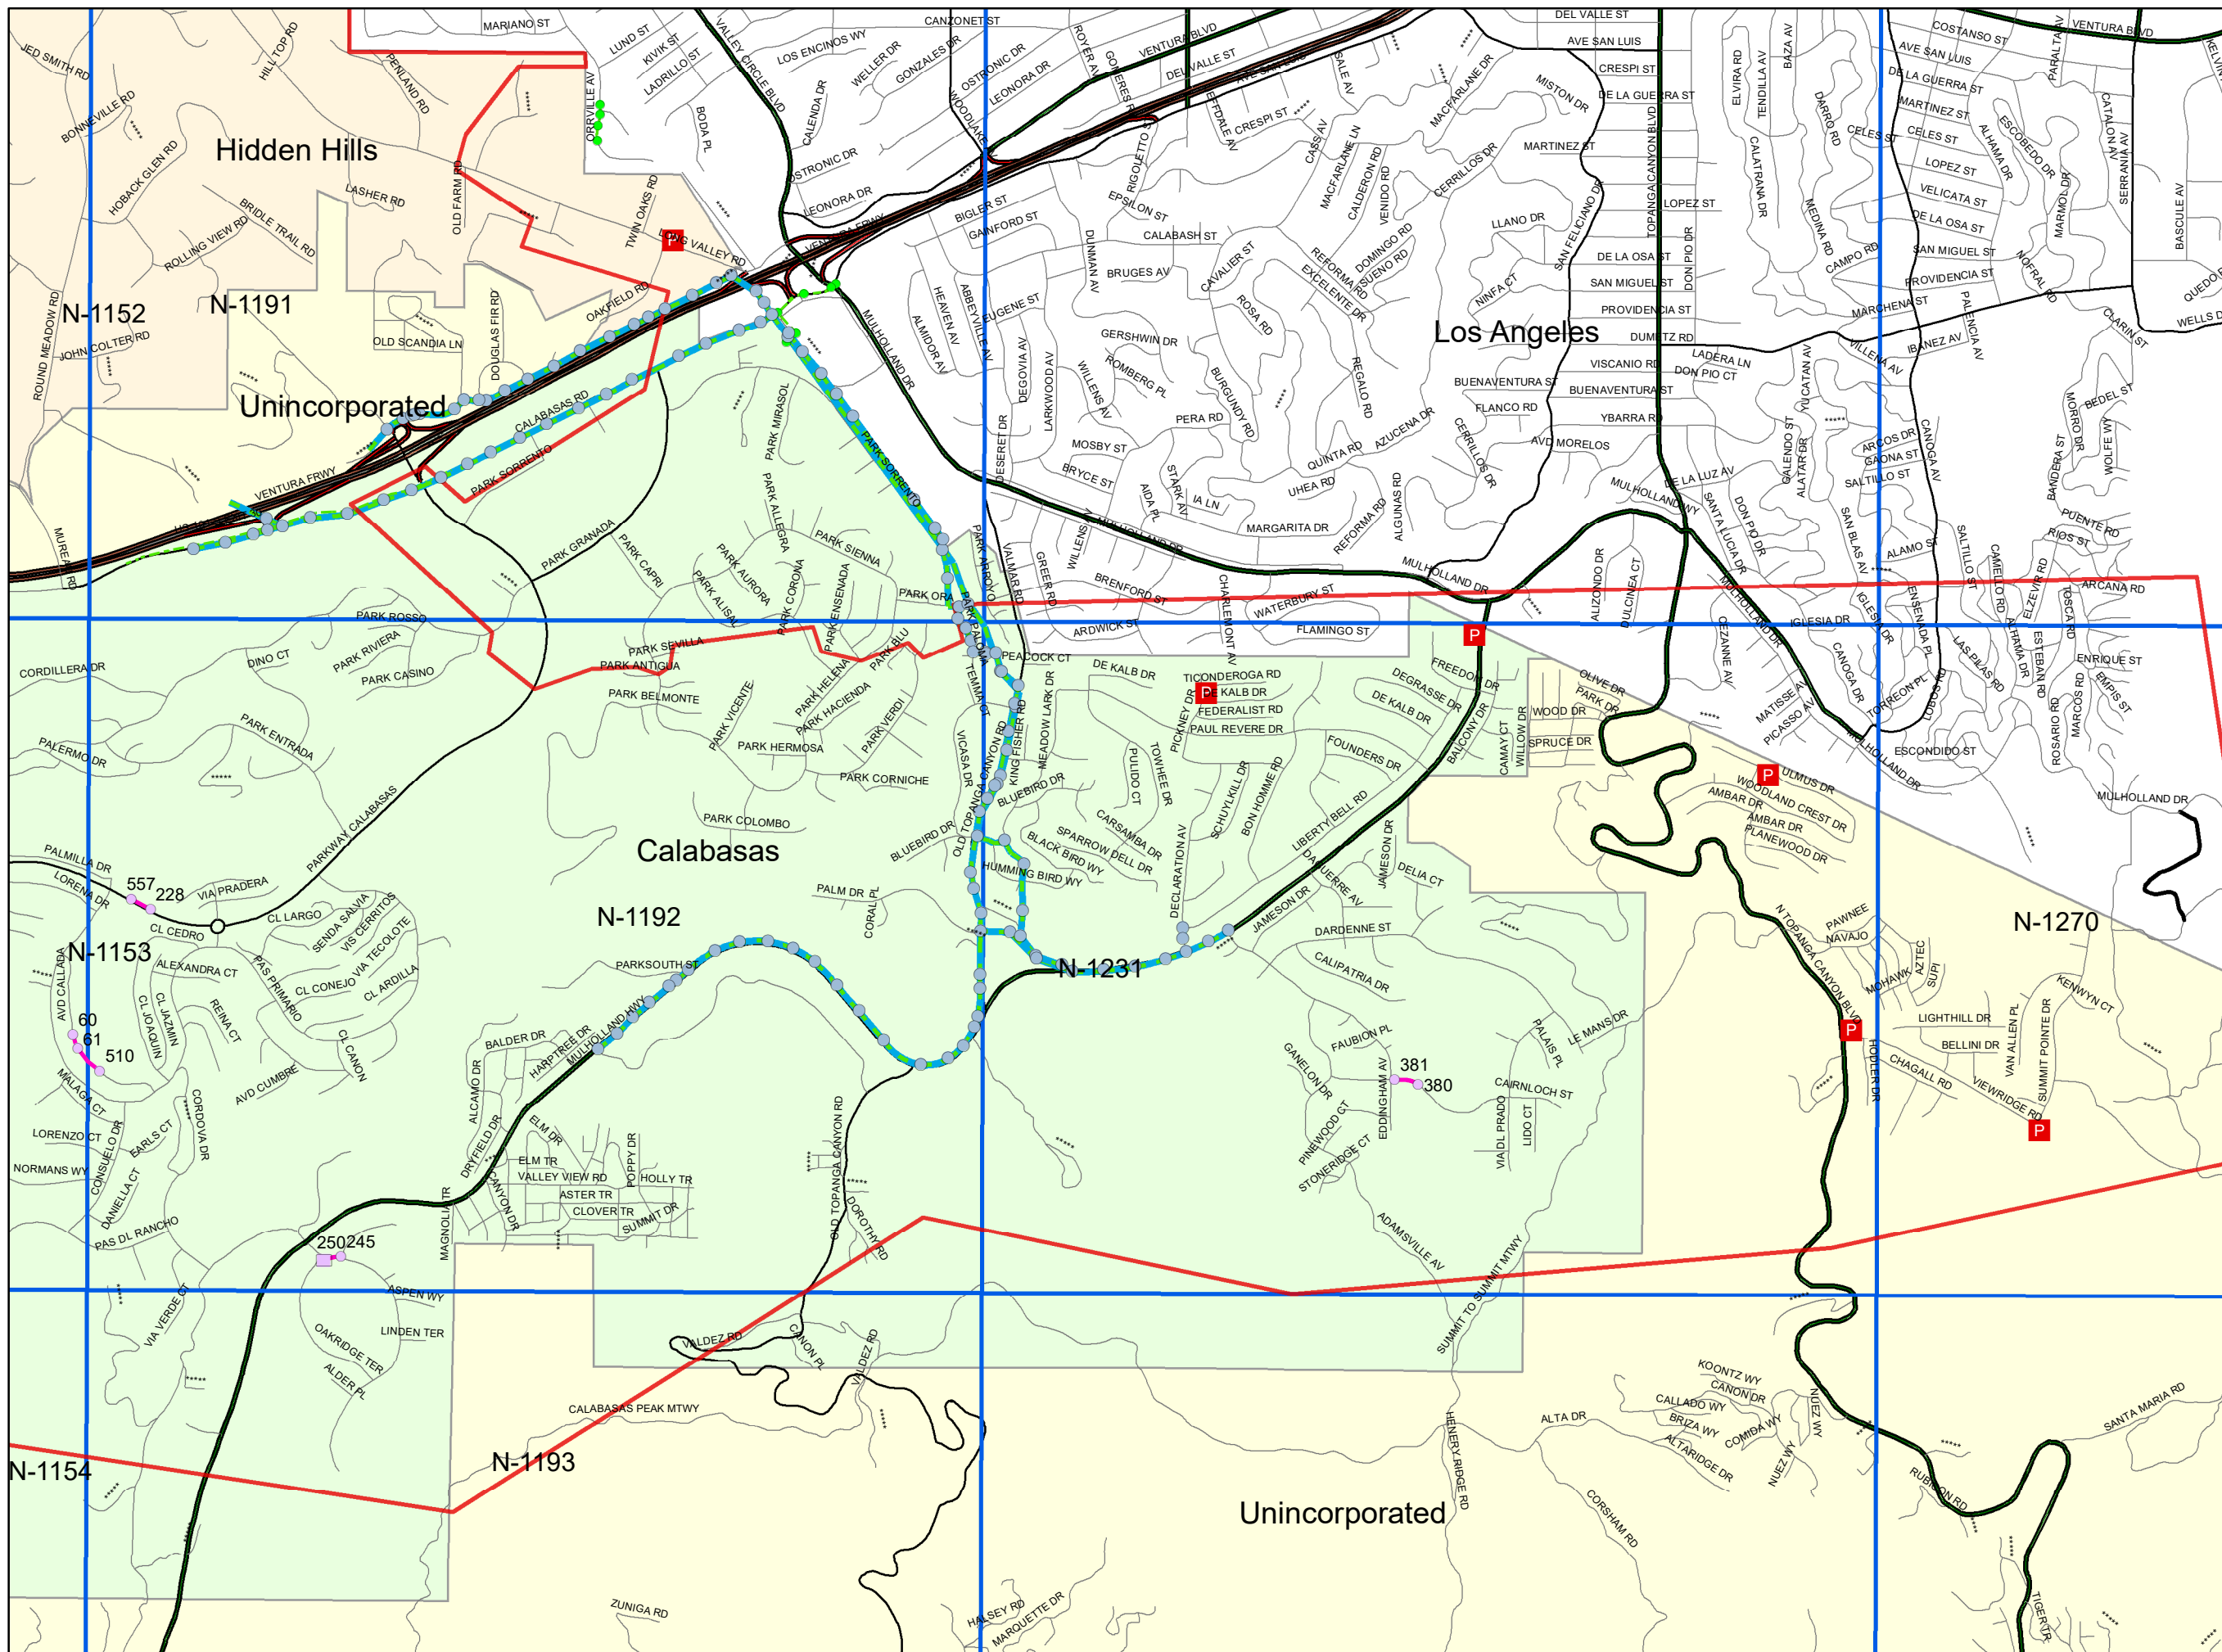
HIGH WATER LEVELS

| ITEM NO. | START MH | END MH | STREET | OBSERVATION: LOCATION | CAPACITY | CORRECTIVE ACTION |
|---|---|---|---|--|---|---|
| 1 | 1153-0091 | 1153-0090 | PARKWAY CALABASAS | High water mark; Sag | NO | Hydrojet |
| 2 | 1192-0250 | 1192-0245 | MOUNTAIN PARK DR | High water mark | NO | Hydrojet |
| 3 | 1118-0202 | 1118-TRNK | MEADOW CREEK LN | Camera under water; Sag | NO | Hydrojet |
| 4 | 1118-0031 | 1118-0032 | HELMOND DR | Camera under water; Sag | NO | Hydrojet |

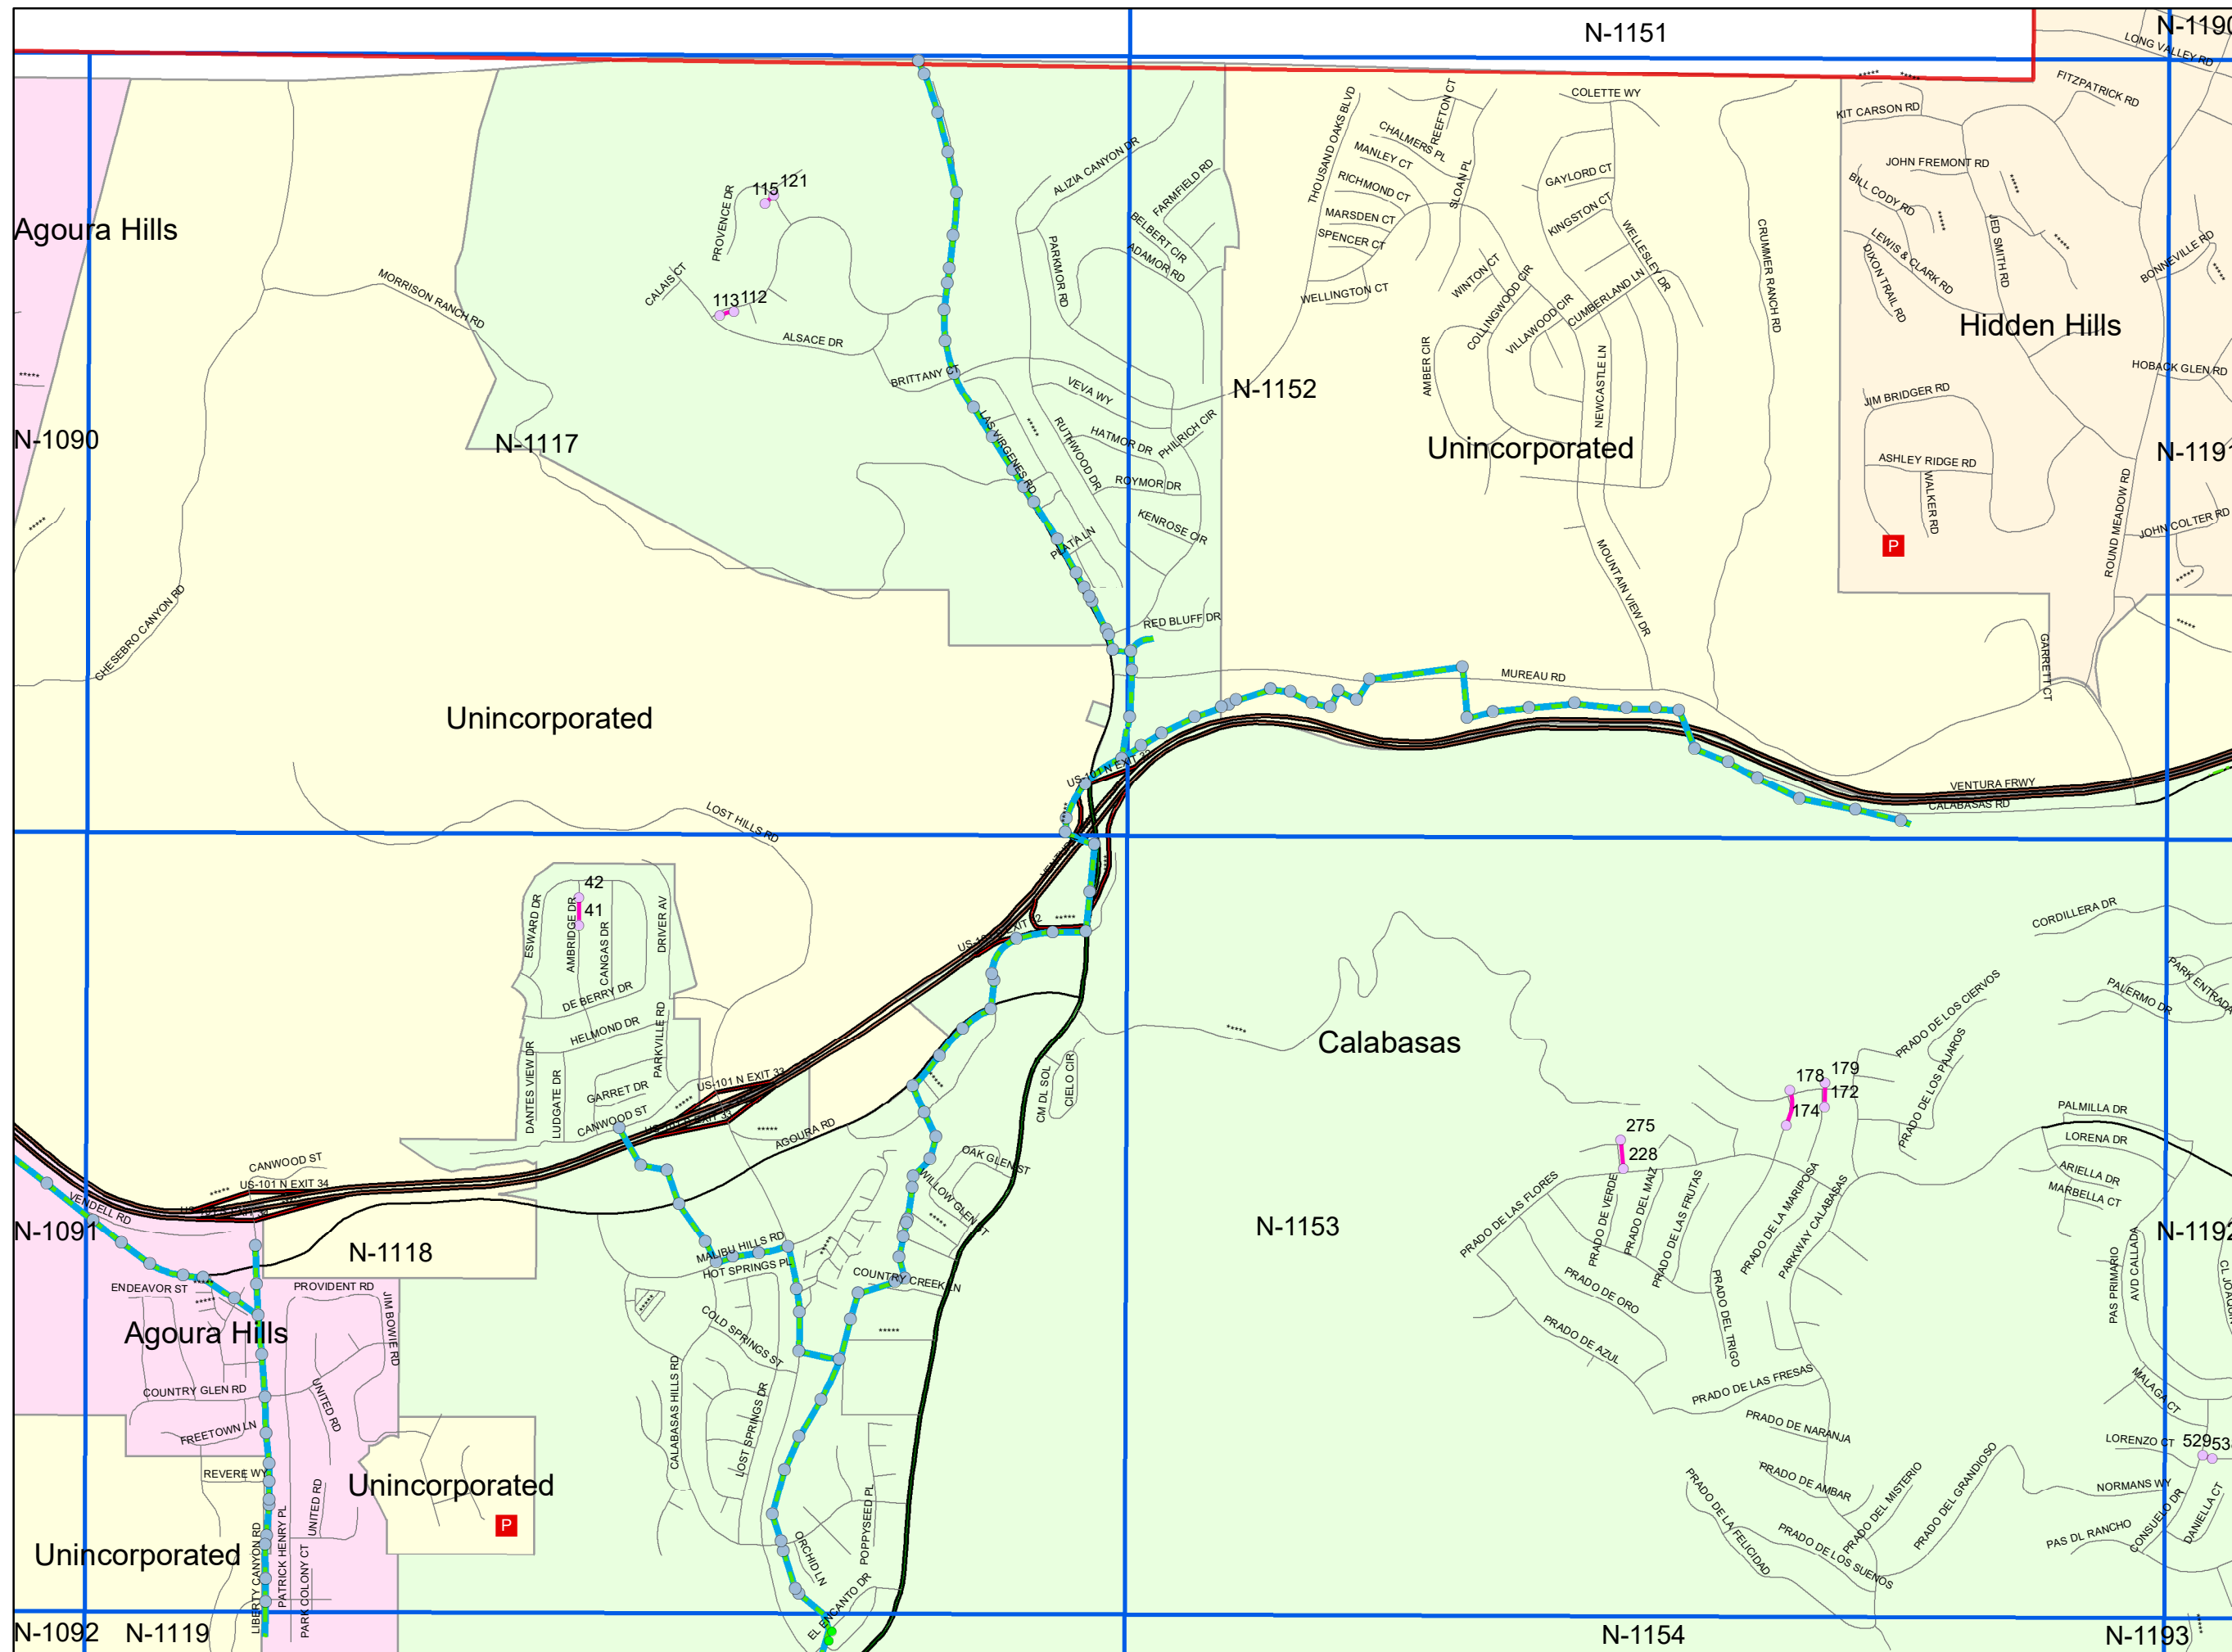
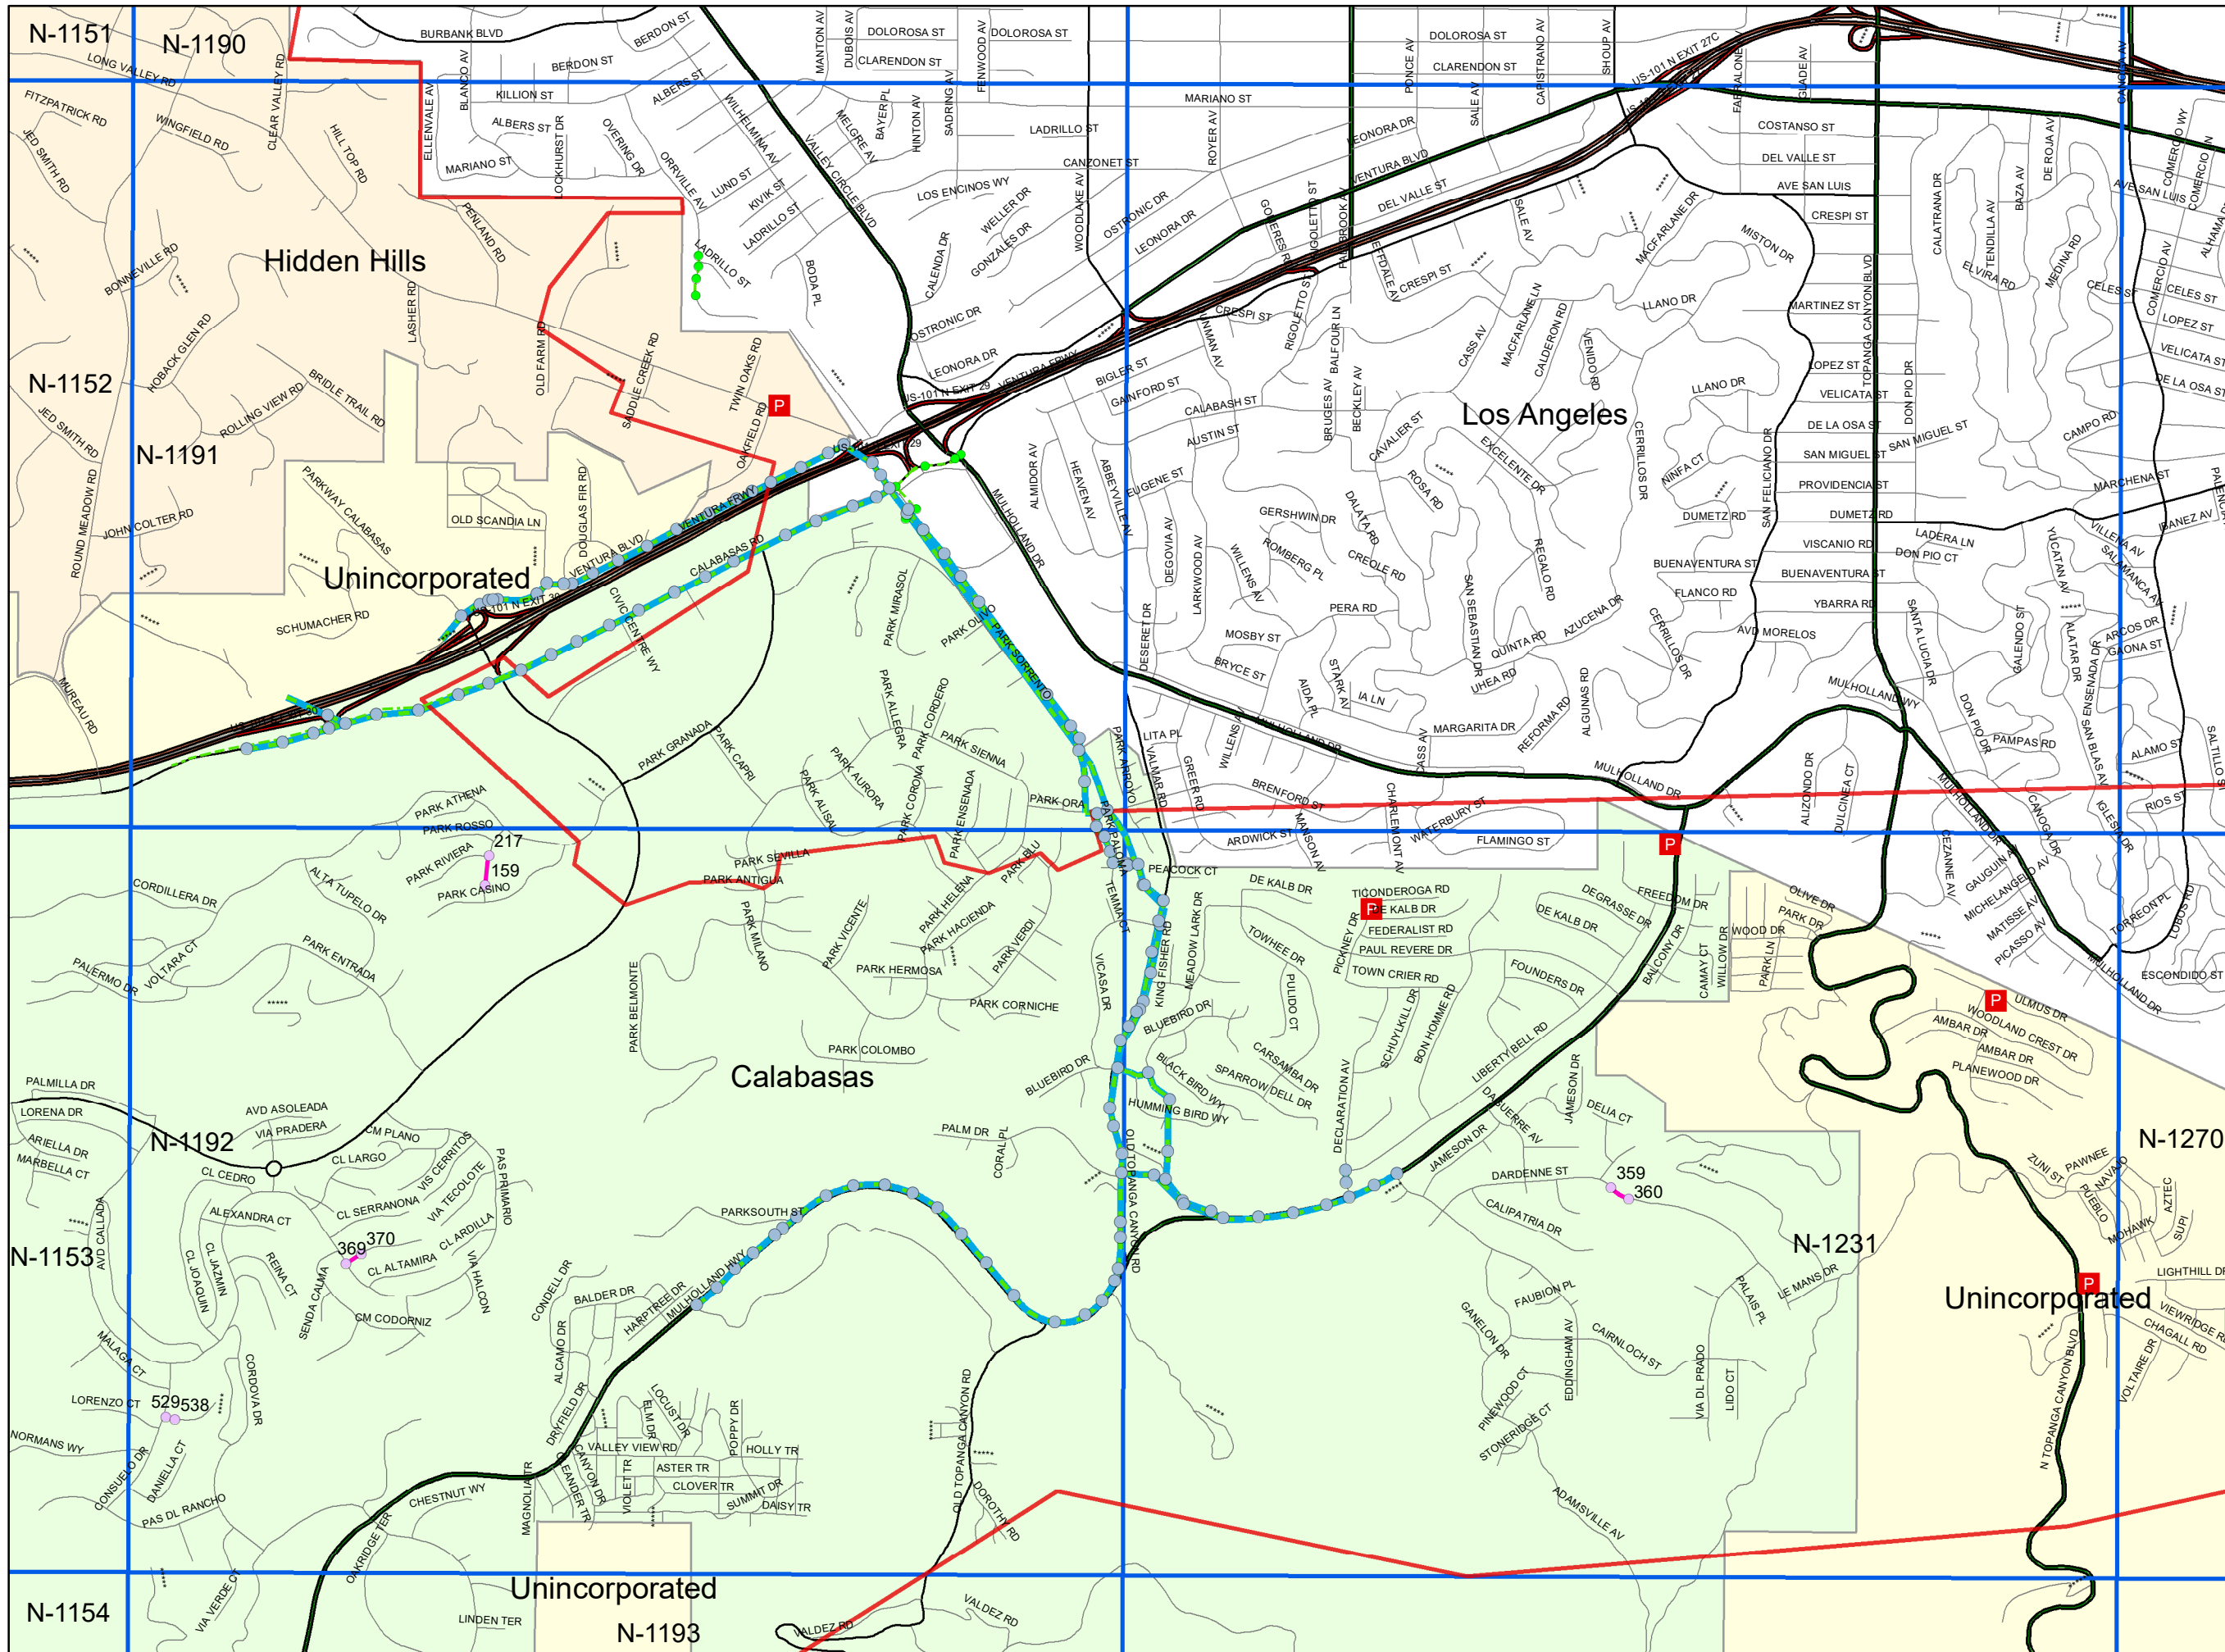
INFILTRATION

| ITEM NO. | START MH | END MH | STREET | OBSERVATION | PROPOSED CORRECTIVE METHOD | LENGTH OF REPAIR (FT) |
|---|---|---|---|---|--|---|
| 1 | 1118-0042 | 1118-0041 | AMBRIDGE DR | Infiltration runner: 0' | Infiltration is minimal. No action needed. | |
| 2 | 1231-0360 | 1231-0359 | DARDENNE ST | Infiltration dripper: 100' | Lining: MH to MH | 214 |
| 3 | 1192-0538 | 1192-0529 | EARLS CT | Infiltration dripper: 80' | Lining: MH to MH | 80 |
| 10 | 1192-0370 | 1192-0369 | CALLE CONEJO | Infiltration runner: 156' | Lining: MH to MH | 182 |

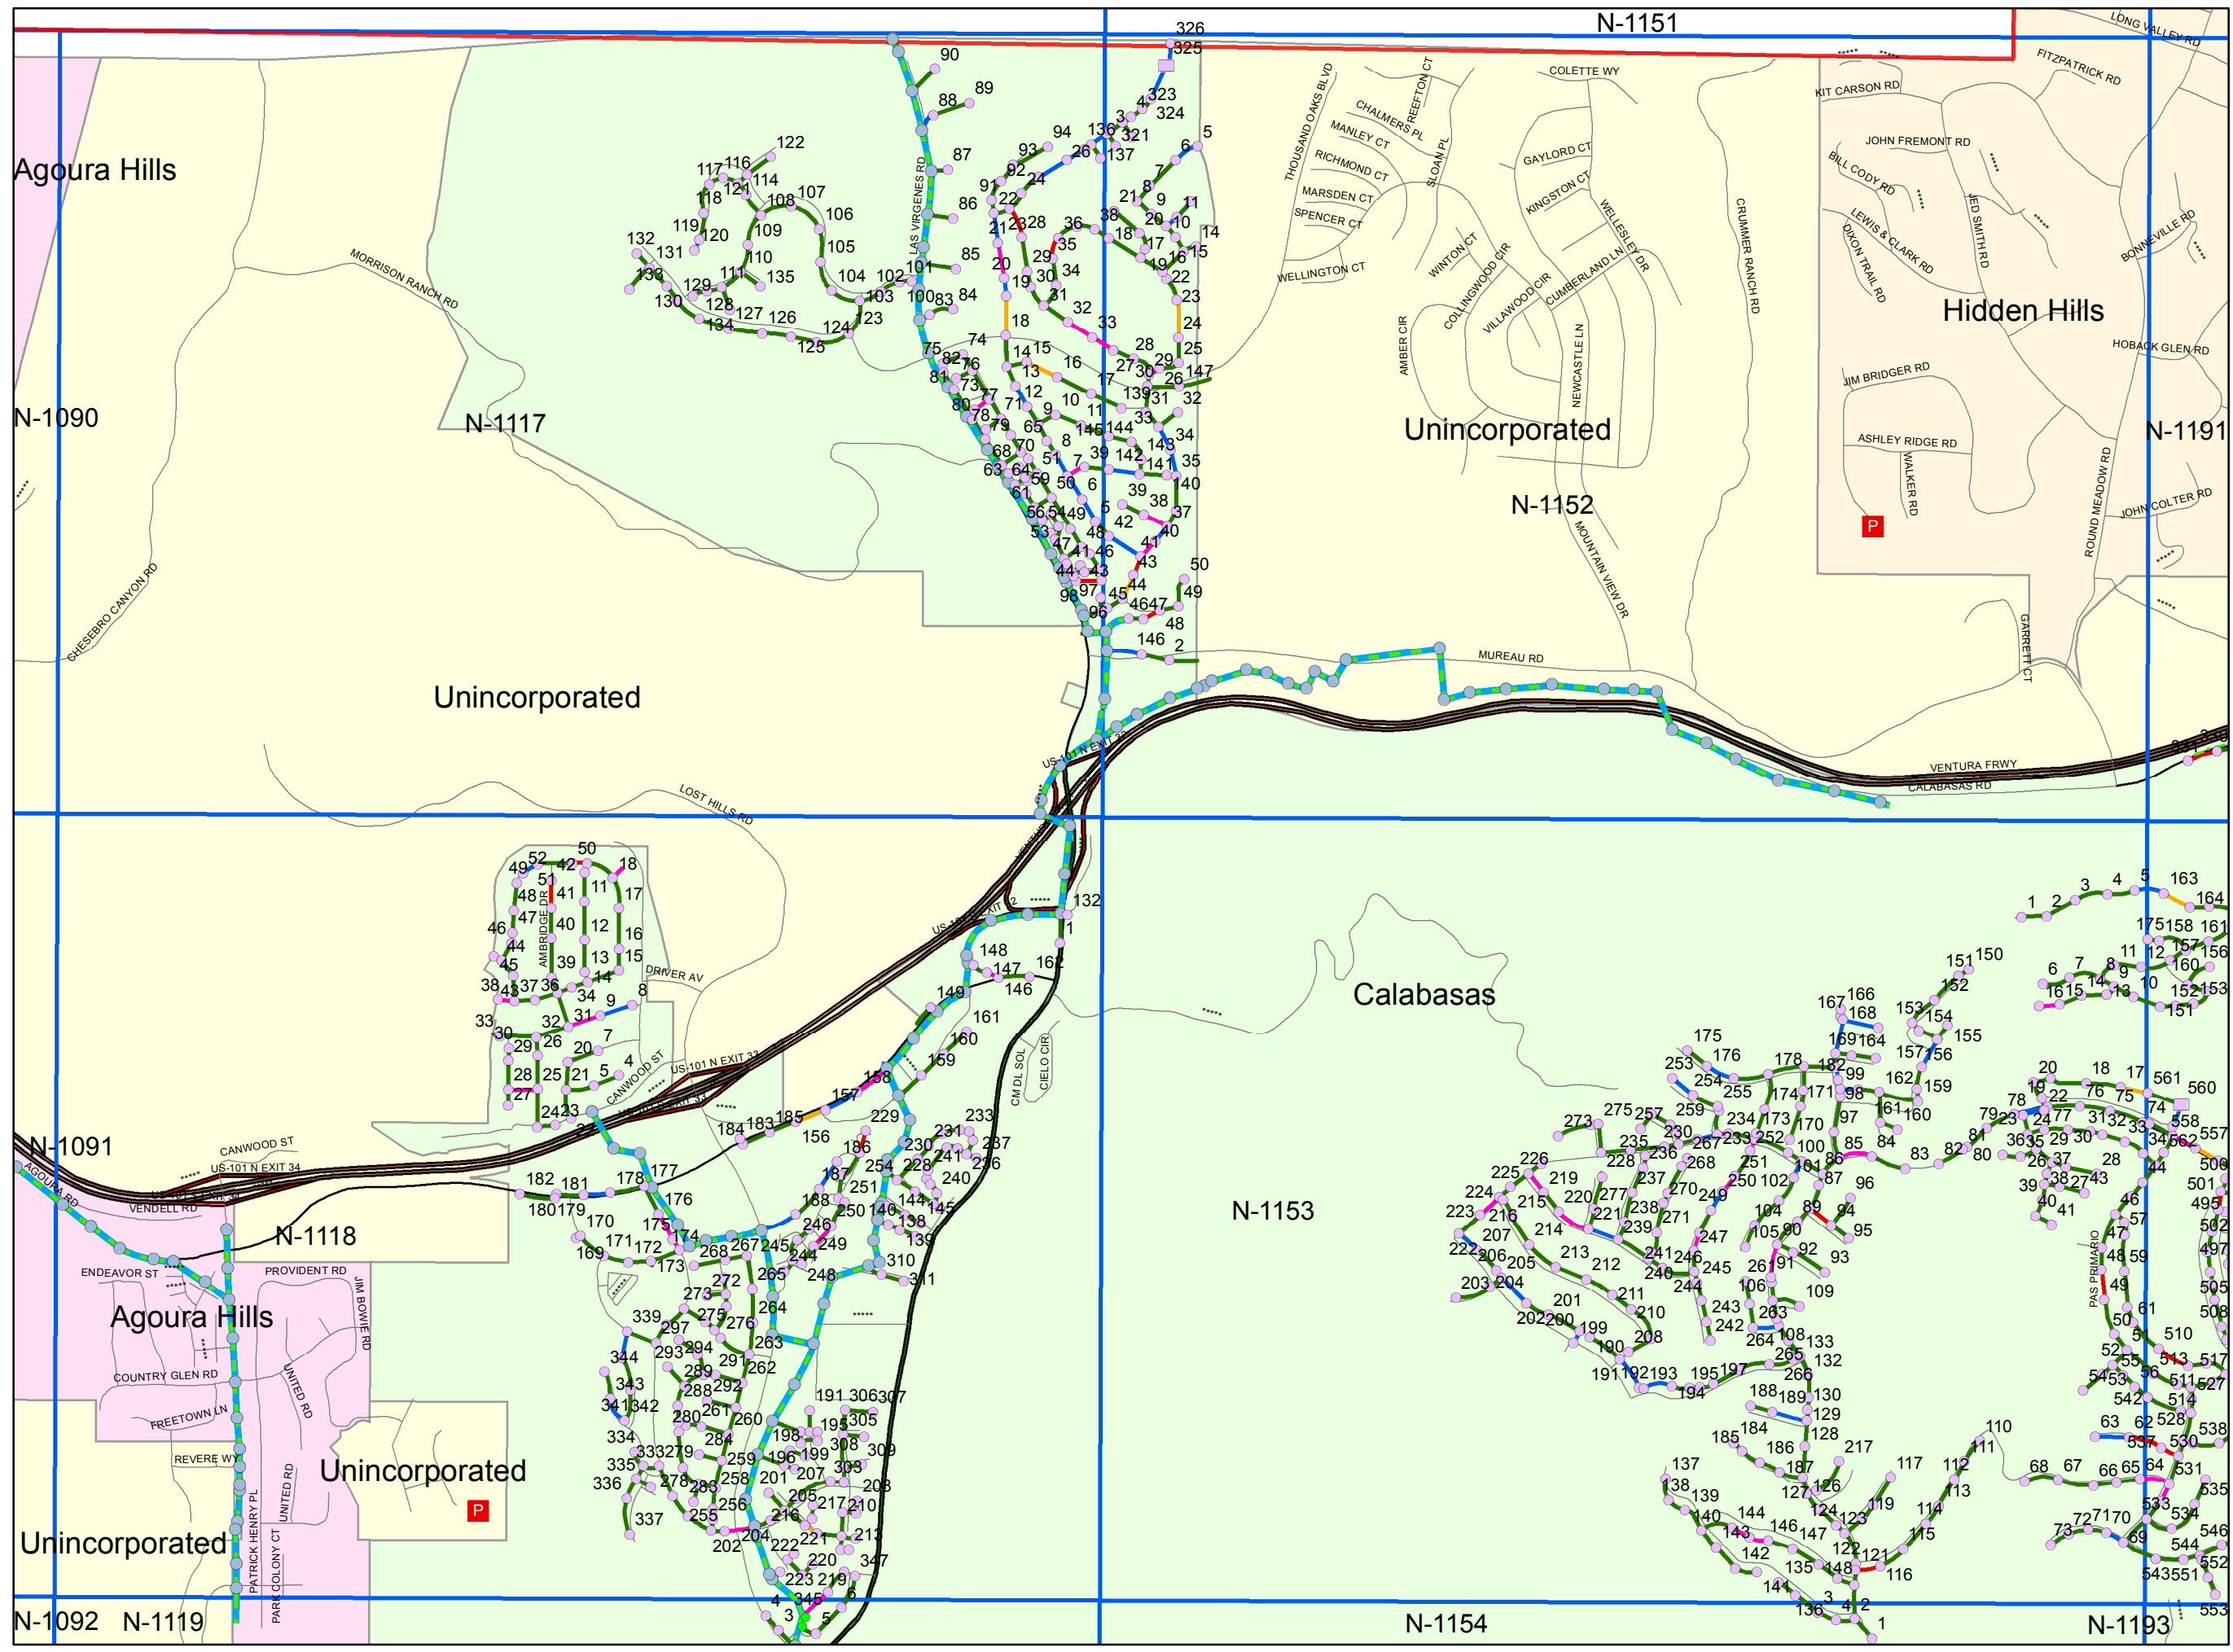
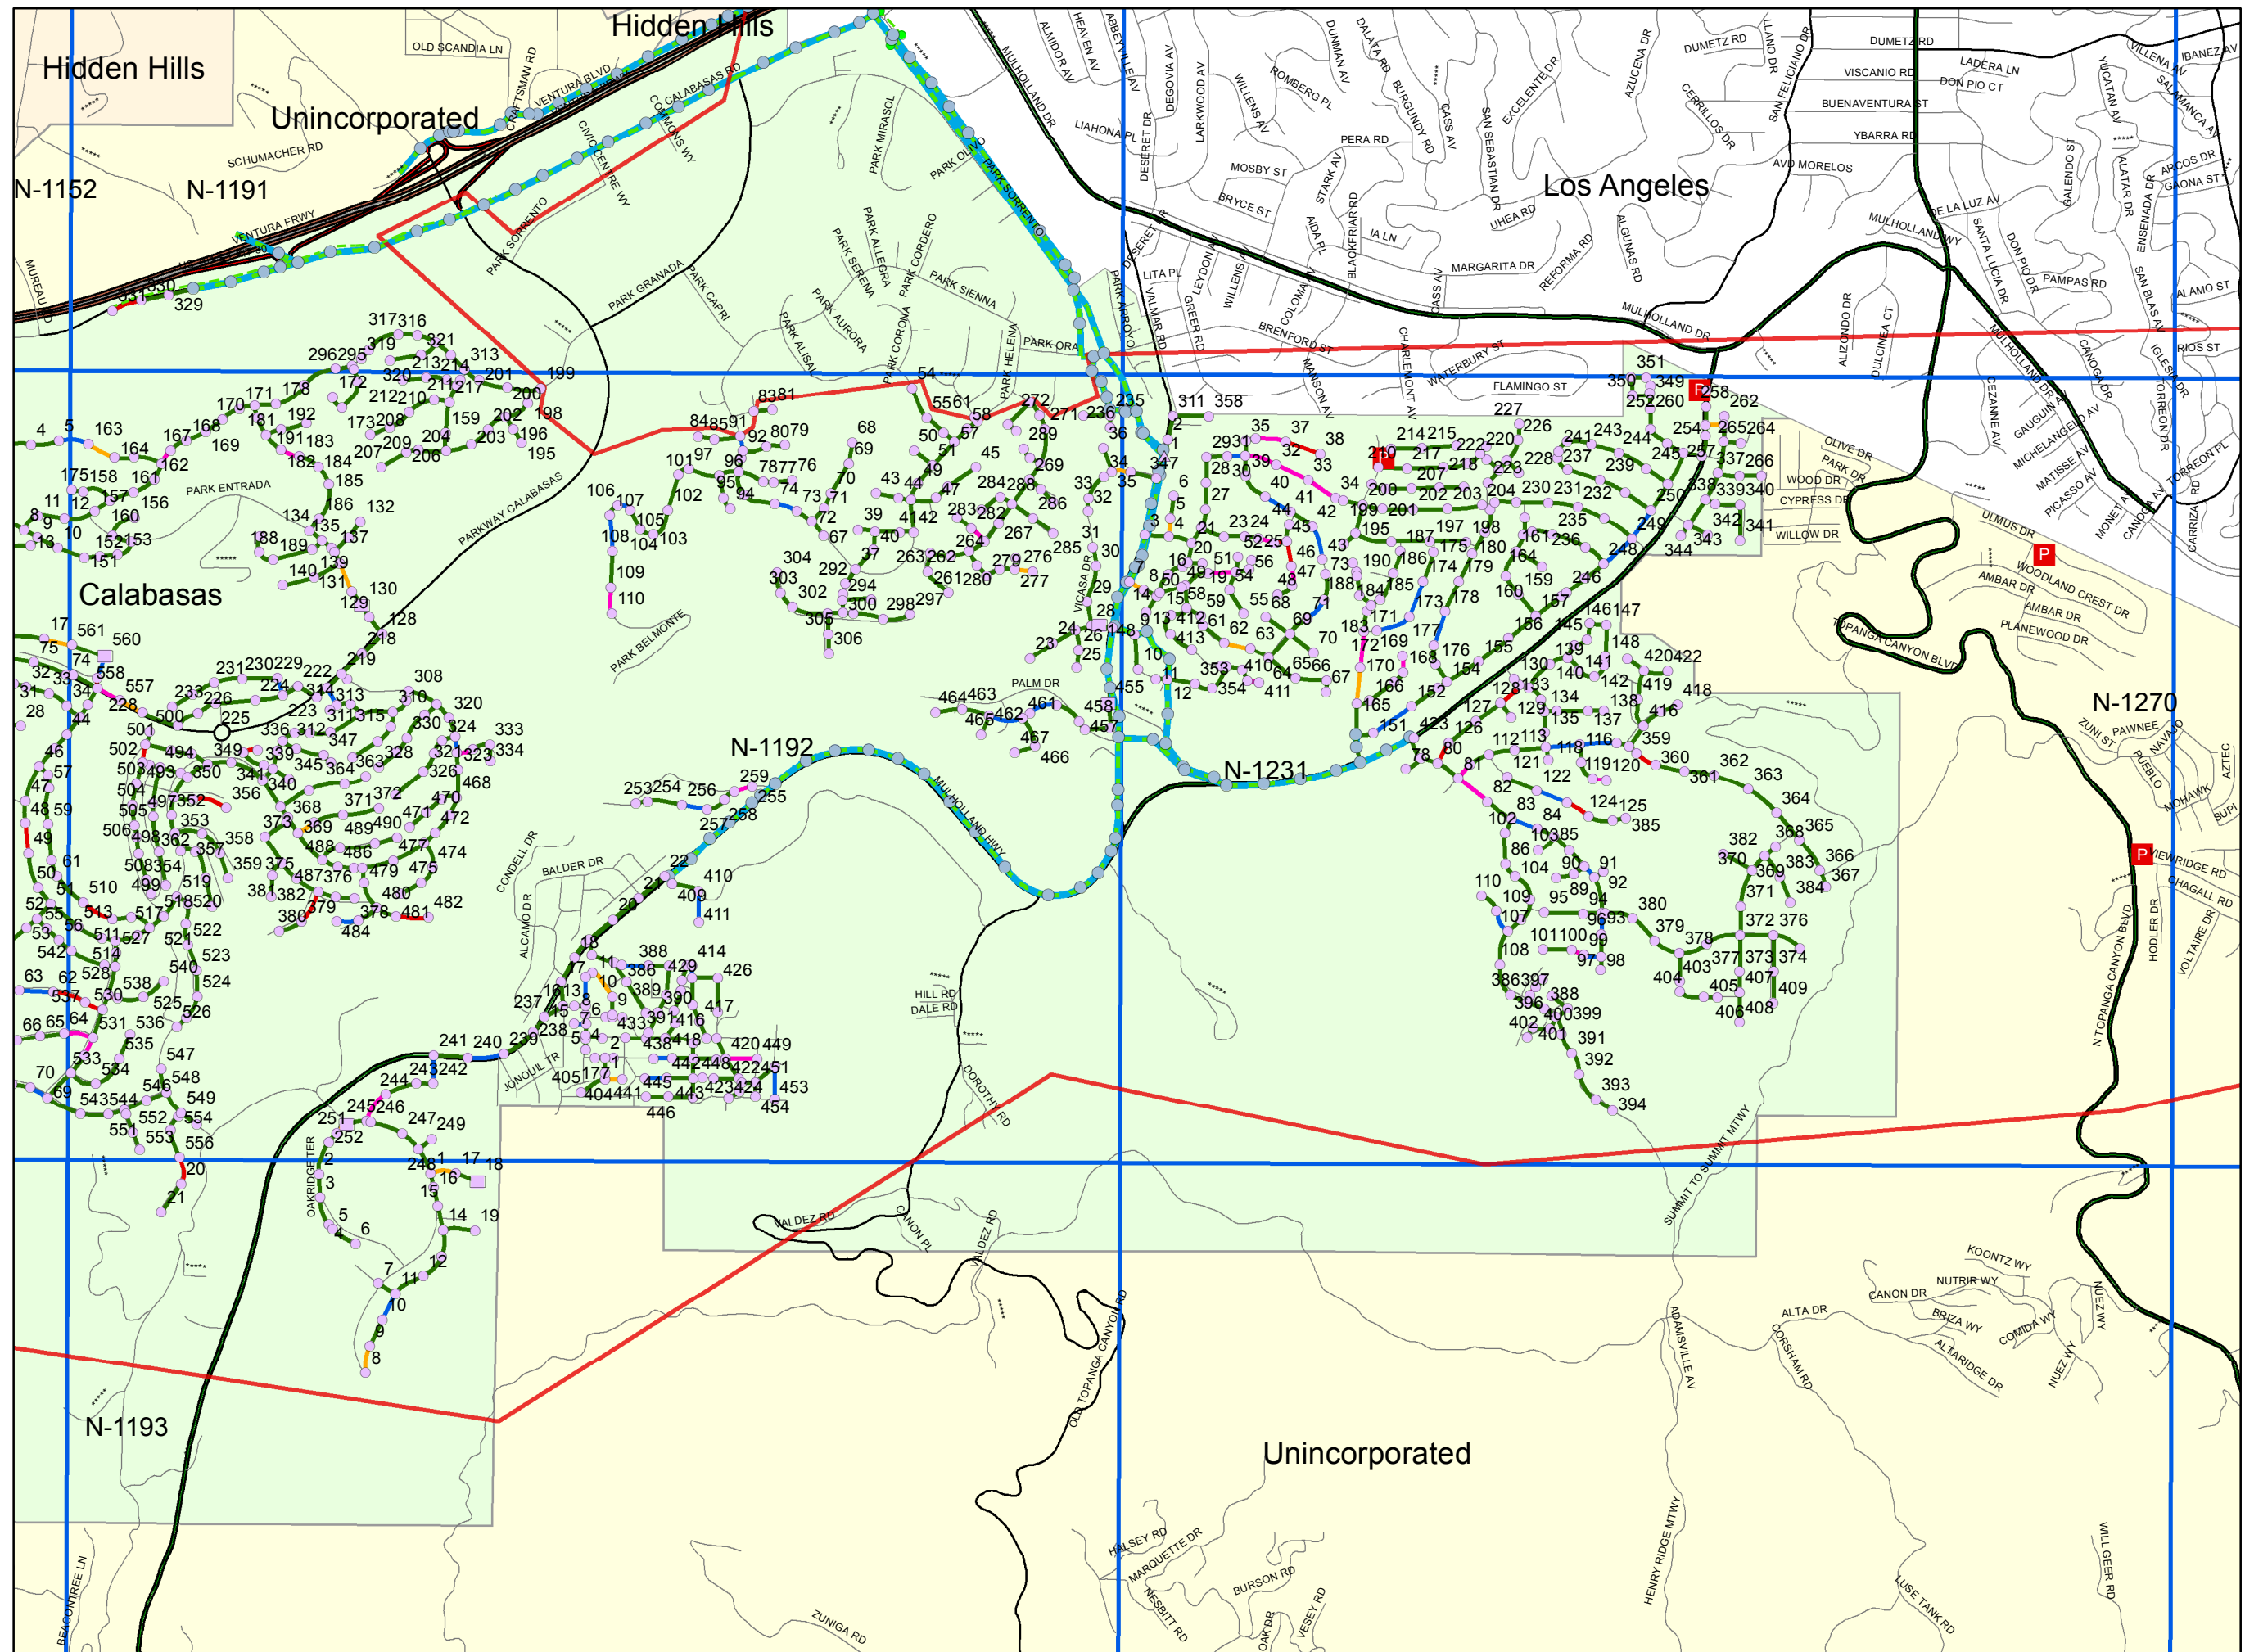
CITY OF CALABASAS
QUICK STRUCTURAL RATING (QSR)

Our inspection revealed that approximately 94.1 percent of the inspected pipe segments within the City were free of severe structural defects. However, the remaining 5.9 percent of the inspected pipe segments had a PACP structural grade of 4 or 5 as indicated in the Quick Structural Rating Table shown below. These segments have been placed on a priority list based on the severity and the need for action. For items 1 through 95 in the Quick Structural Rating Report Priority List (Enclosure 3), which warrant a corrective action, the proposed corrective action will be programmed in the next 24 months as part of the ongoing Accumulative Capital Outlay Program.
