**CONSOLIDATED SEWER MAINTENANCE DISTRICT  
CONDITION-ASSESSMENT PROGRAM REPORT  
PROJECT NO. Y0TV1415A**

**CONDITION-ASSESSMENT REPORT  
LOS ANGELES COUNTY PUBLIC WORKS  
CONSOLIDATED SEWER MAINTENANCE DISTRICT**

# ENCLOSURE 2 CCTV PROJECT YOTV1415A

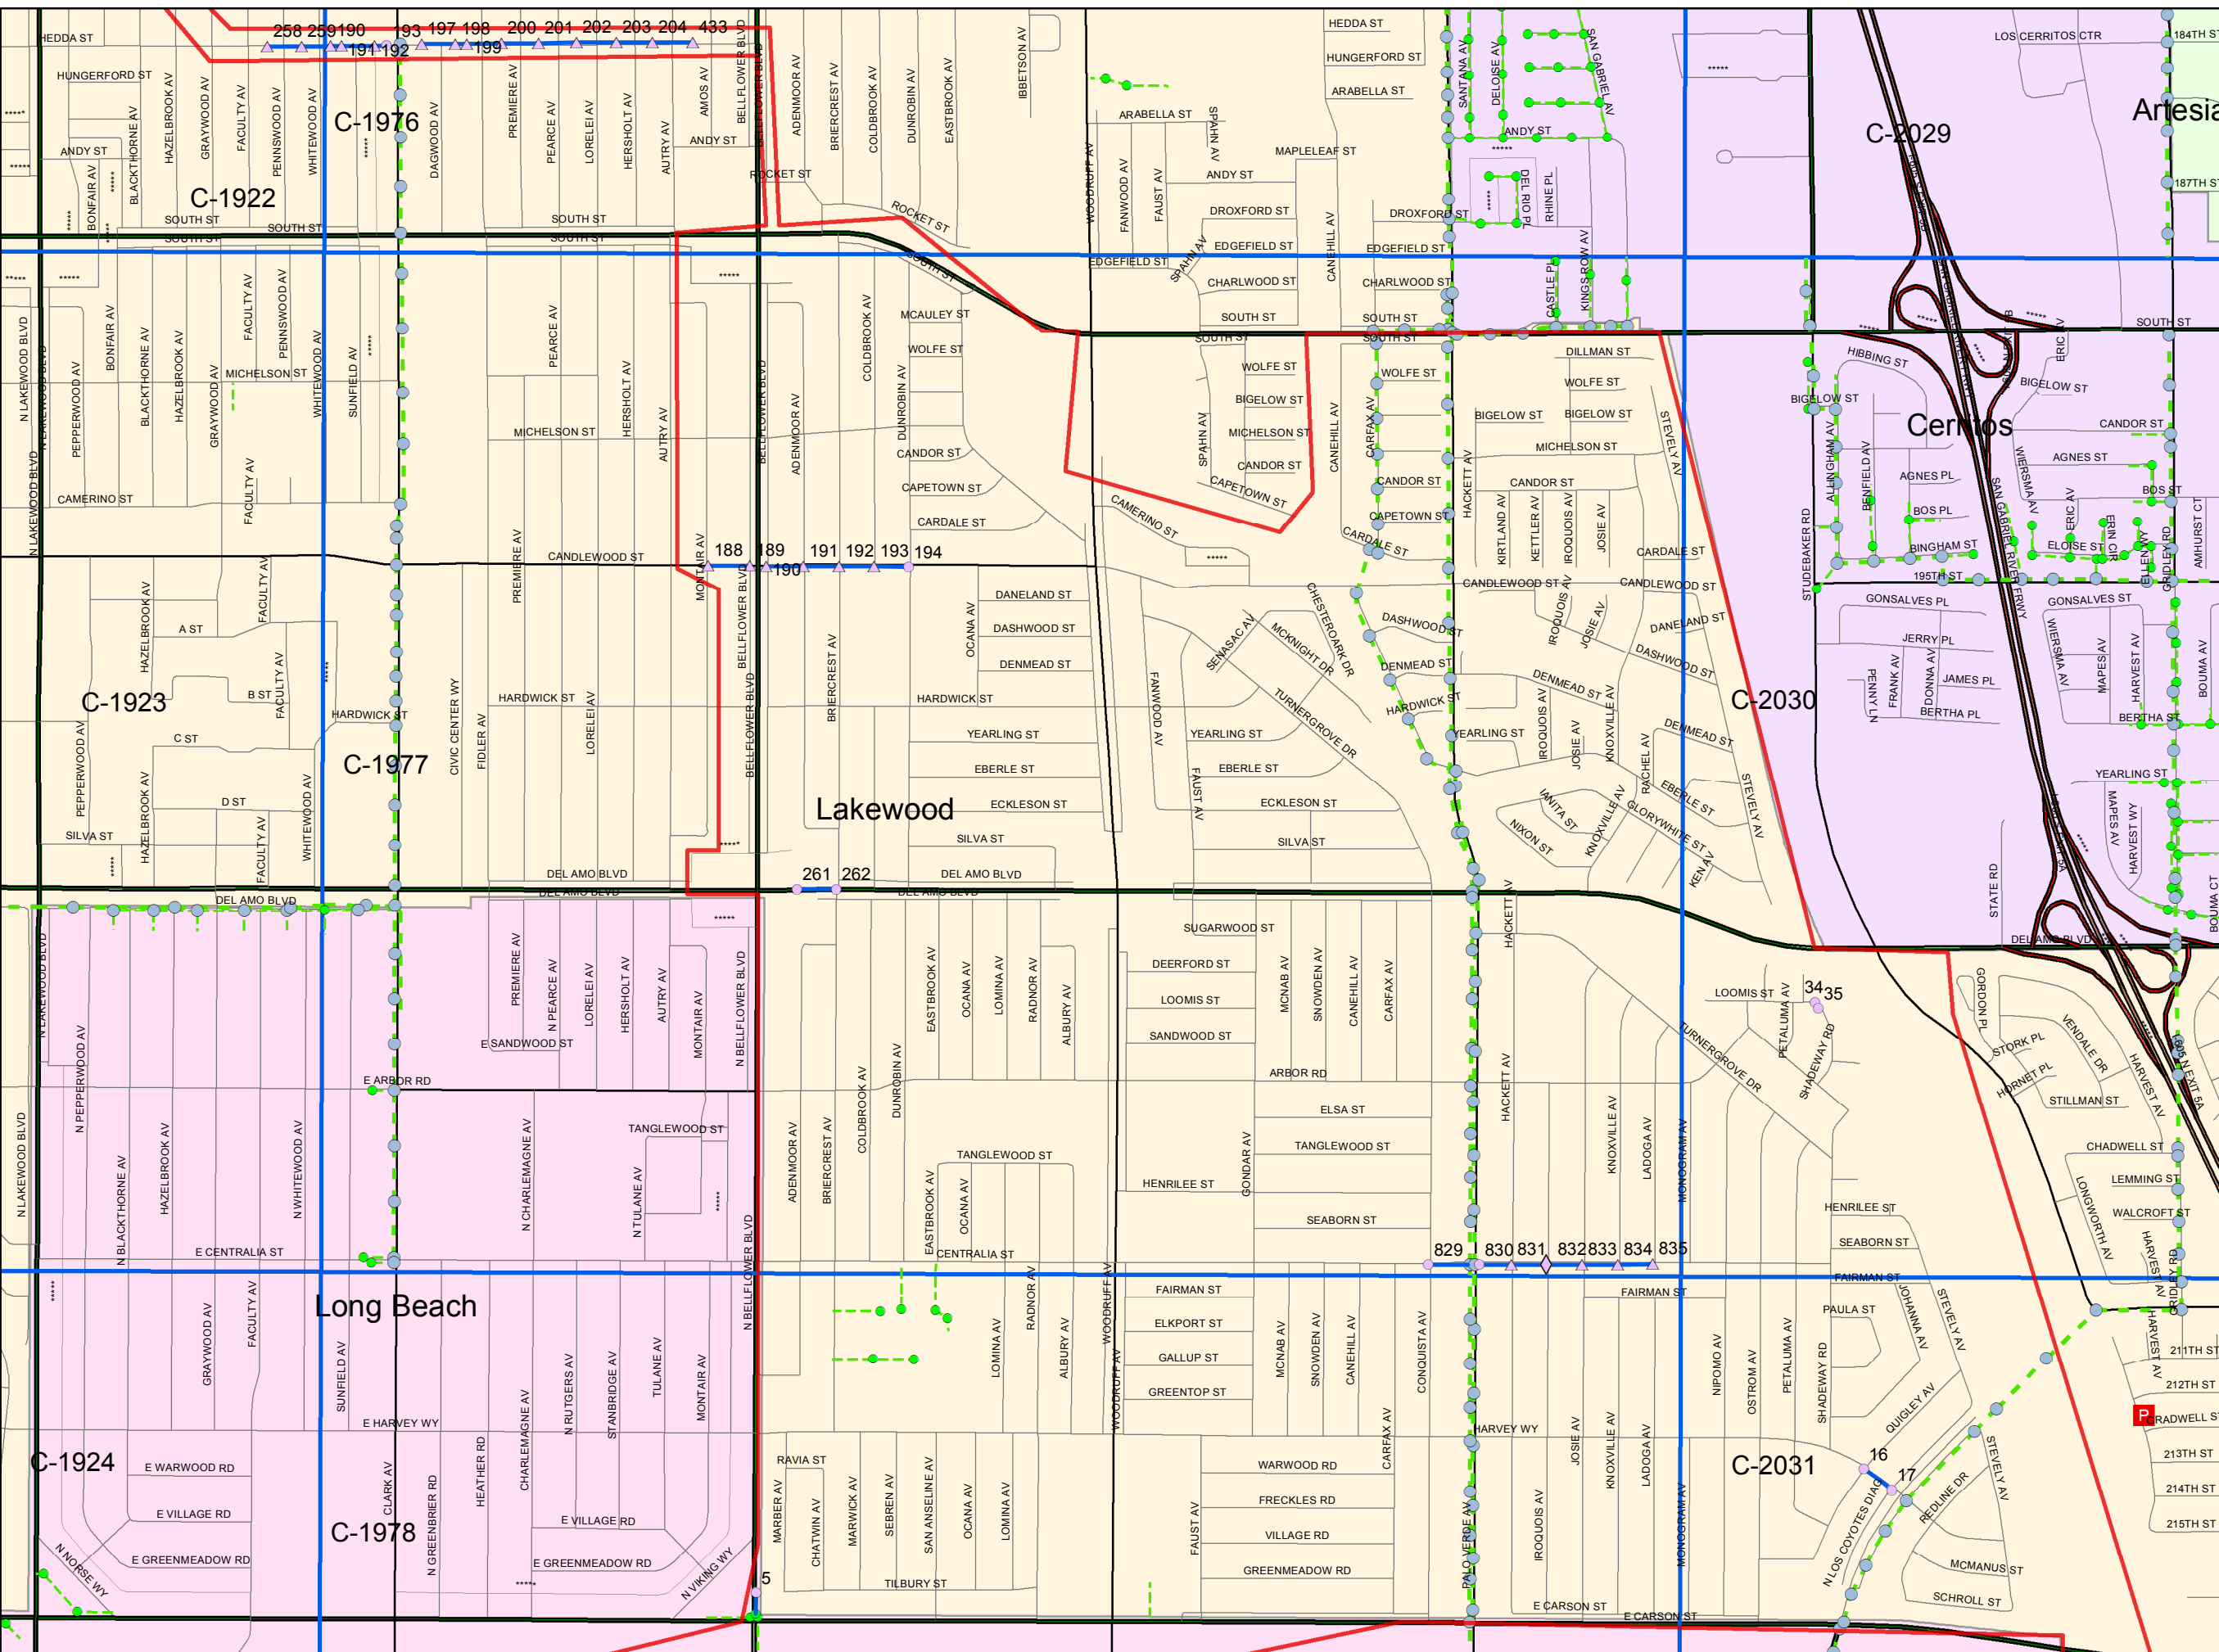
## HIGH WATER LEVELS

**ENCLOSURE 2  
HIGH WATER LEVELS  
CITY OF LAKEWOOD (Y0TV1415A)**

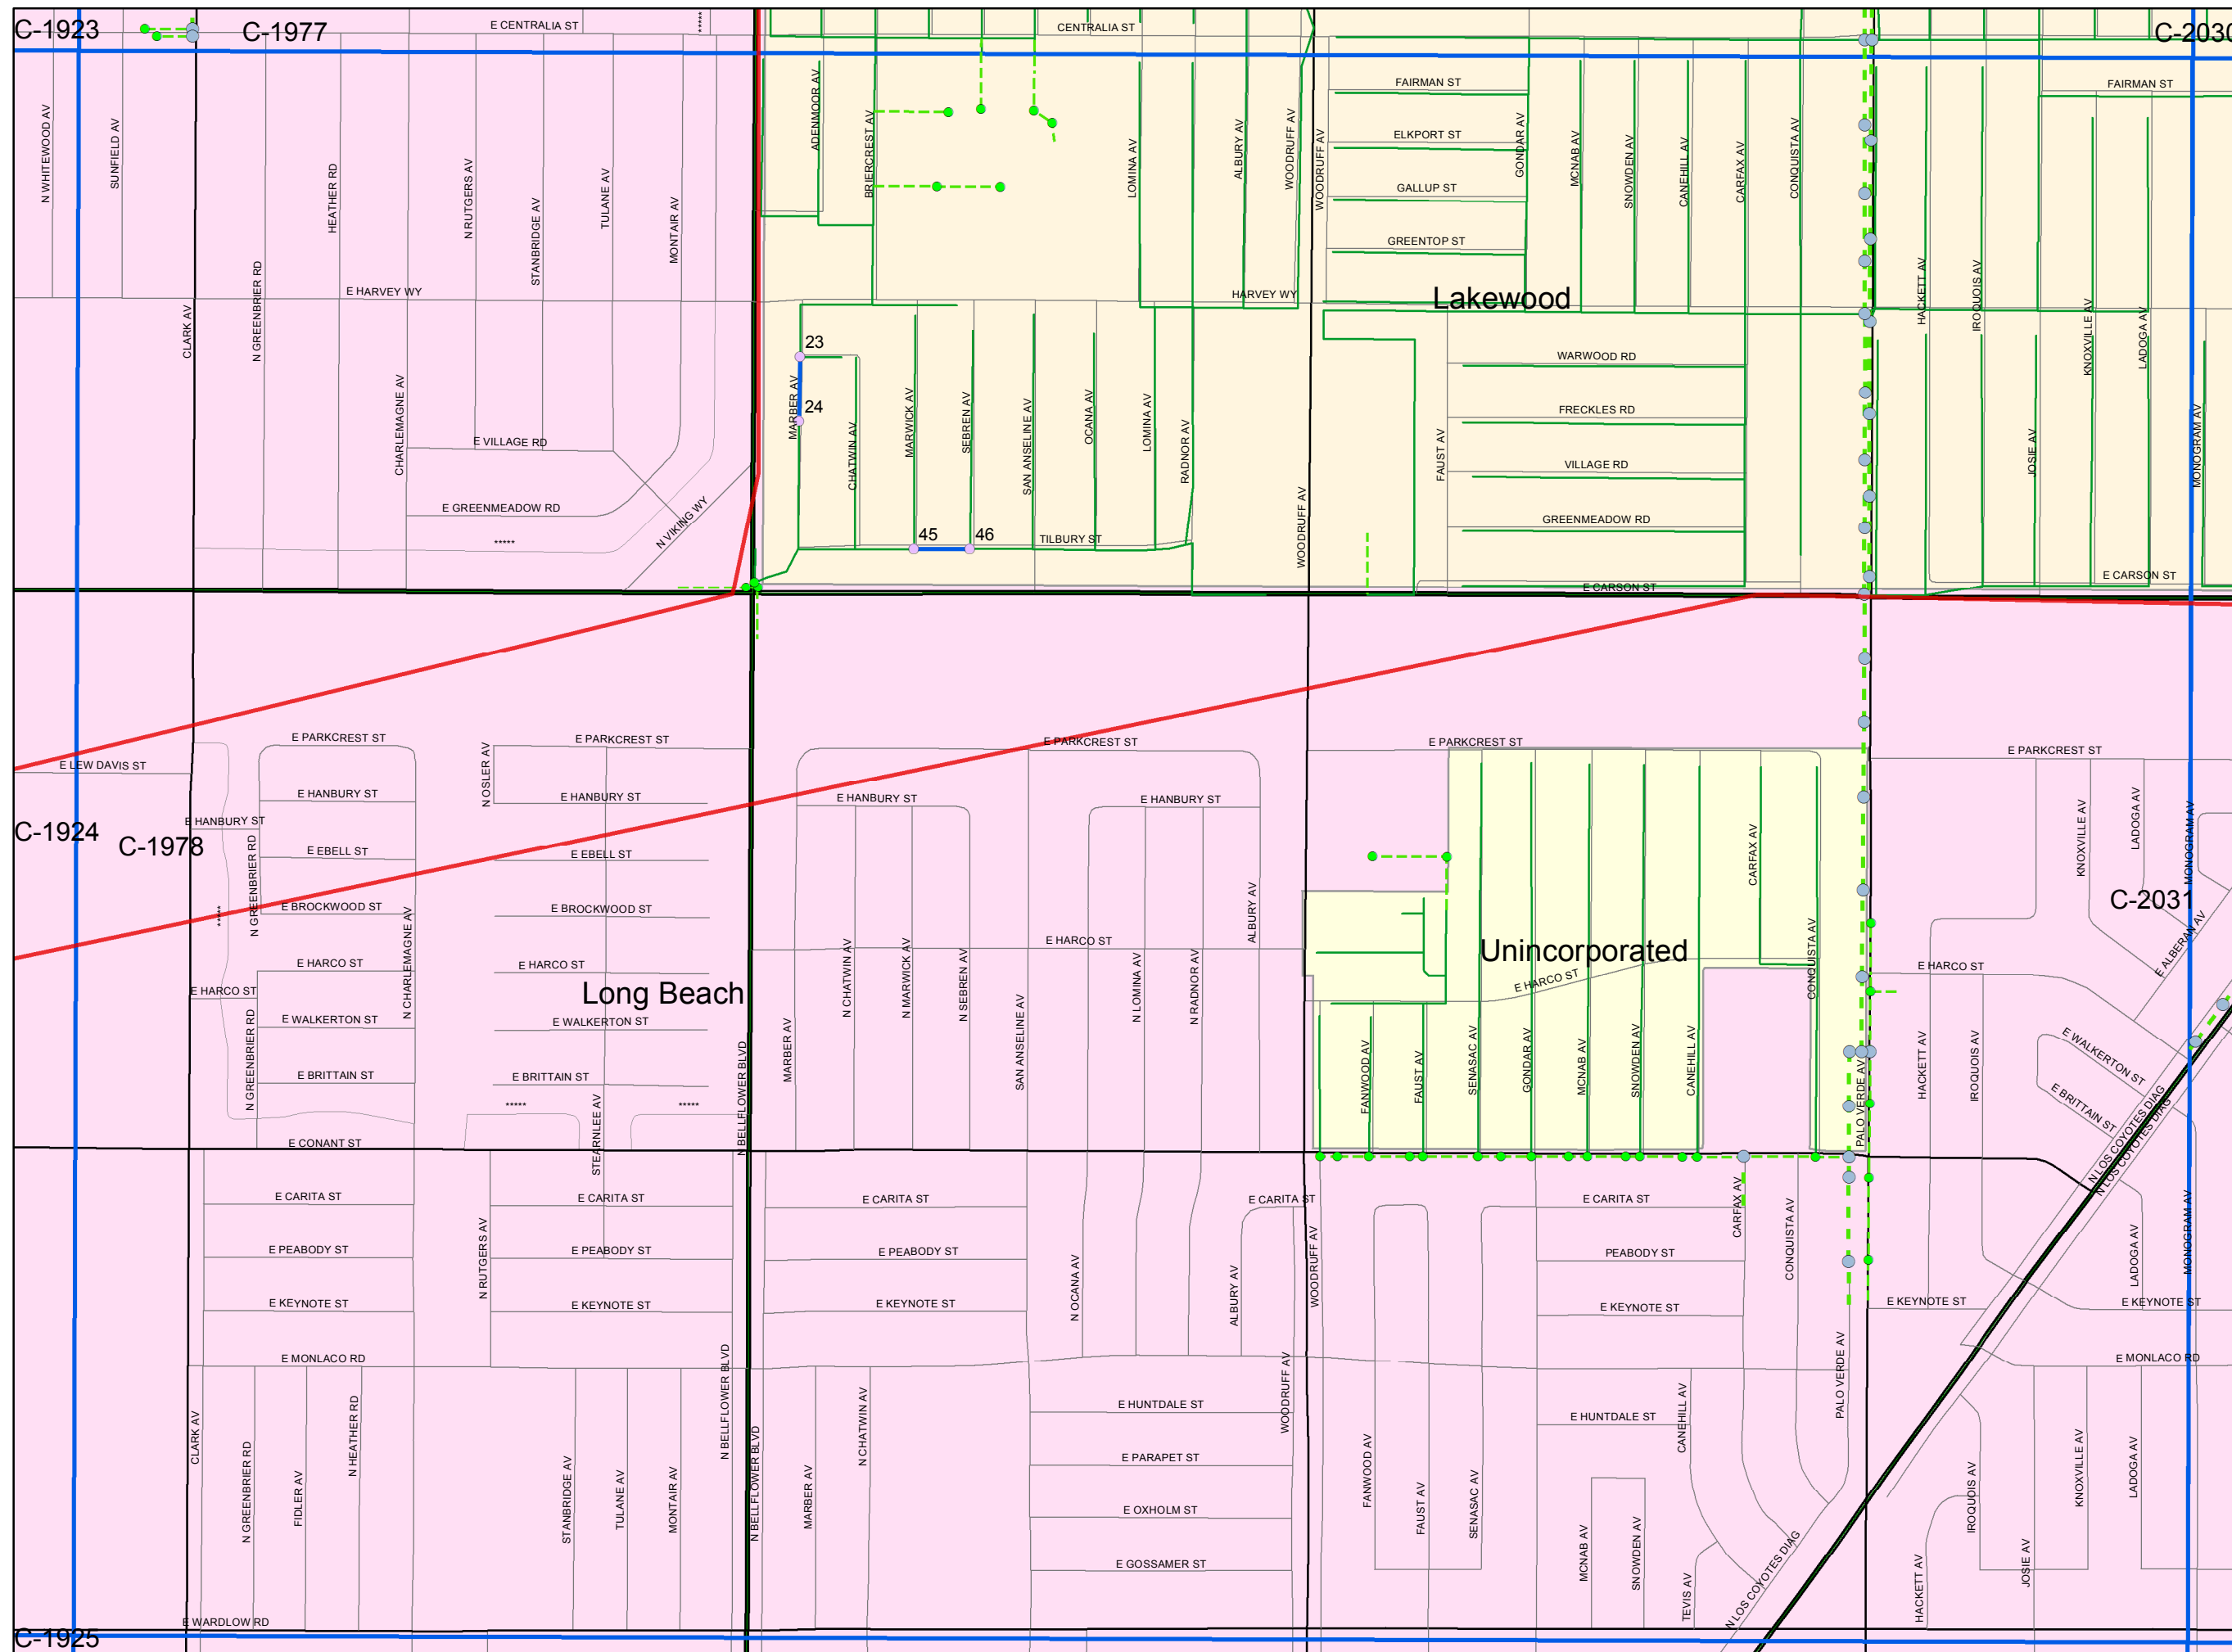
## INFILTRATION

<b>ITEM NO.</b>	<b>QMR</b>	<b>START MH</b>	<b>END MH</b>	<b>STREET</b>	<b>OBSERVATION</b>	<b>PROPOSED CORRECTIVE METHOD</b>	<b>LENGTH OF REPAIR (FT)</b>
1	4100	1978-0023	1978-0024	MARBER AV	Infiltration runner: 58'	Lining: MH to MH	302
2	4100	1978-0046	1978-0045	TILBURY ST	Infiltration runner: 227'	Lining: MH to MH	263
