**CONSOLIDATED SEWER MAINTENANCE DISTRICT  
CONDITION ASSESSMENT PROGRAM REPORT  
PROJECT NO Y0TV1112C**

**CONDITION ASSESSMENT REPORT  
COUNTY OF LOS ANGELES DEPARTMENT OF PUBLIC WORKS  
CONSOLIDATED SEWER MAINTENANCE DISTRICT**

**CONDITION ASSESSMENT REPORT  
LOS ANGELES COUNTY PUBLIC WORKS  
CONSOLIDATED SEWER MAINTENANCE DISTRICT**

| PROJECT NAME: Y0TV1112C | PROJECT MGR: | ERIC LIU |

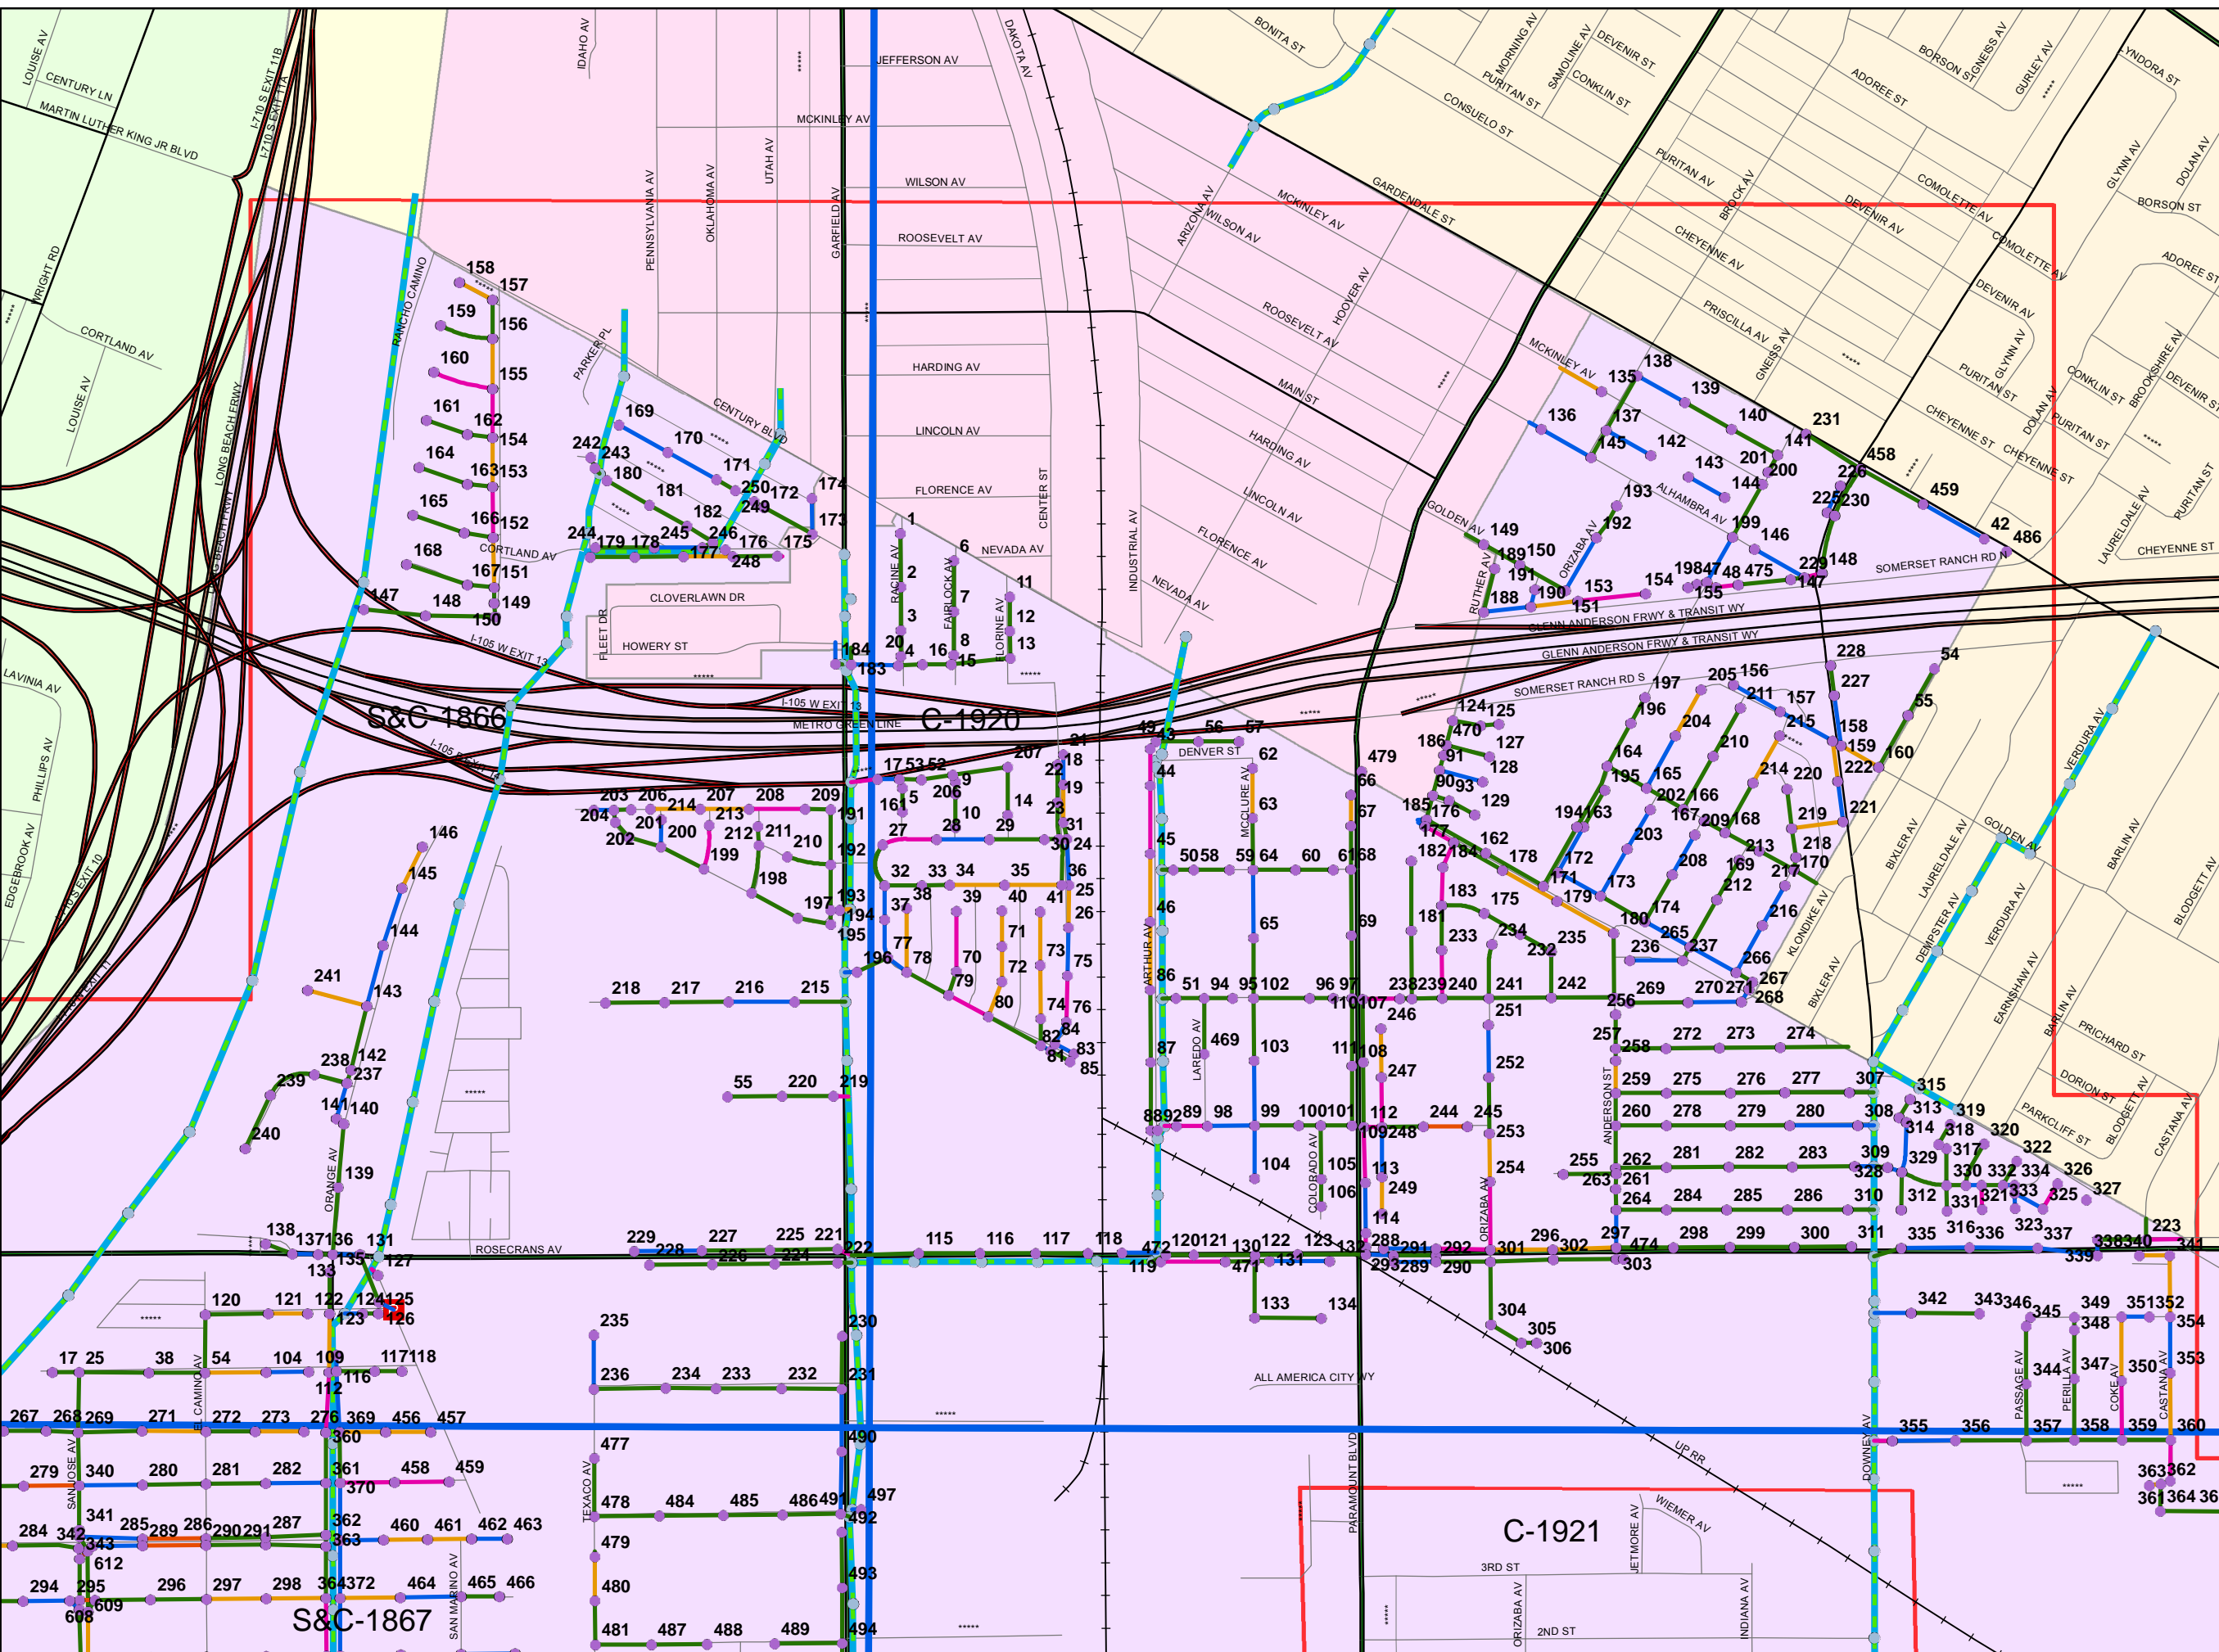
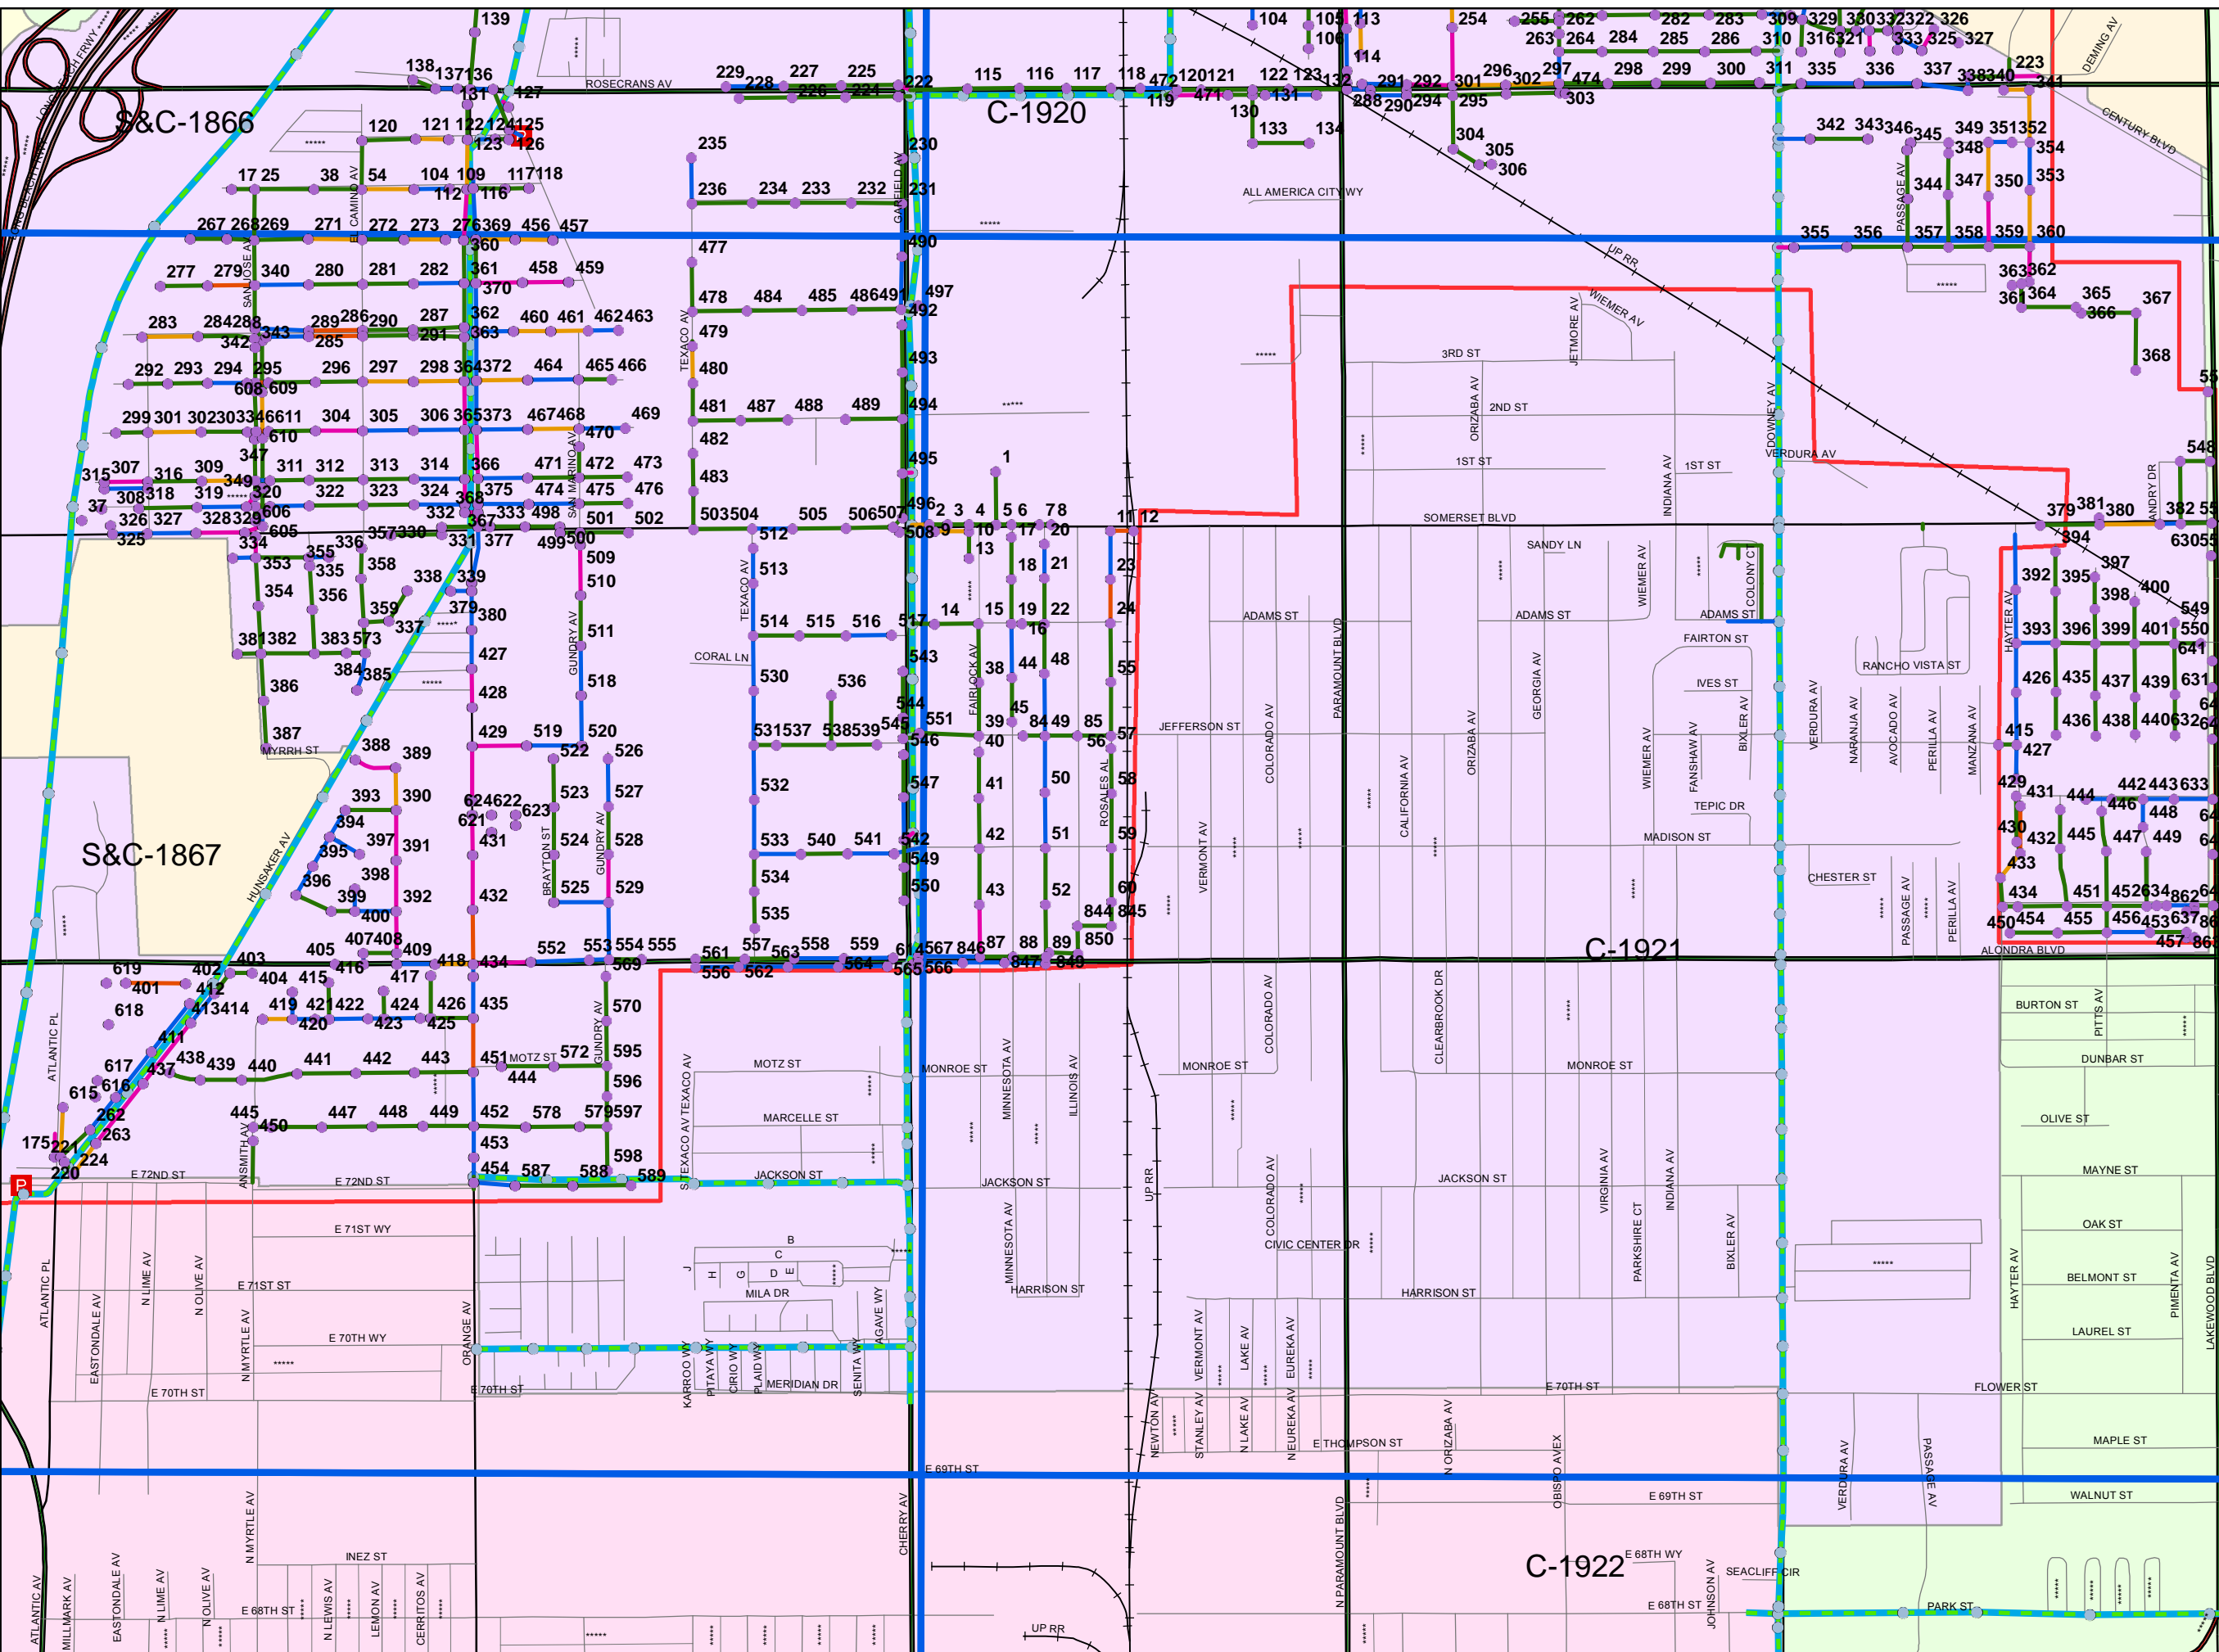
A color-coded map showing the quick maintenance rating for each pipe segment is provided in Enclosure 2.

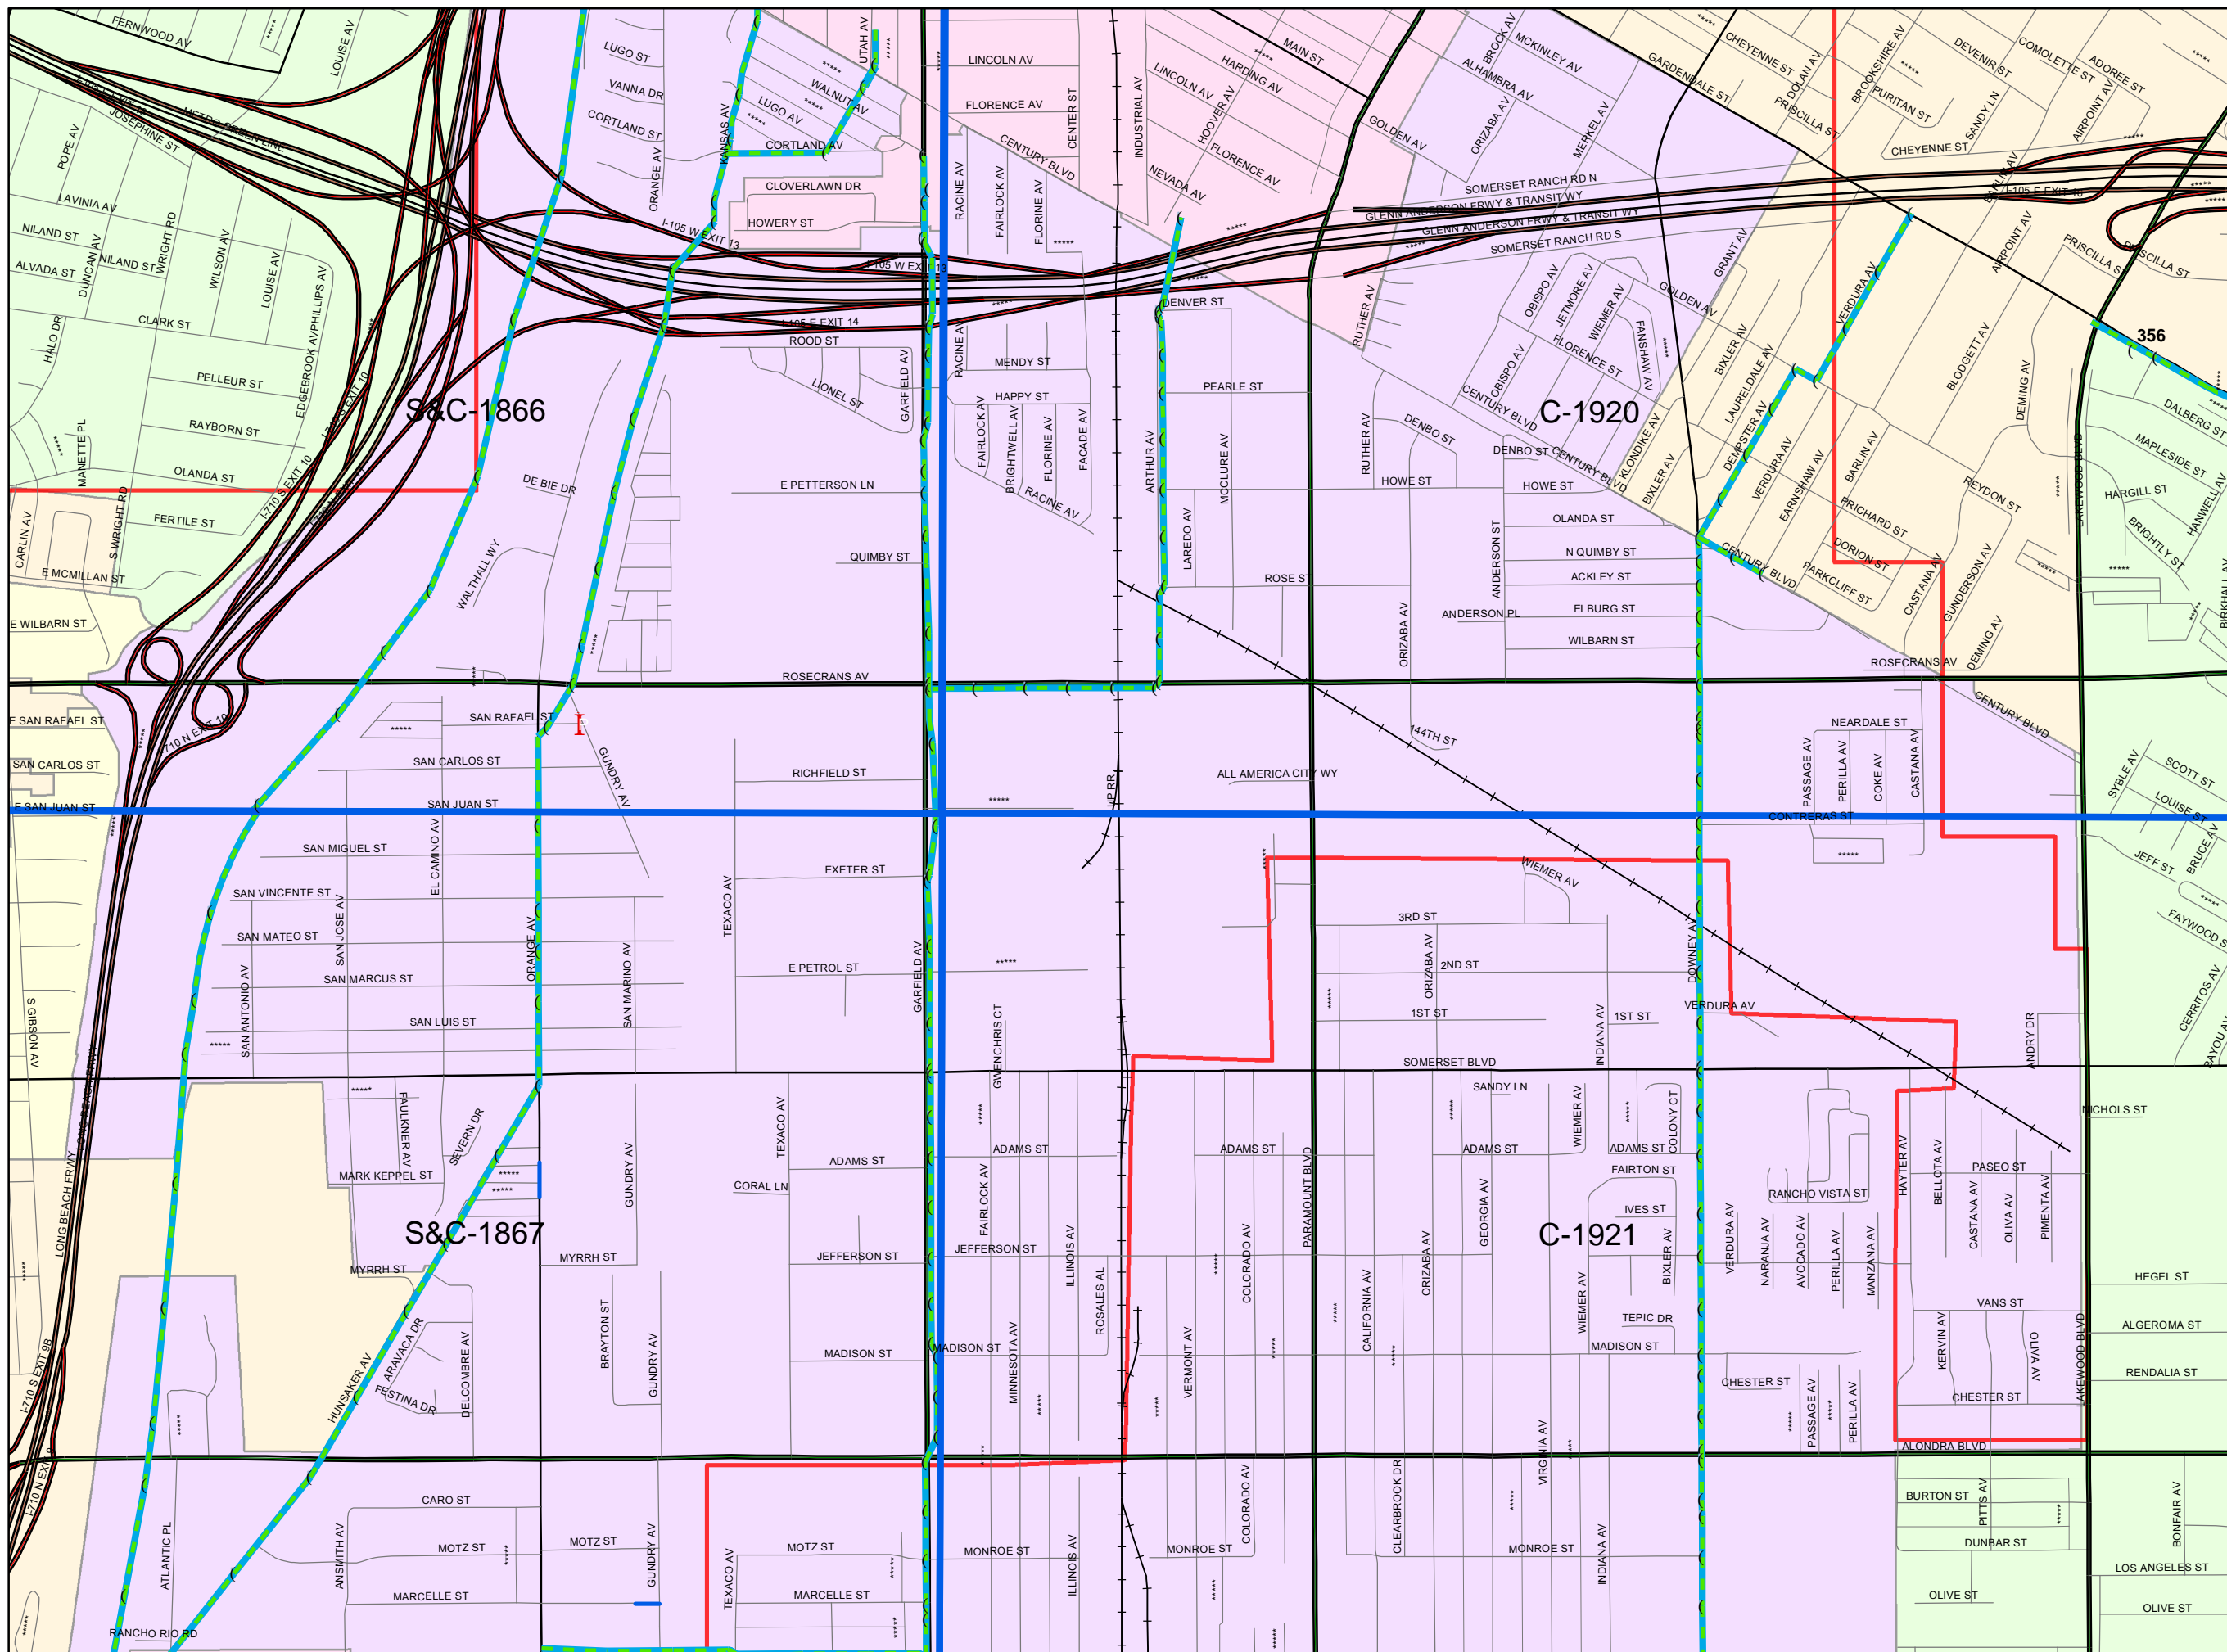
**ENCLOSURE 2  
HIGH WATER LEVELS  
CITY OF PARAMOUNT (Y0TV1112C)**

Our inspection revealed that approximately 97.0 percent of the system televised has adequate capacity. Approximately 3.0 percent of the segments inspected exhibited visual signs associated with high water levels. The capacity of the sewer pipe can be determined by analyzing several PACP codes, including Water Level, Water Mark, and miscellaneous remarks, which indicate the camera was underwater or there were sags in the line. A sewer pipe is considered at capacity when 50 percent of the diameter of the sewer pipe is full of water. However, there are conditions in which the Water Level or Water Mark has reached 50 percent or greater due to heavy flows in adjoining pipes, a

temporary stoppage caused by debris in the sewer lines, or a sag in the line. Therefore, additional review of these pipe segments was conducted to determine if any capacity issues exist.

All sewer pipes where the Water Level, Water Mark, and miscellaneous remarks of camera underwater or sags in the line are at or above 50 percent capacity have been listed and analyzed on the High Water Level Table in Enclosure 2. The nature of these high water level conditions is also summarized on this table.

A map showing the sewer lines with high water levels is provided in Enclosure 2.

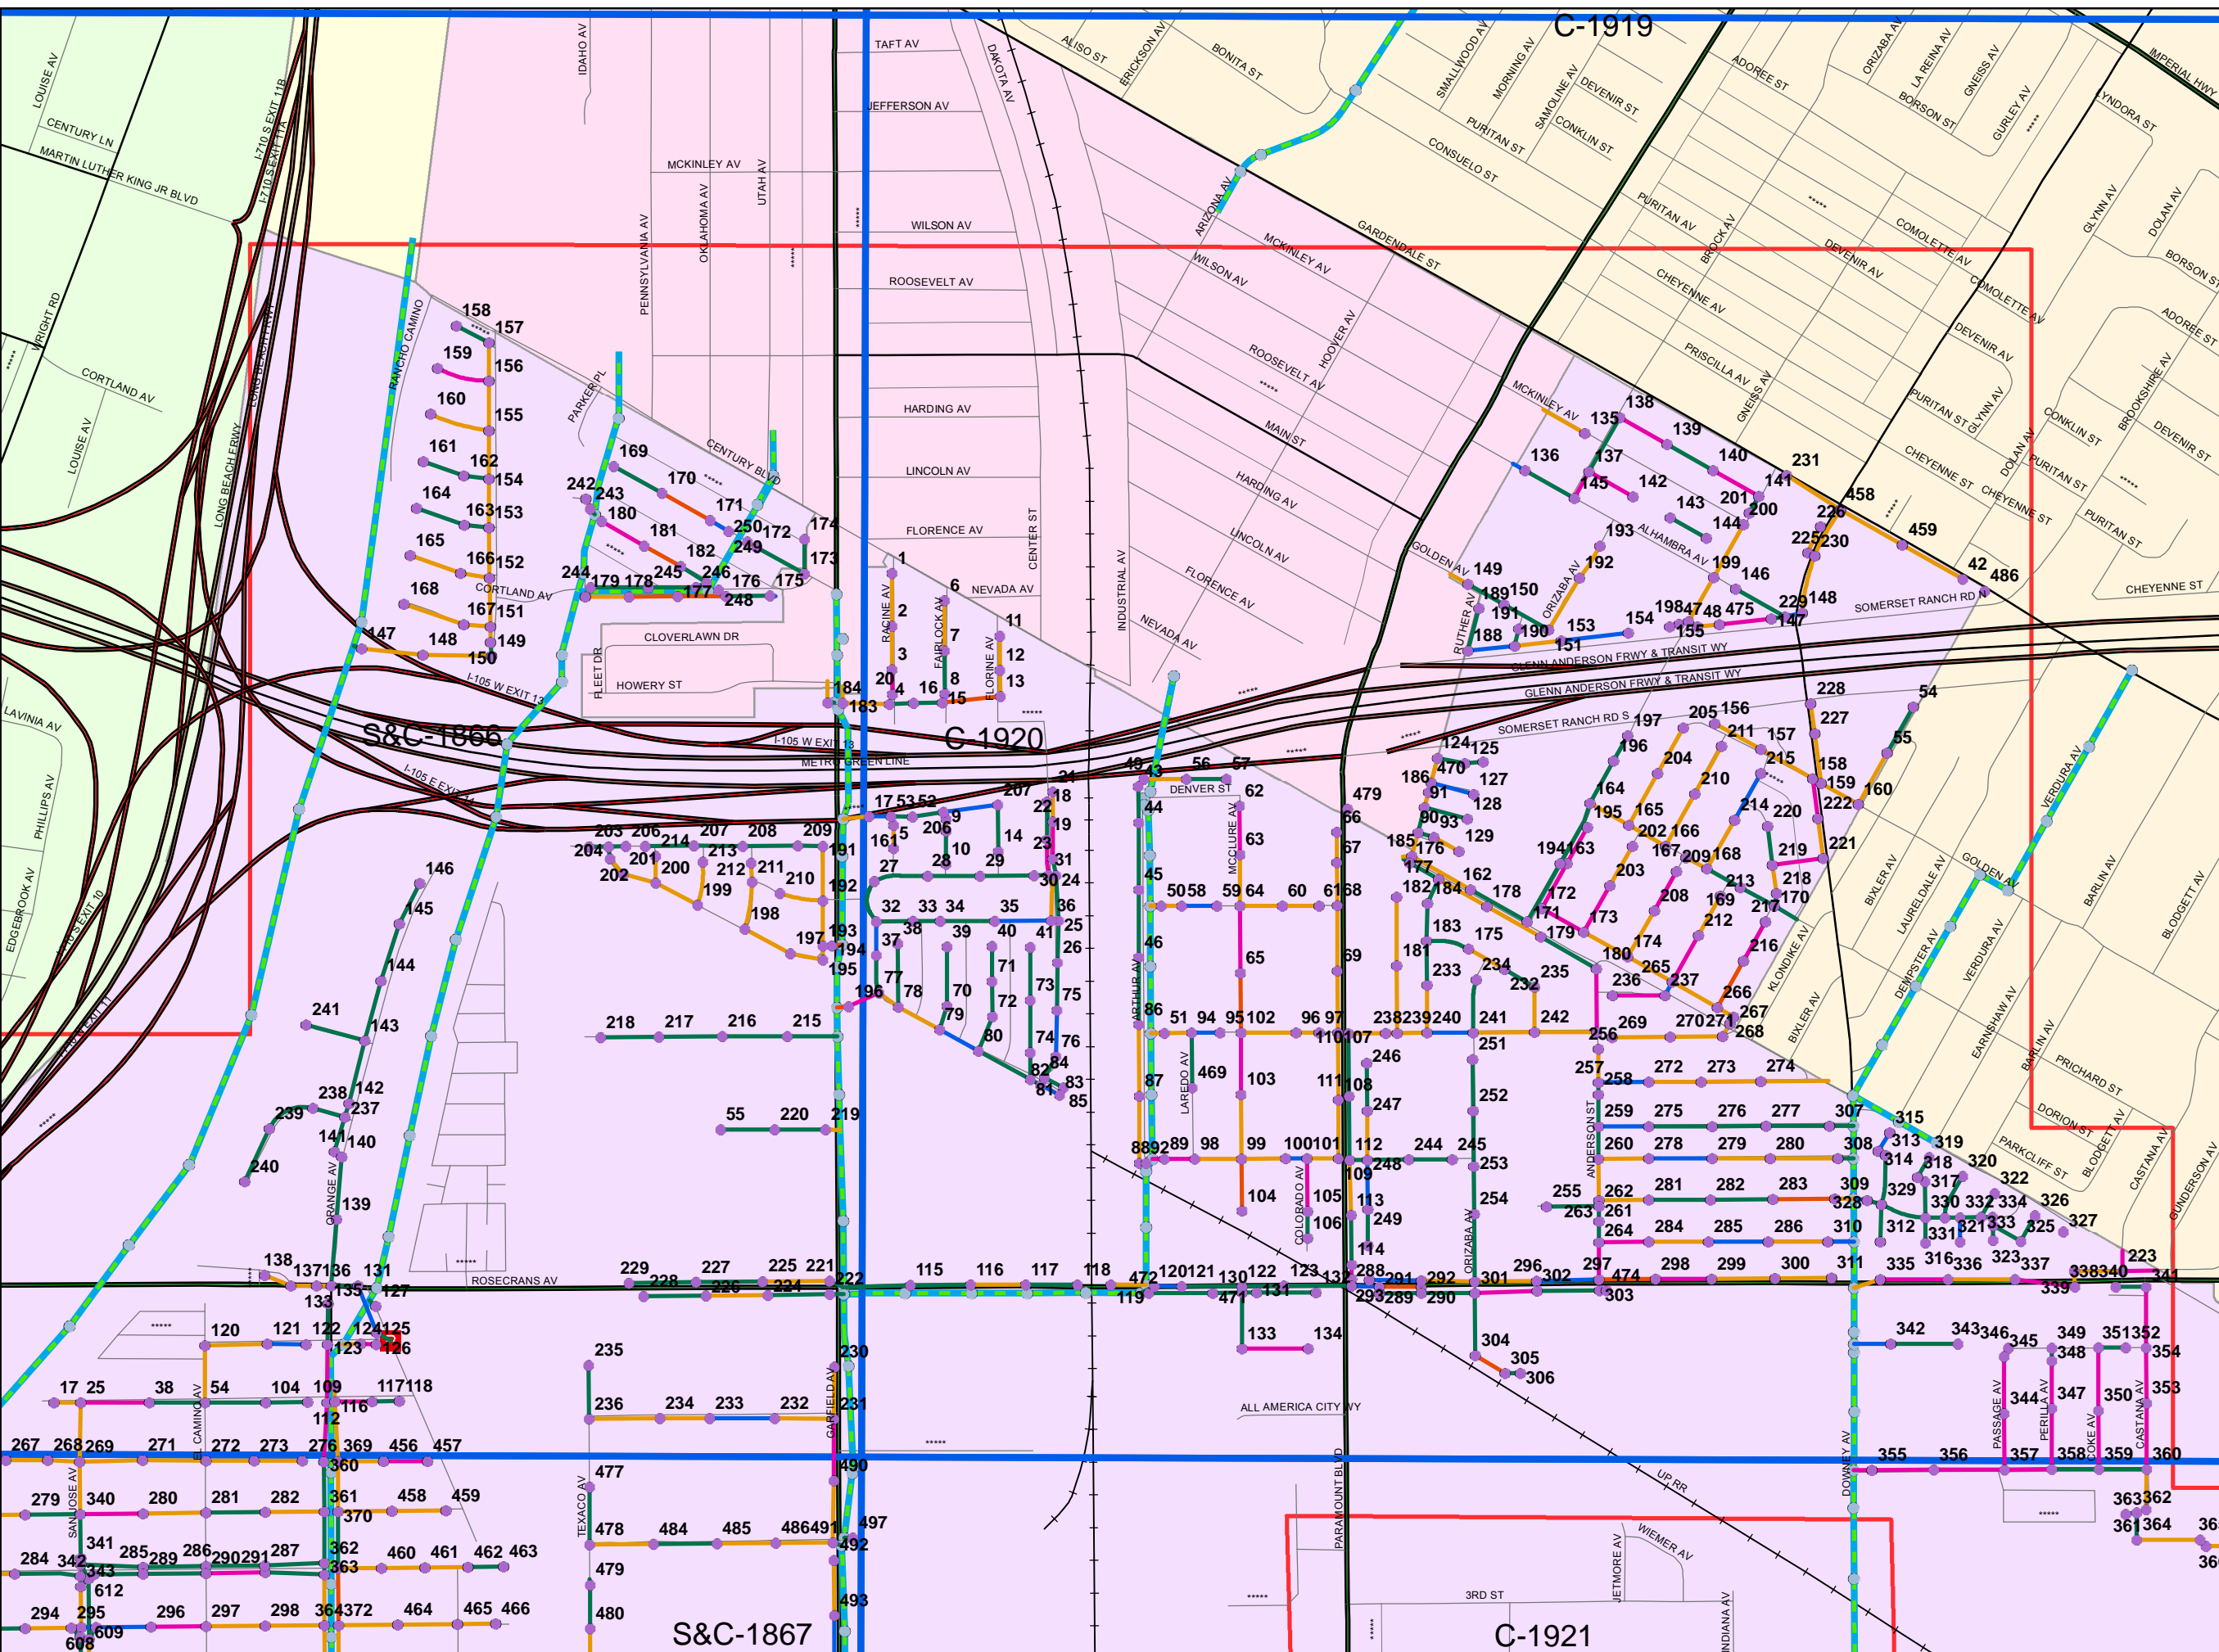
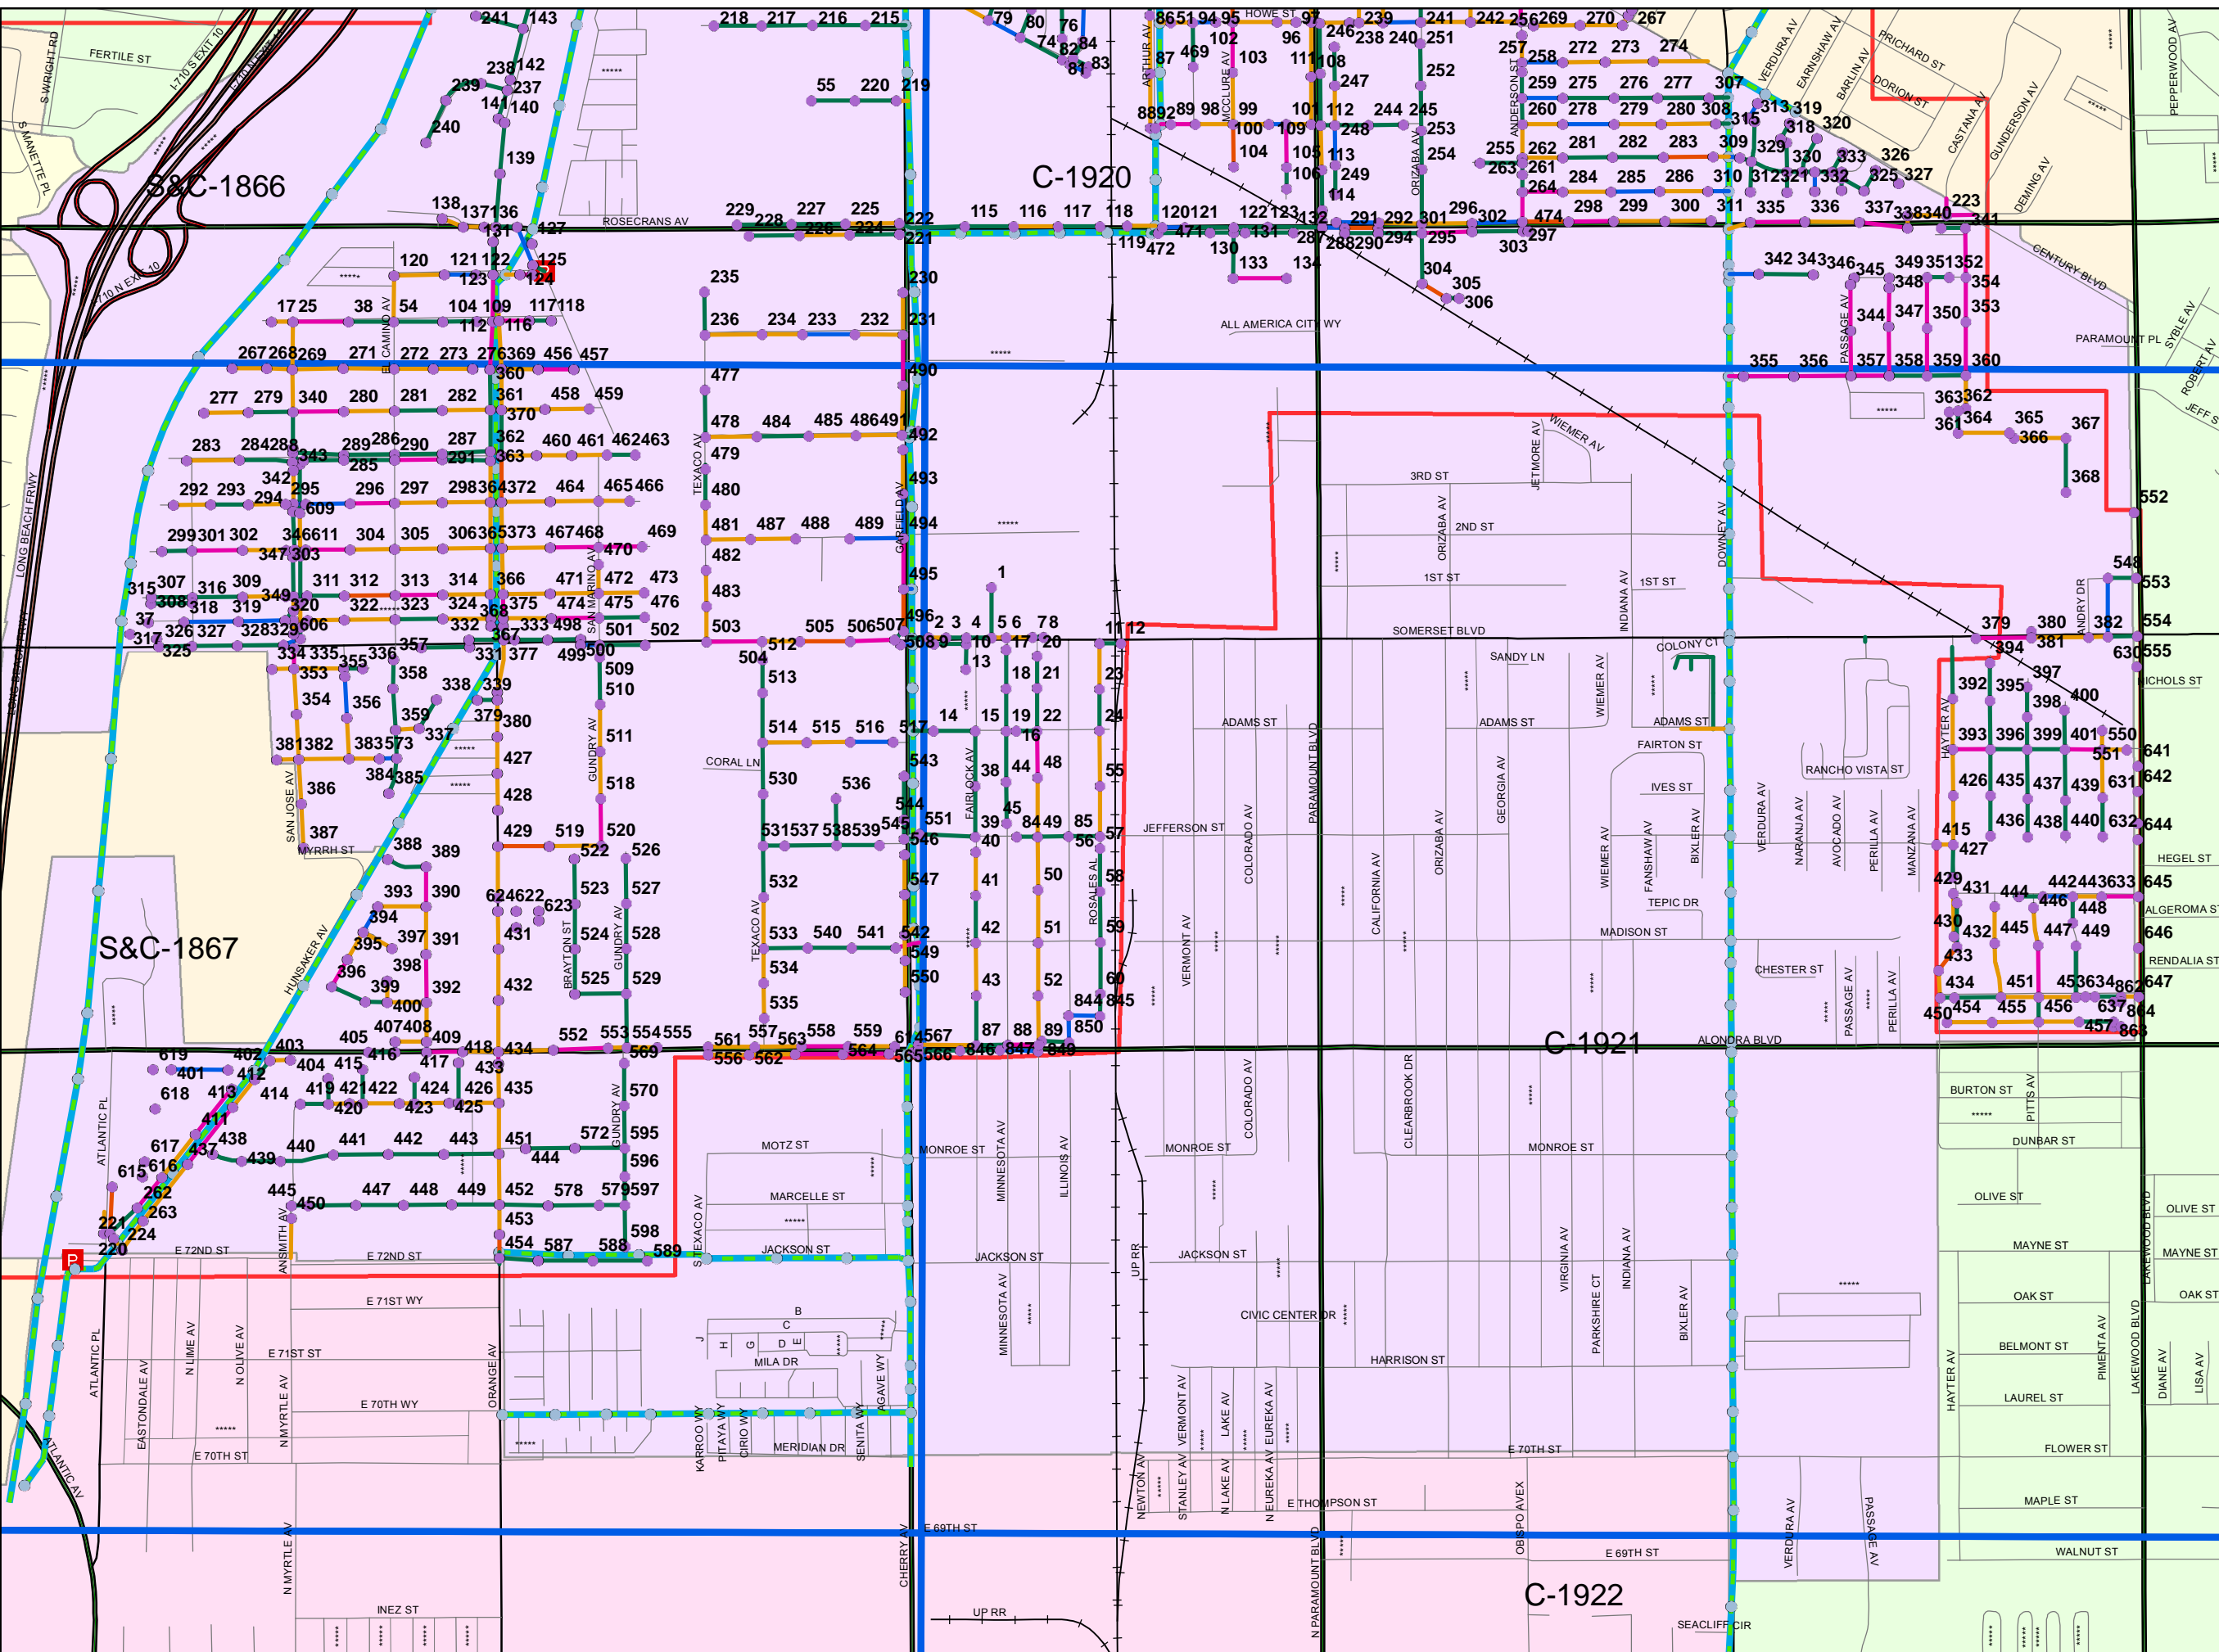
Our inspection revealed that approximately 84.4 percent of the inspected pipe segments within the City were free of severe structural defects. The remaining 15.6 percent of the inspected pipe segments had a PACP structural grade of 4 or 5 as indicated in the Quick Structural Rating Table shown below. These segments have been placed on a priority list based on the severity and the need for action. For items 1 through 123 in the Quick Structural Rating Report Priority List (Enclosure 3), which warrant a corrective action, the proposed corrective action will be programmed in the next 24 months as part of the ongoing Accumulative Capital Outlay Program.

A color-coded map showing the Quick Structural Rating for each pipe segment is located in Enclosure 3.
