CONSOLIDATED SEWER MAINTENANCE DISTRICT CONDITION ASSESSMENT PROGRAM REPORT PROJECT Y0TV0708B

**CONDITION ASSESSMENT REPORT
COUNTY OF LOS ANGELES DEPARTMENT OF PUBLIC WORKS
CONSOLIDATED SEWER MAINTENANCE DISTRICT**

PROJECT NAME	Y0TV0708B	PROJECT MGR:	Marzena Laskowska
PROJECT DATE	11/05/07-01/23/08	CONTACT NO:	(626) 300-3348
SUP DISTRICT(s):	1	MAP PAGE(S):	2024, 2025, 2077, 2078
Report By	Marzena Laskowska	Report Date:	03/31/09

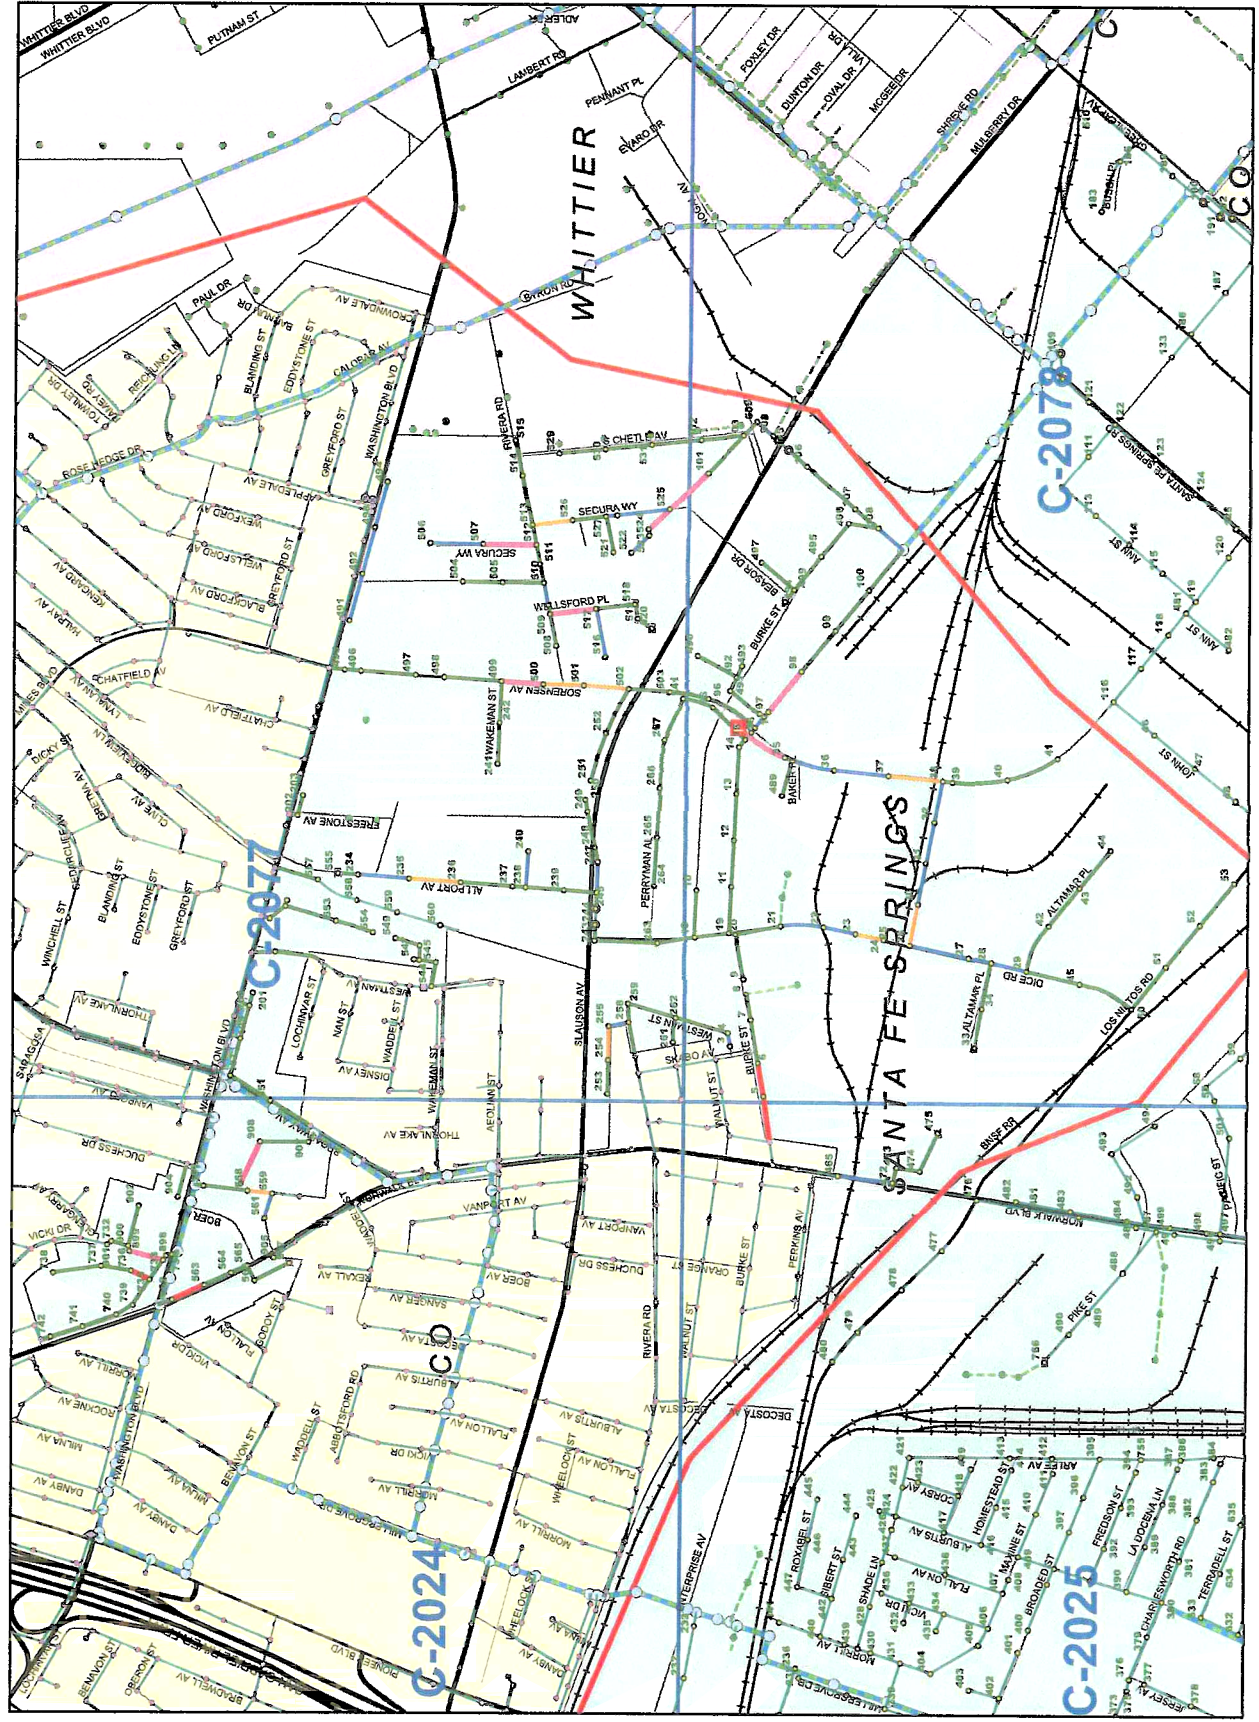
ENCLOSURE 2 CCTV PROJECT YOTV0708B

Our inspection revealed that approximately 92.1 percent of the system televised was free of blockages or restrictions that would impede sewer flows. However, the remaining 7.9 percent of the inspected pipe segments within the City of Santa Fe Springs area had a PACP maintenance grade of 4 or 5 as indicated in the Quick Maintenance Rating Table shown below. These segments have been incorporated into our routine cleaning schedule with corrective action taken as noted on the Quick Maintenance Rating Report Priority List (Enclosure 2). Also included is a color-coded map showing the quick maintenance rating for each pipe segment.

Item No.	QMR	Start MH	End MH	Street	Observation	Corrective Action Taken
1	5200	2078-0005	2025-0468	BURKE ST	Deposits	Hydrojet on 120-day Periodic (cleaned 5/21/08)
2	5141	2024-0563	2024-0562	NORWALK BV	Deposits; grease	Hydrojet (completed 7/30/08)
3	5131	2078-0005	2078-0006	BURKE ST	Deposits	Hydrojet on 120-day Periodic (cleaned 5/21/08)
4	5100	2024-0734	2024-0898	WASHINGTON BV	Deposits; grease	Hydrojet (completed 7/30/08)
5	5100	2024-0736	2024-0735	EASEMENT	Deposits	Hydrojet (completed 7/30/08)
6	4H2M	2077-0517	2077-0509	WELLSFORD PL	High water level	Hydrojet (completed 9/19/08)
7	4B3E	2077-0525	2077-0524	EASEMENT	High water level	Hydrojet (completed 3/23/09)
8	4B00	2024-0899	2024-0733	VICKI DR	High water level	Hydrojet (completed 7/30/08)
9	4A2B	2077-0525	2078-0101	SECURA WY	High water level	Hydrojet (completed 9/23/08)
10	4131	2077-0499	2077-0500	SORENSEN AV	Calcium deposits	Hydrojet (completed 3/23/09)

11	4131	2077-0512	2077-0507	SECURA WY	Deposits (encrustation)	Hydrojet (completed 5/27/08)
12	412S	2078-0098	2078-0097	EASEMENT	Deposits (encrustation)	Hydrojet (completed 7/31/08)
13	4100	2078-0035	2078-PUMP	SORENSEN AV	Deposits; grease	Hydrojet unable to clean; potential of dropping into wet well.
14	4100	2024-0908	2024-0909	EASEMENT	Intruding tap	Noted on maintenance maps.

It was noted that a few of these segments involved high concentration of fat, oil, and grease (FOG) in residential areas. It is recommended that these areas with prevalent FOG deposits be targeted with public awareness regarding preventative measures on FOG issues. We have included a copy of a door-hanger providing information on such issues for your reference (Enclosure 5). In the future, our maintenance crews will distribute this FOG brochure, targeting residential areas where FOG has been observed. We find this public awareness strategy to be the most effective means of addressing FOG problems in residential areas.

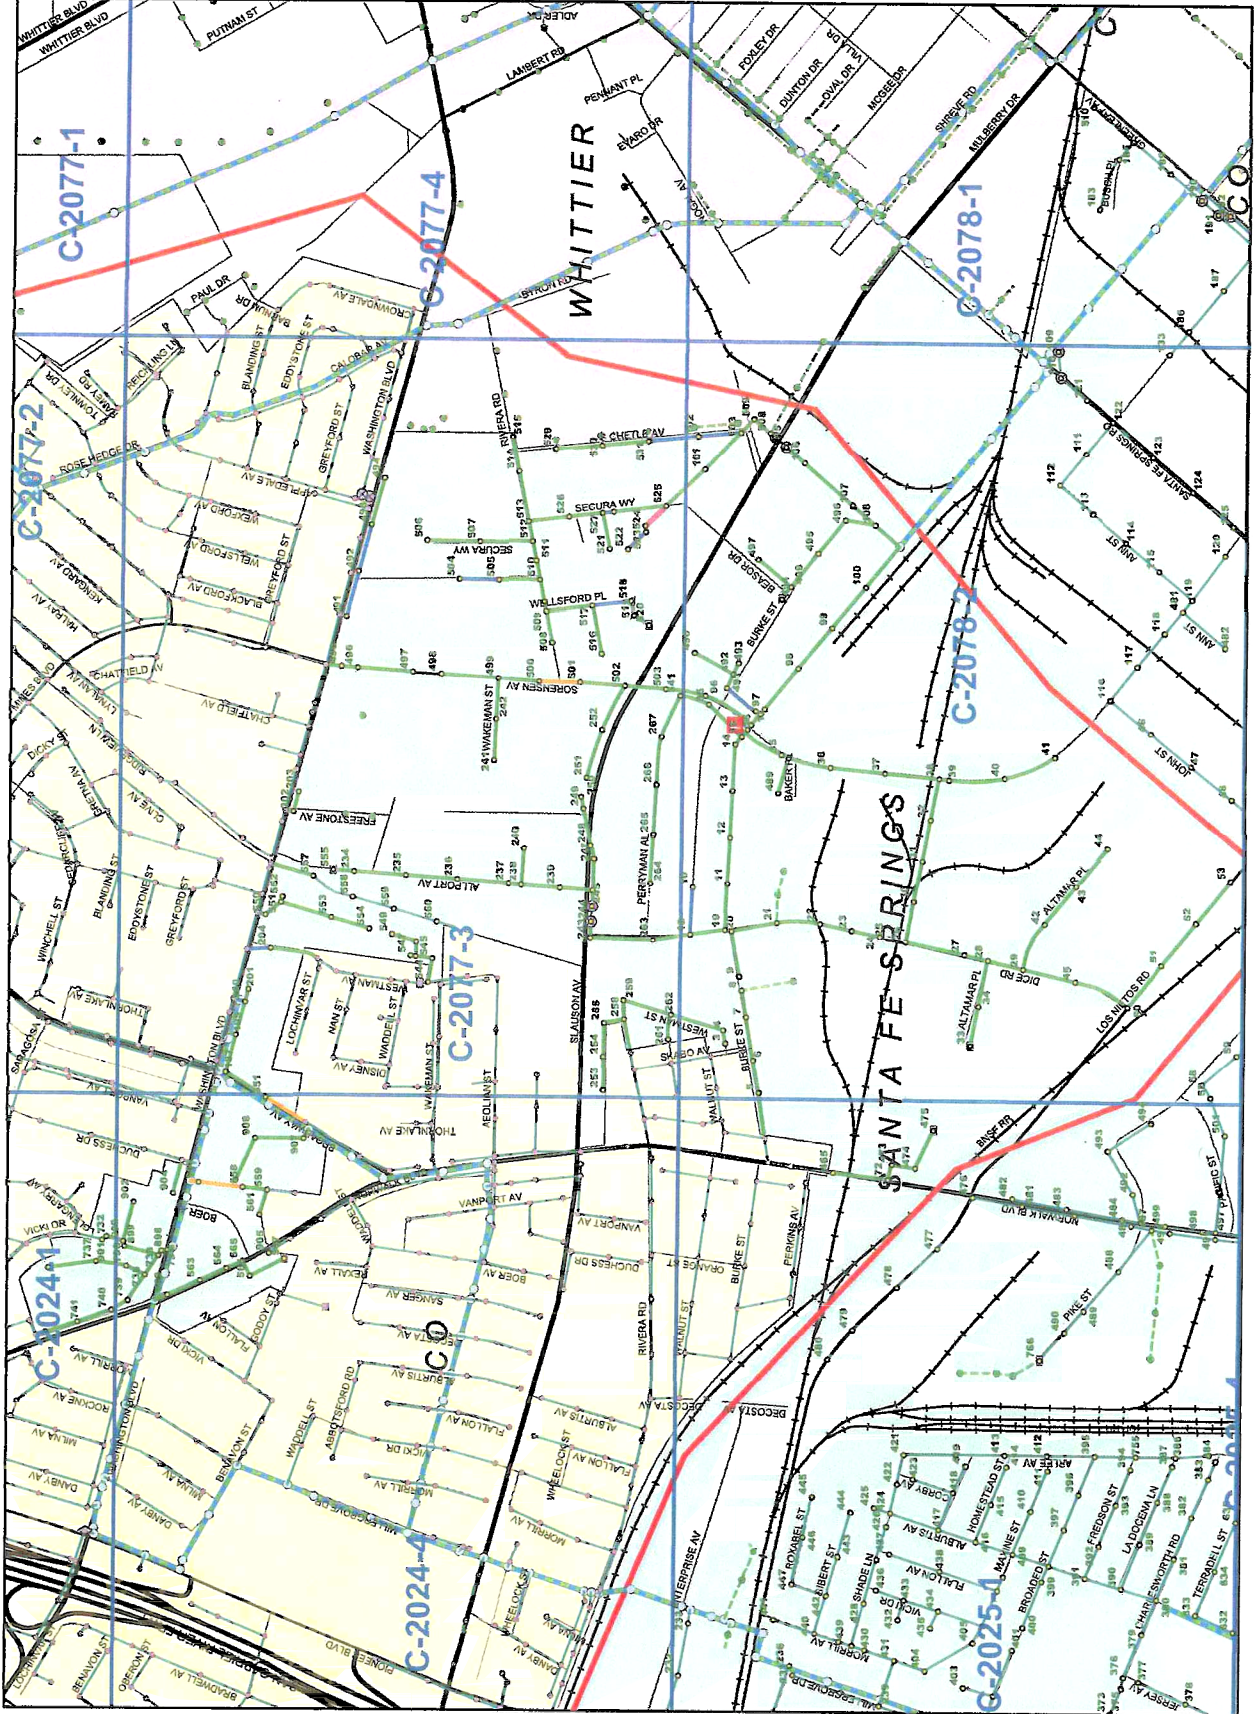
ENCLOSURE 3

Our inspection revealed that approximately 99.6 percent of the inspected pipe segments within the City of Santa Fe Springs were free of severe structural defects. However, the remaining 0.4 percent of the inspected pipe segments had a PACP structural grade of 4 or 5 as indicated in the Quick Structural Rating Table shown below. This segment had a defect that did not impact the structural integrity of the pipe. Therefore, no action is required at this time. A copy of the actual inspection report for this segment is included in Enclosure 4. A color-coded map showing the Quick Structural Rating for each pipe segment is located in Enclosure 3.

Item No.	QSR	Start MH	End MH	Street	Observation: Location	Proposed Corrective Method
1	4100	2077-0525	2077-0524	Easement E/O Secura Way	Fractures: 0'	Structural integrity in tact. No action at this time.
