DEPARTMENT OF PUBLIC WORKS

CONSOLIDATED SEWER MAINTENANCE DISTRICT CONDITION ASSESSMENT PROGRAM REPORT PROJECT NO. Y0TV0809A

**CONDITION ASSESSMENT REPORT
COUNTY OF LOS ANGELES DEPARTMENT OF PUBLIC WORKS
CONSOLIDATED SEWER MAINTENANCE DISTRICT**

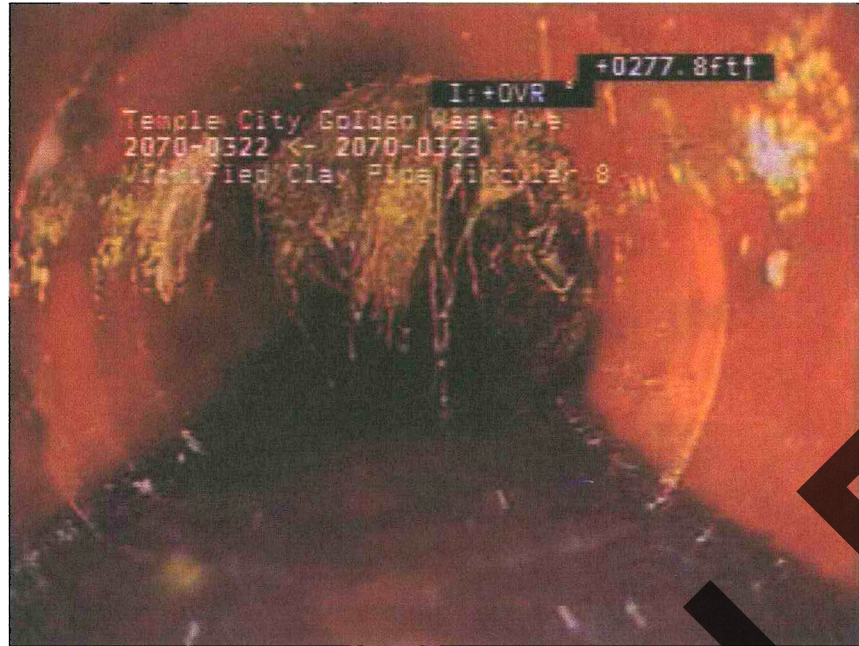
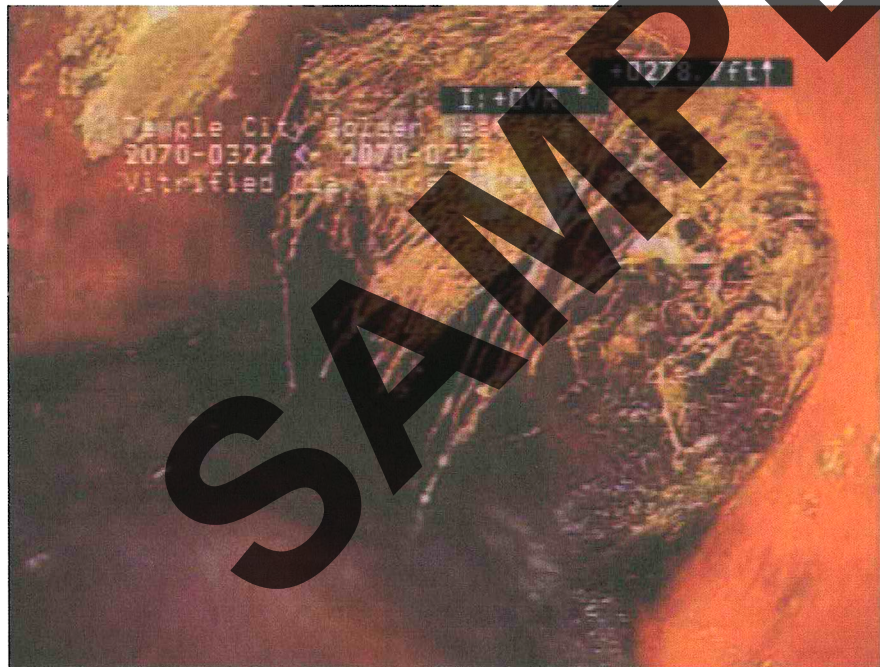
6435 GOLDEN WEST AVENUE
TEMPLE CITY
Roots at Lateral Connection

your sewer lateral within 90 days to remove roots and any other obstructions that may cause a sewage backup. Failure to do so may result in future overflows and subject you to civil prosecution, reimbursement costs, and fines up to \$1,000. Reference 20.24.160 Violation - Penalty; 20.24.170 Continued violations, 20.32.690 Reimbursement for repairs and maintenance following violations.
