# COUNTY OF LOS ANGELES

**CONSOLIDATED SEWER MAINTENANCE DISTRICT  
CONDITION-ASSESSMENT PROGRAM REPORT  
PROJECT NO. Y0TV1314B2**

**CONDITION-ASSESSMENT REPORT  
LOS ANGELES COUNTY PUBLIC WORKS  
CONSOLIDATED SEWER MAINTENANCE DISTRICT**

PROJECT NAME:	Y0TV1314B2	PROJECT MGR:	Eric Liu
PROJECT DATE:	7/23/2014	CONTACT NO:	(626) 300-3369
SUP. DISTRICT(s):	1	MAP PAGE(S):	2345, 2346,2347, 2389
Report By:	Eric Liu	Report Date:	06/24/2019

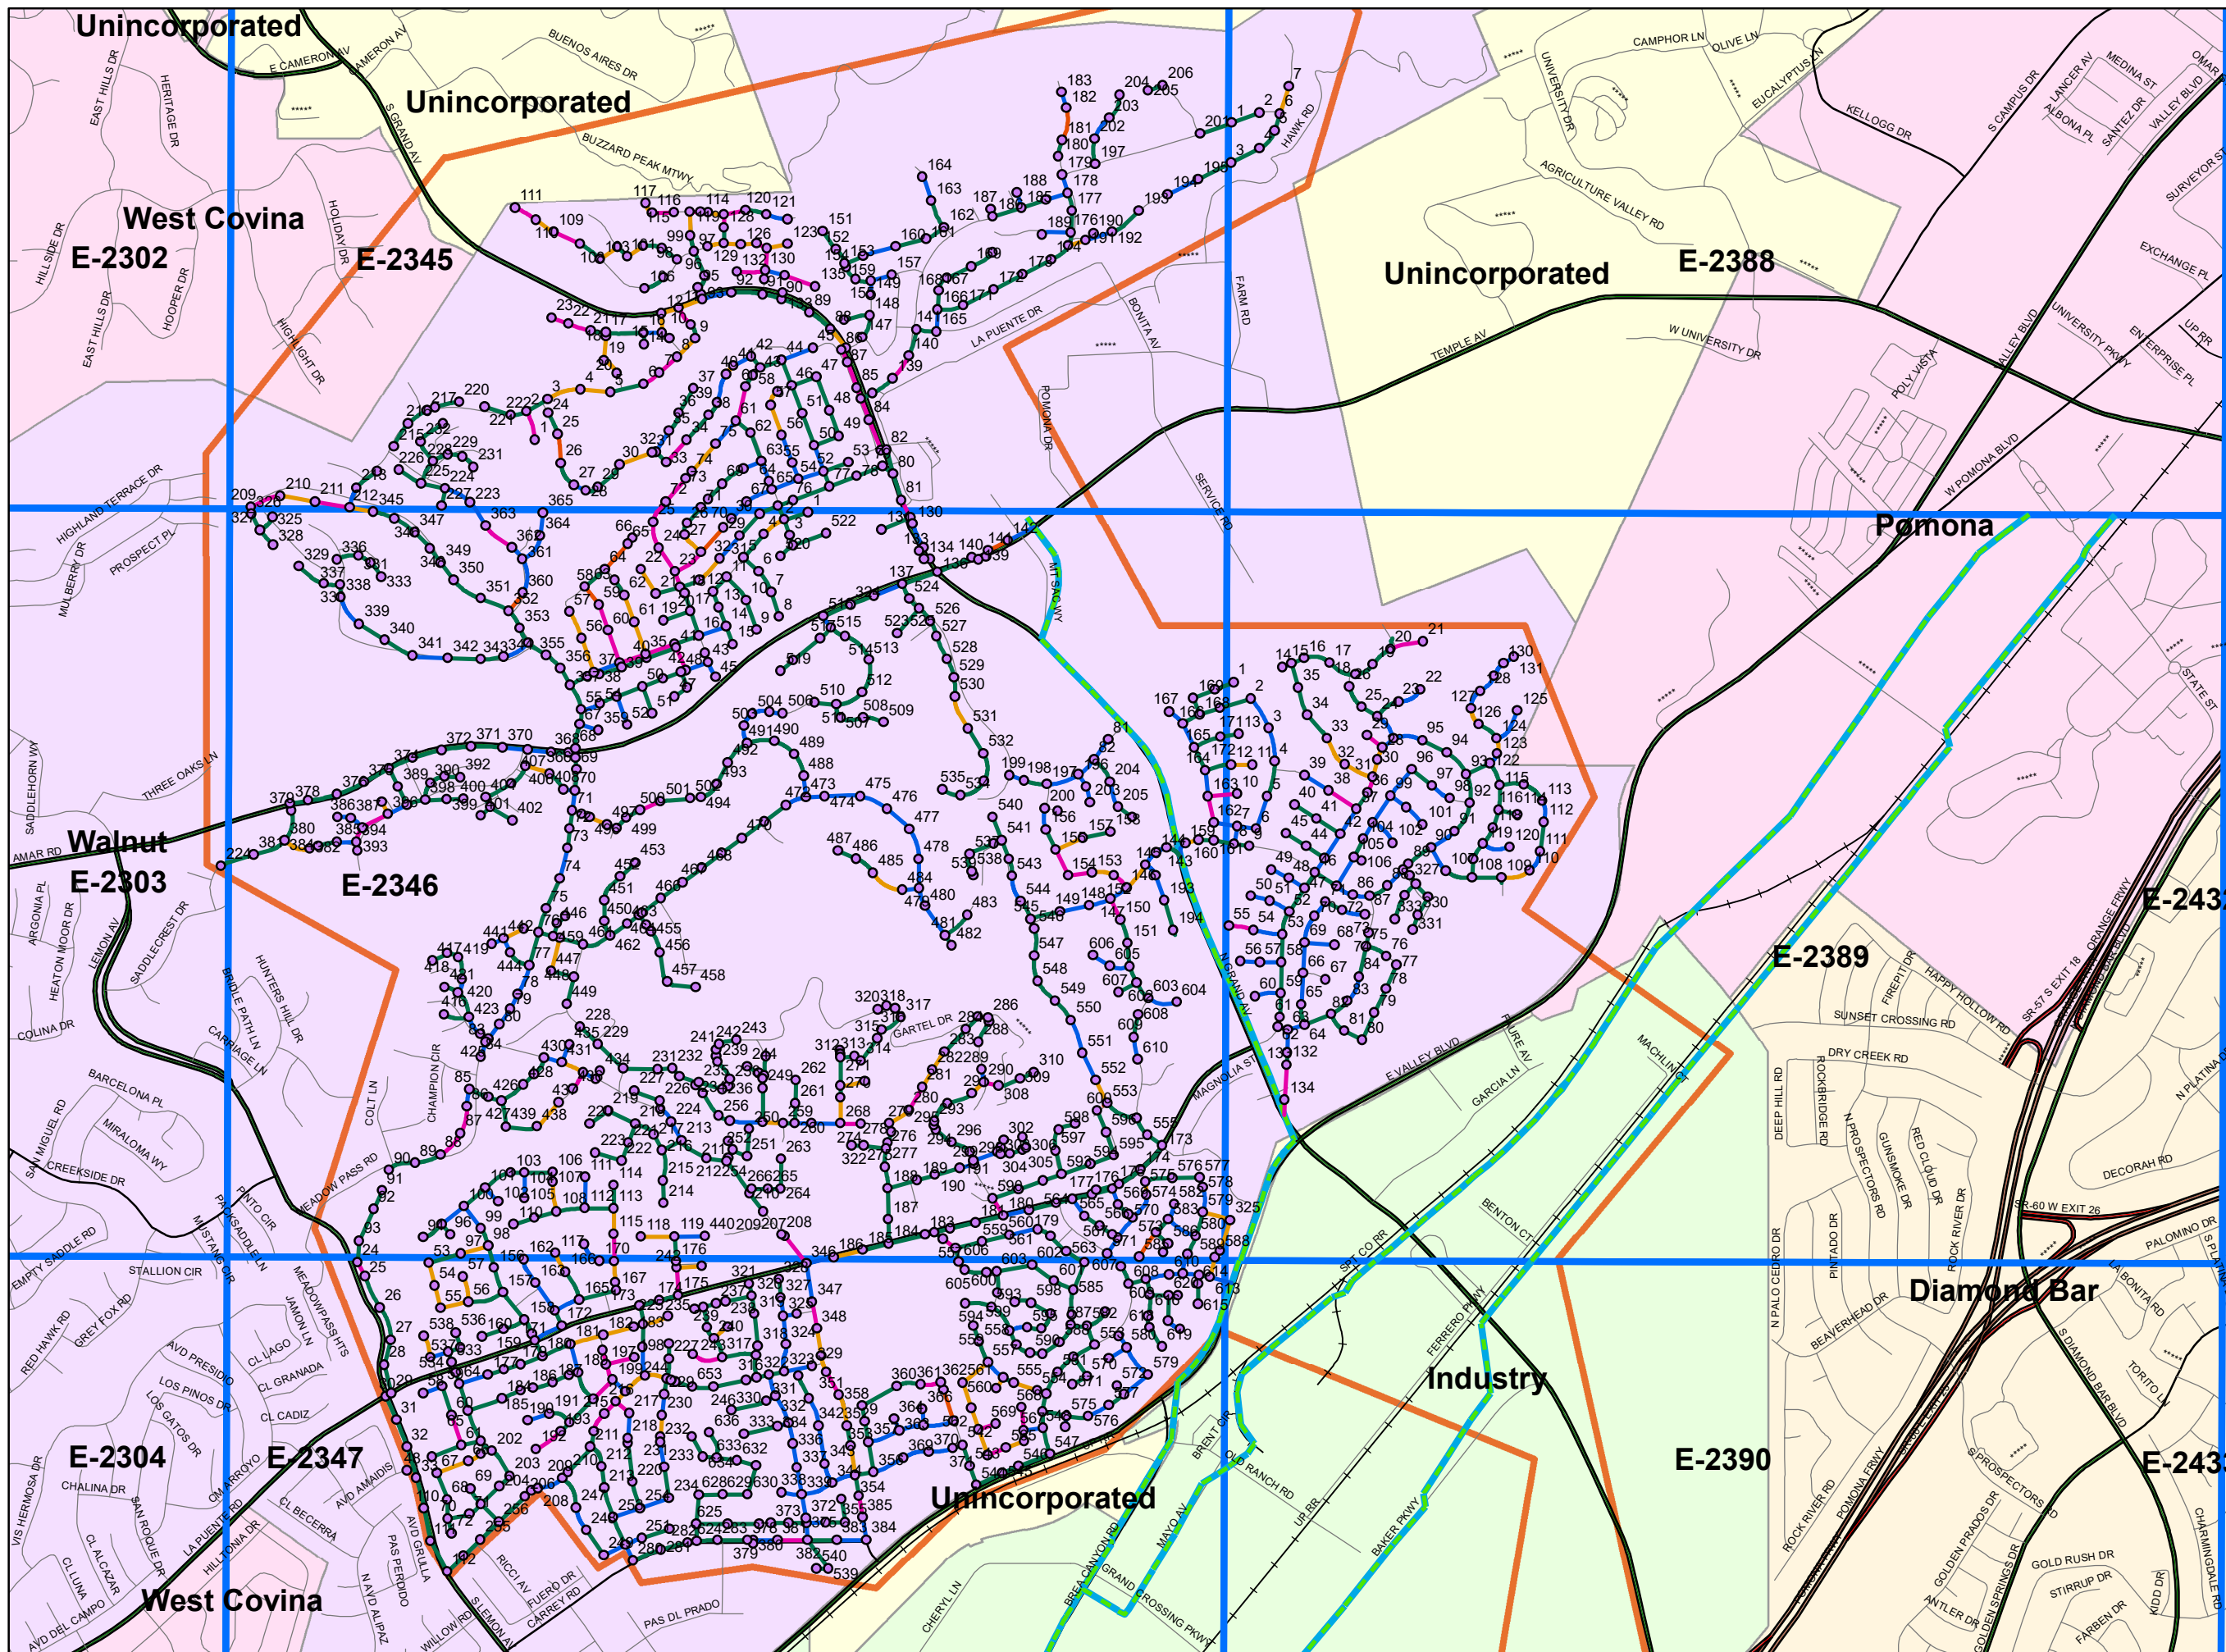
### WALNUT QUICK MAINTENANCE RATING (QMR)

Our inspection revealed that approximately 82.3 percent of the system televised in your City as part of Project No. Y0TV1314B2 was free of significant blockages or restrictions that would impede sewer flows. The remaining 17.7 percent of the pipe segments had a PACP maintenance grade of 3, 4, or 5 as indicated in the Quick Maintenance Rating Table shown below. These segments have been incorporated into our periodic cleaning schedule for enhanced maintenance.

A color-coded map showing the quick maintenance rating for each pipe segment is provided in Enclosure 2.

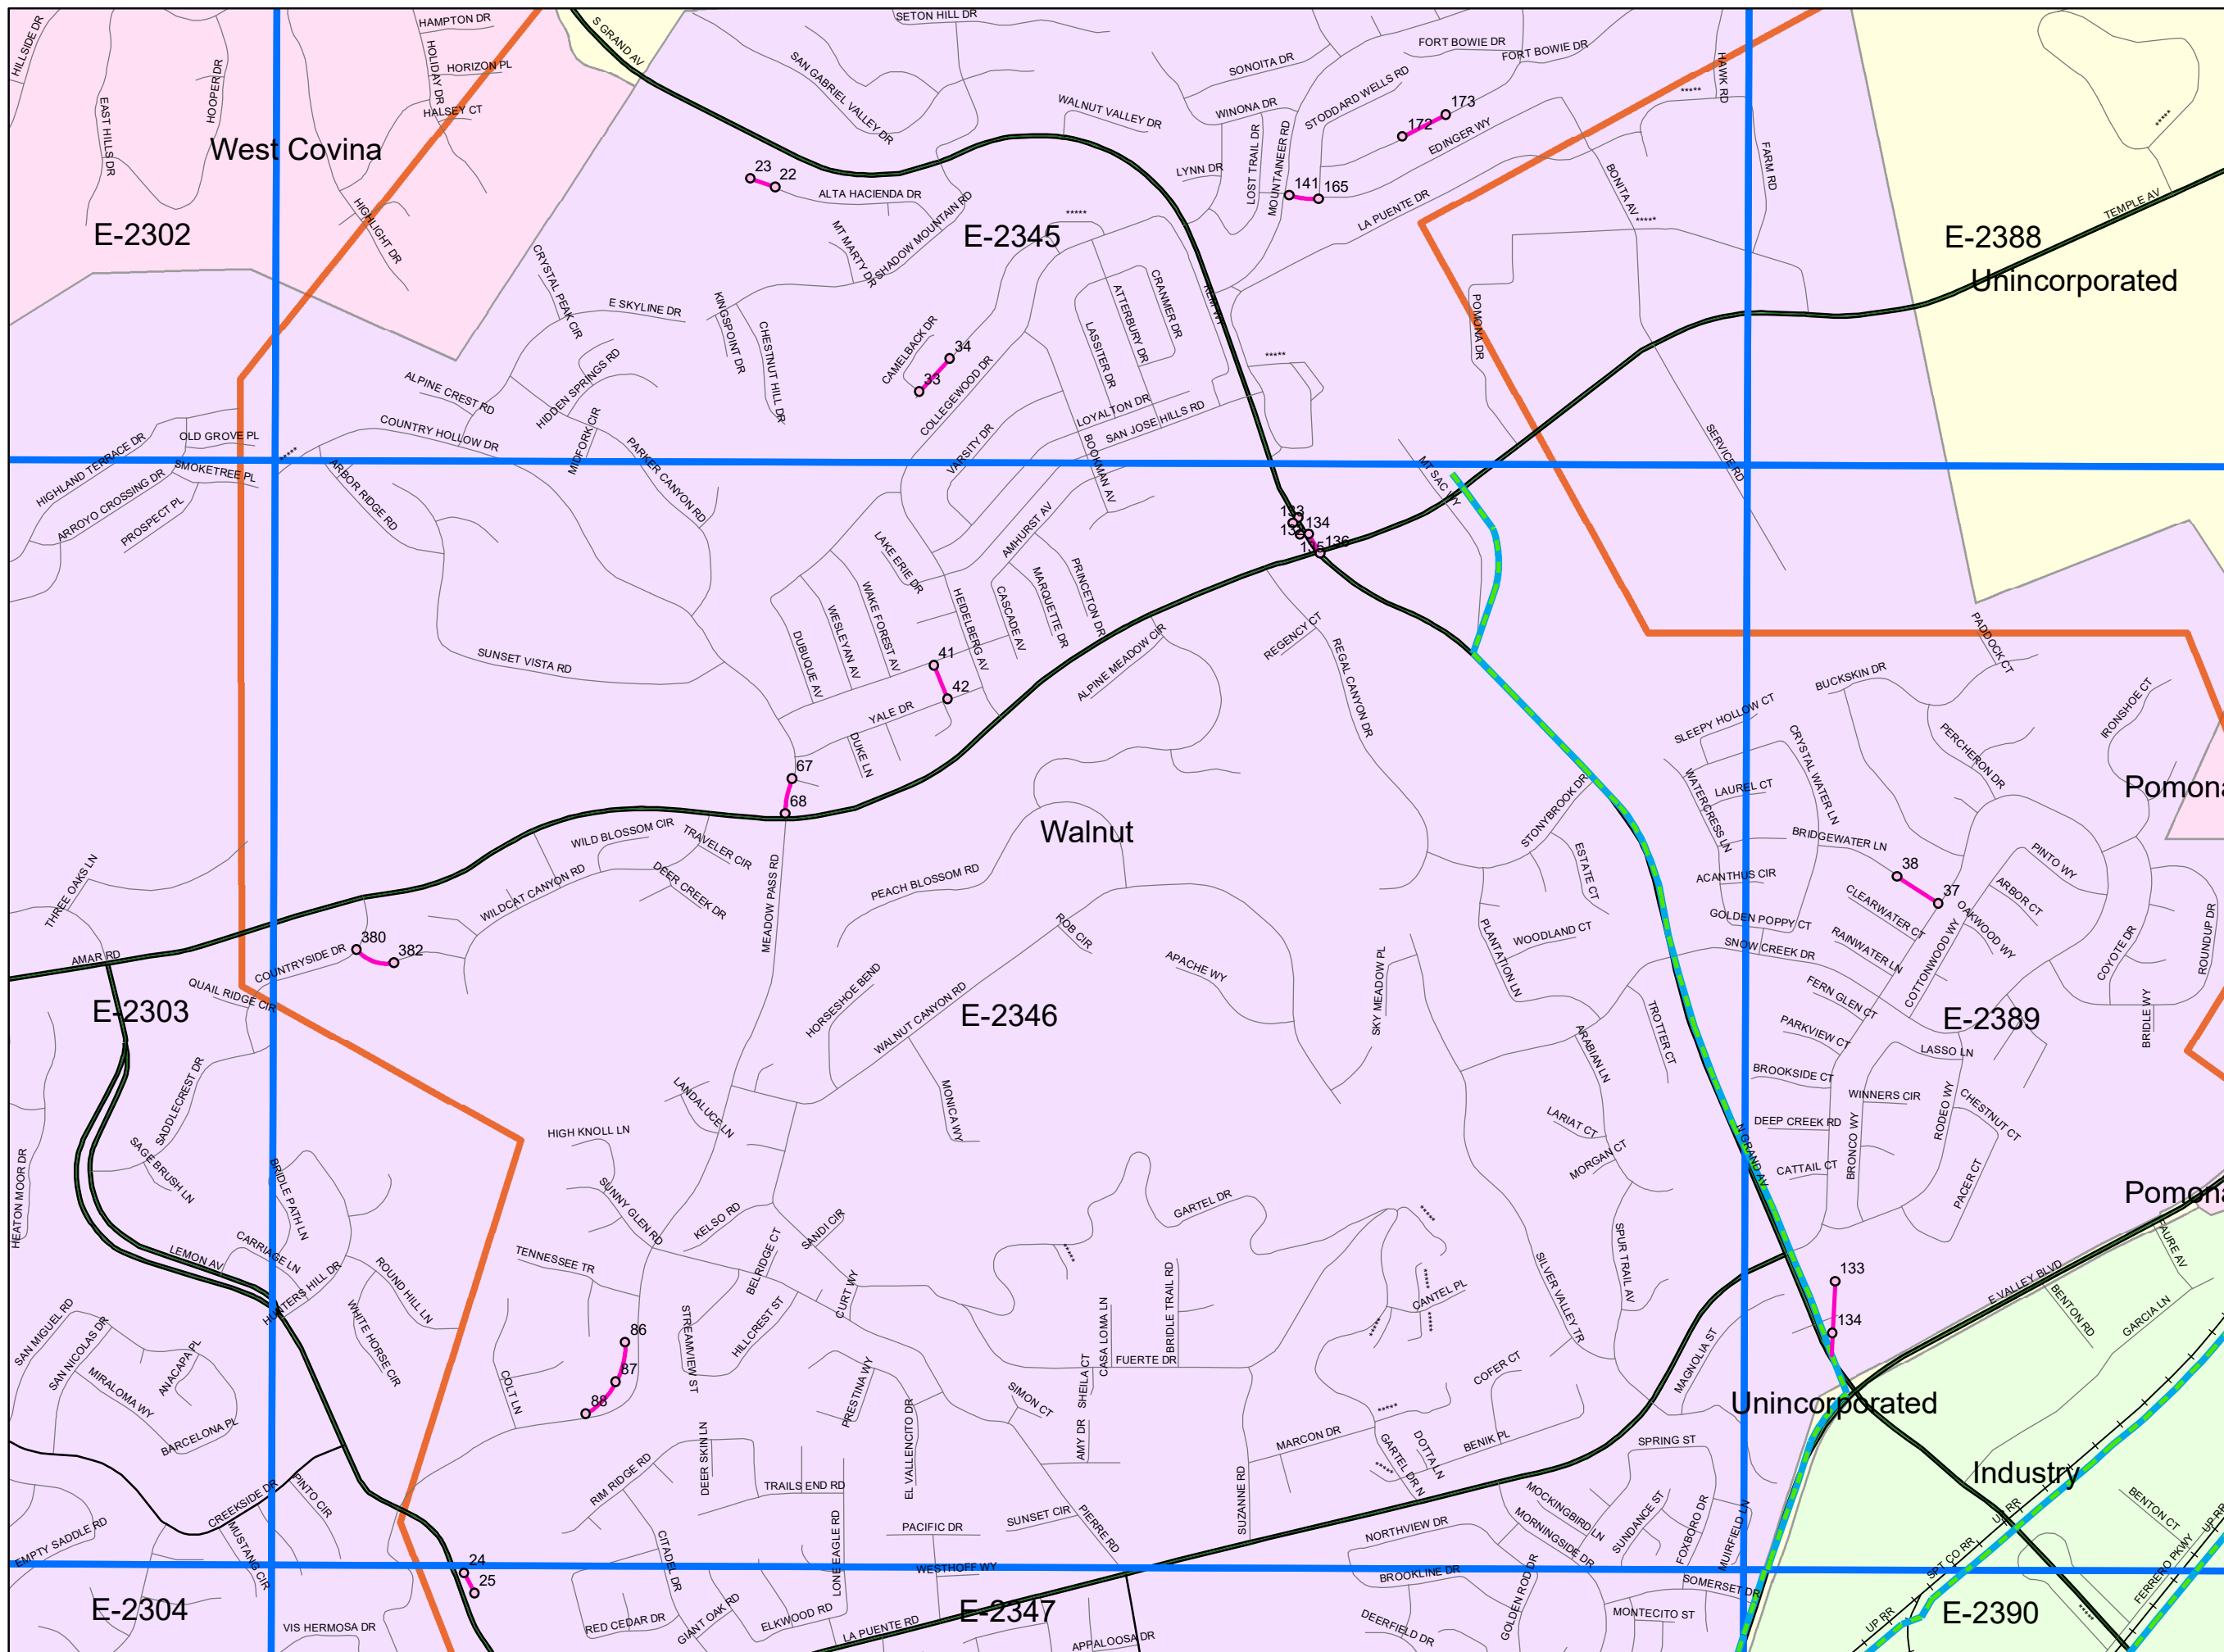
## HIGH WATER LEVEL

Our inspection revealed that approximately 98.8 percent of the system televised has adequate capacity. Approximately 1.2 percent of the segments inspected exhibited visual signs associated with high-water levels. The capacity of the sewer pipe can be determined by analyzing several PACP codes, including Water Level, Water Mark, and miscellaneous remarks, which indicate the camera was underwater or there were sags in the line. A sewer pipe is considered at capacity when 50 percent of the diameter of the sewer pipe is full of water. However, there are conditions in which the Water Level or Water Mark has reached 50 percent or greater due to heavy flows in adjoining pipes, a temporary stoppage caused by debris in the sewer lines, or a sag in the line. Therefore, additional review of these pipe segments was conducted to determine if any capacity issues exist.

All sewer pipes where the Water Level, Water Mark, and miscellaneous remarks of camera underwater or sags in the line are at or above 50 percent capacity have been listed and analyzed on the High-Water Level Table in Enclosure 2. The nature of these high-water level conditions is also summarized on this table. When the items have been identified to have high-water levels due to sewer line capacity, a Yes is indicated in the capacity column. These areas should be reviewed by the City for existing and future capacity needs.

A map showing the sewer lines with high-water levels is provided in Enclosure 2.

<b>ITEM NO.</b>	<b>START MH</b>	<b>END MH</b>	<b>STREET</b>	<b>OBSERVATION: LOCATION</b>	<b>CAPACITY</b>	<b>CORRECTIVE ACTION</b>
1	2389-0038	2389-0037	BRIDGEWATER LN	CAMERA UNDERWATER	NO	Hydrojet
2	2346-0041	2346-0042		CAMERA UNDERWATER	NO	Hydrojet
3	2346-0134	2346-0135	GRAND AV	Water Mark (50%)	NO	Hydrojet
4	2345-0033	2345-0034	BUCKLAND DR	Water Mark (50%)	NO	Hydrojet
5	2389-0133	2389-0134		Water Mark (50%)	NO	Hydrojet
6	2345-0023	2345-0022	ALTA HACIENDA DR	Water Mark (50%)	NO	Hydrojet
7	2346-0086	2346-0087	MEADOWPASS RD	Water Mark (50%)	NO	Hydrojet
8	2346-0087	2346-0088	MEADOWPASS RD	Water Mark (50%)	NO	Hydrojet
9	2346-0132	2346-0133	GRAND AV	Water Mark (50%)	NO	Hydrojet
10	2346-0135	2346-0136A	GRAND AV	Water Mark (50%)	NO	Hydrojet
11	2347-0024	2347-0025		CAMERA UNDERWATER	NO	Hydrojet
12	2389-0134	2389-TRUNK	GRAND AV	Water Mark (50%)	NO	Hydrojet
13	2346-0382	2346-0380	HIDDEN TRAIL PL	SAG	NO	Hydrojet

14	2345-0165	2345-0141	CASTLE DOME DR	CAMERA UNDERWATER	NO	Hydrojet
15	2345-0173	2345-0172	GRANITE WELLS DR	SAG	NO	Hydrojet
16	2346-0067	2346-0068	COUNTRY HOLLOW DR	SAG	NO	Hydrojet

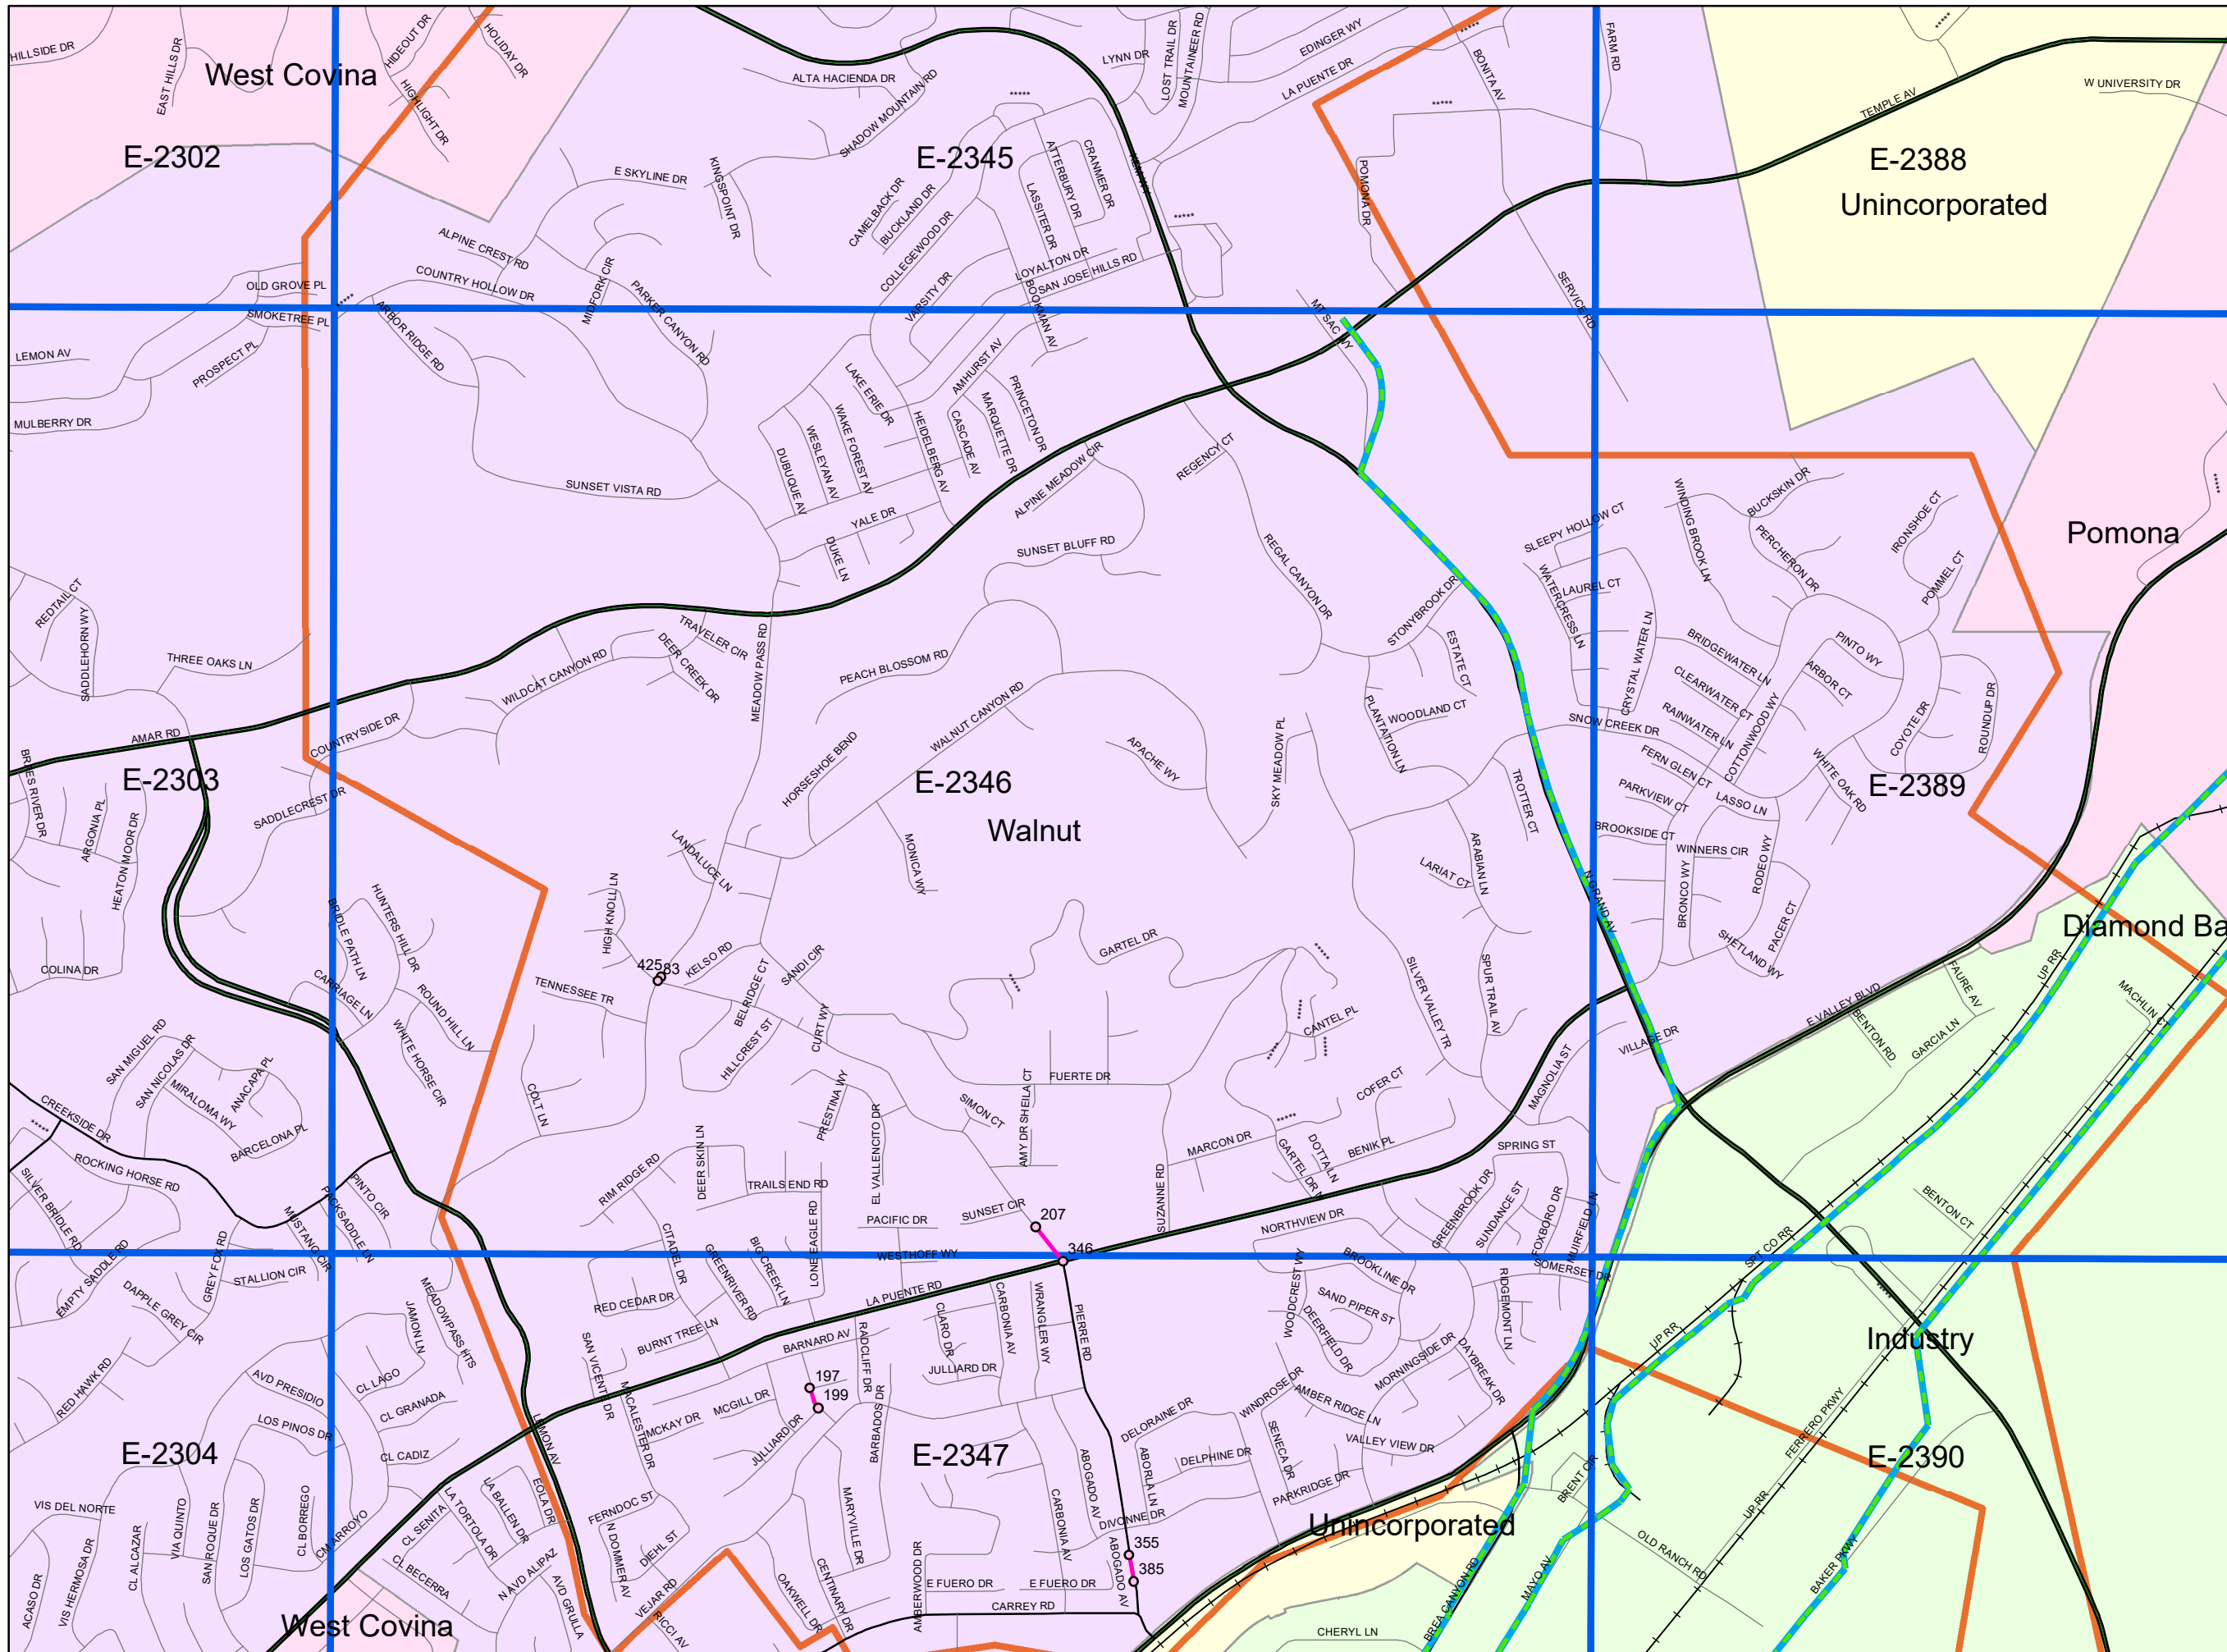
## INFILTRATION

Our inspection revealed that approximately 0.2 percent of the system in your City as part of Project No. Y0TV1314B2 has infiltration within the pipe segments. Infiltration is the ingress of groundwater into the sewers through a defect of porous area of the pipe wall. All sewer pipes where infiltration was found are listed on the Infiltration Table in Enclosure 2. This table also provides the proposed corrective action for these impacted sewer segments. If a corrective action is proposed, the work will be programmed in the next 24 months as part of our ongoing Accumulative Capital Outlay Program.

A map showing the sewer lines with infiltration is provided in Enclosure 2.

<b>ITEM NO.</b>	<b>START MH</b>	<b>END MH</b>	<b>STREET</b>	<b>OBSERVATION</b>	<b>CORRECTIVE ACTION</b>
1	2346-0425	2346-0083	MEADOWPASS RD	Infiltration runner	Lining
2	2347-0197	2347-0199	MARYVILLE DR	Infiltration runner	Lining
3	2347-0355	2347-0385	PIERRE RD	Infiltration runner	Lining
4	2346-0207	2347-0346	PIERRE RD	Infiltration gusher	Lining

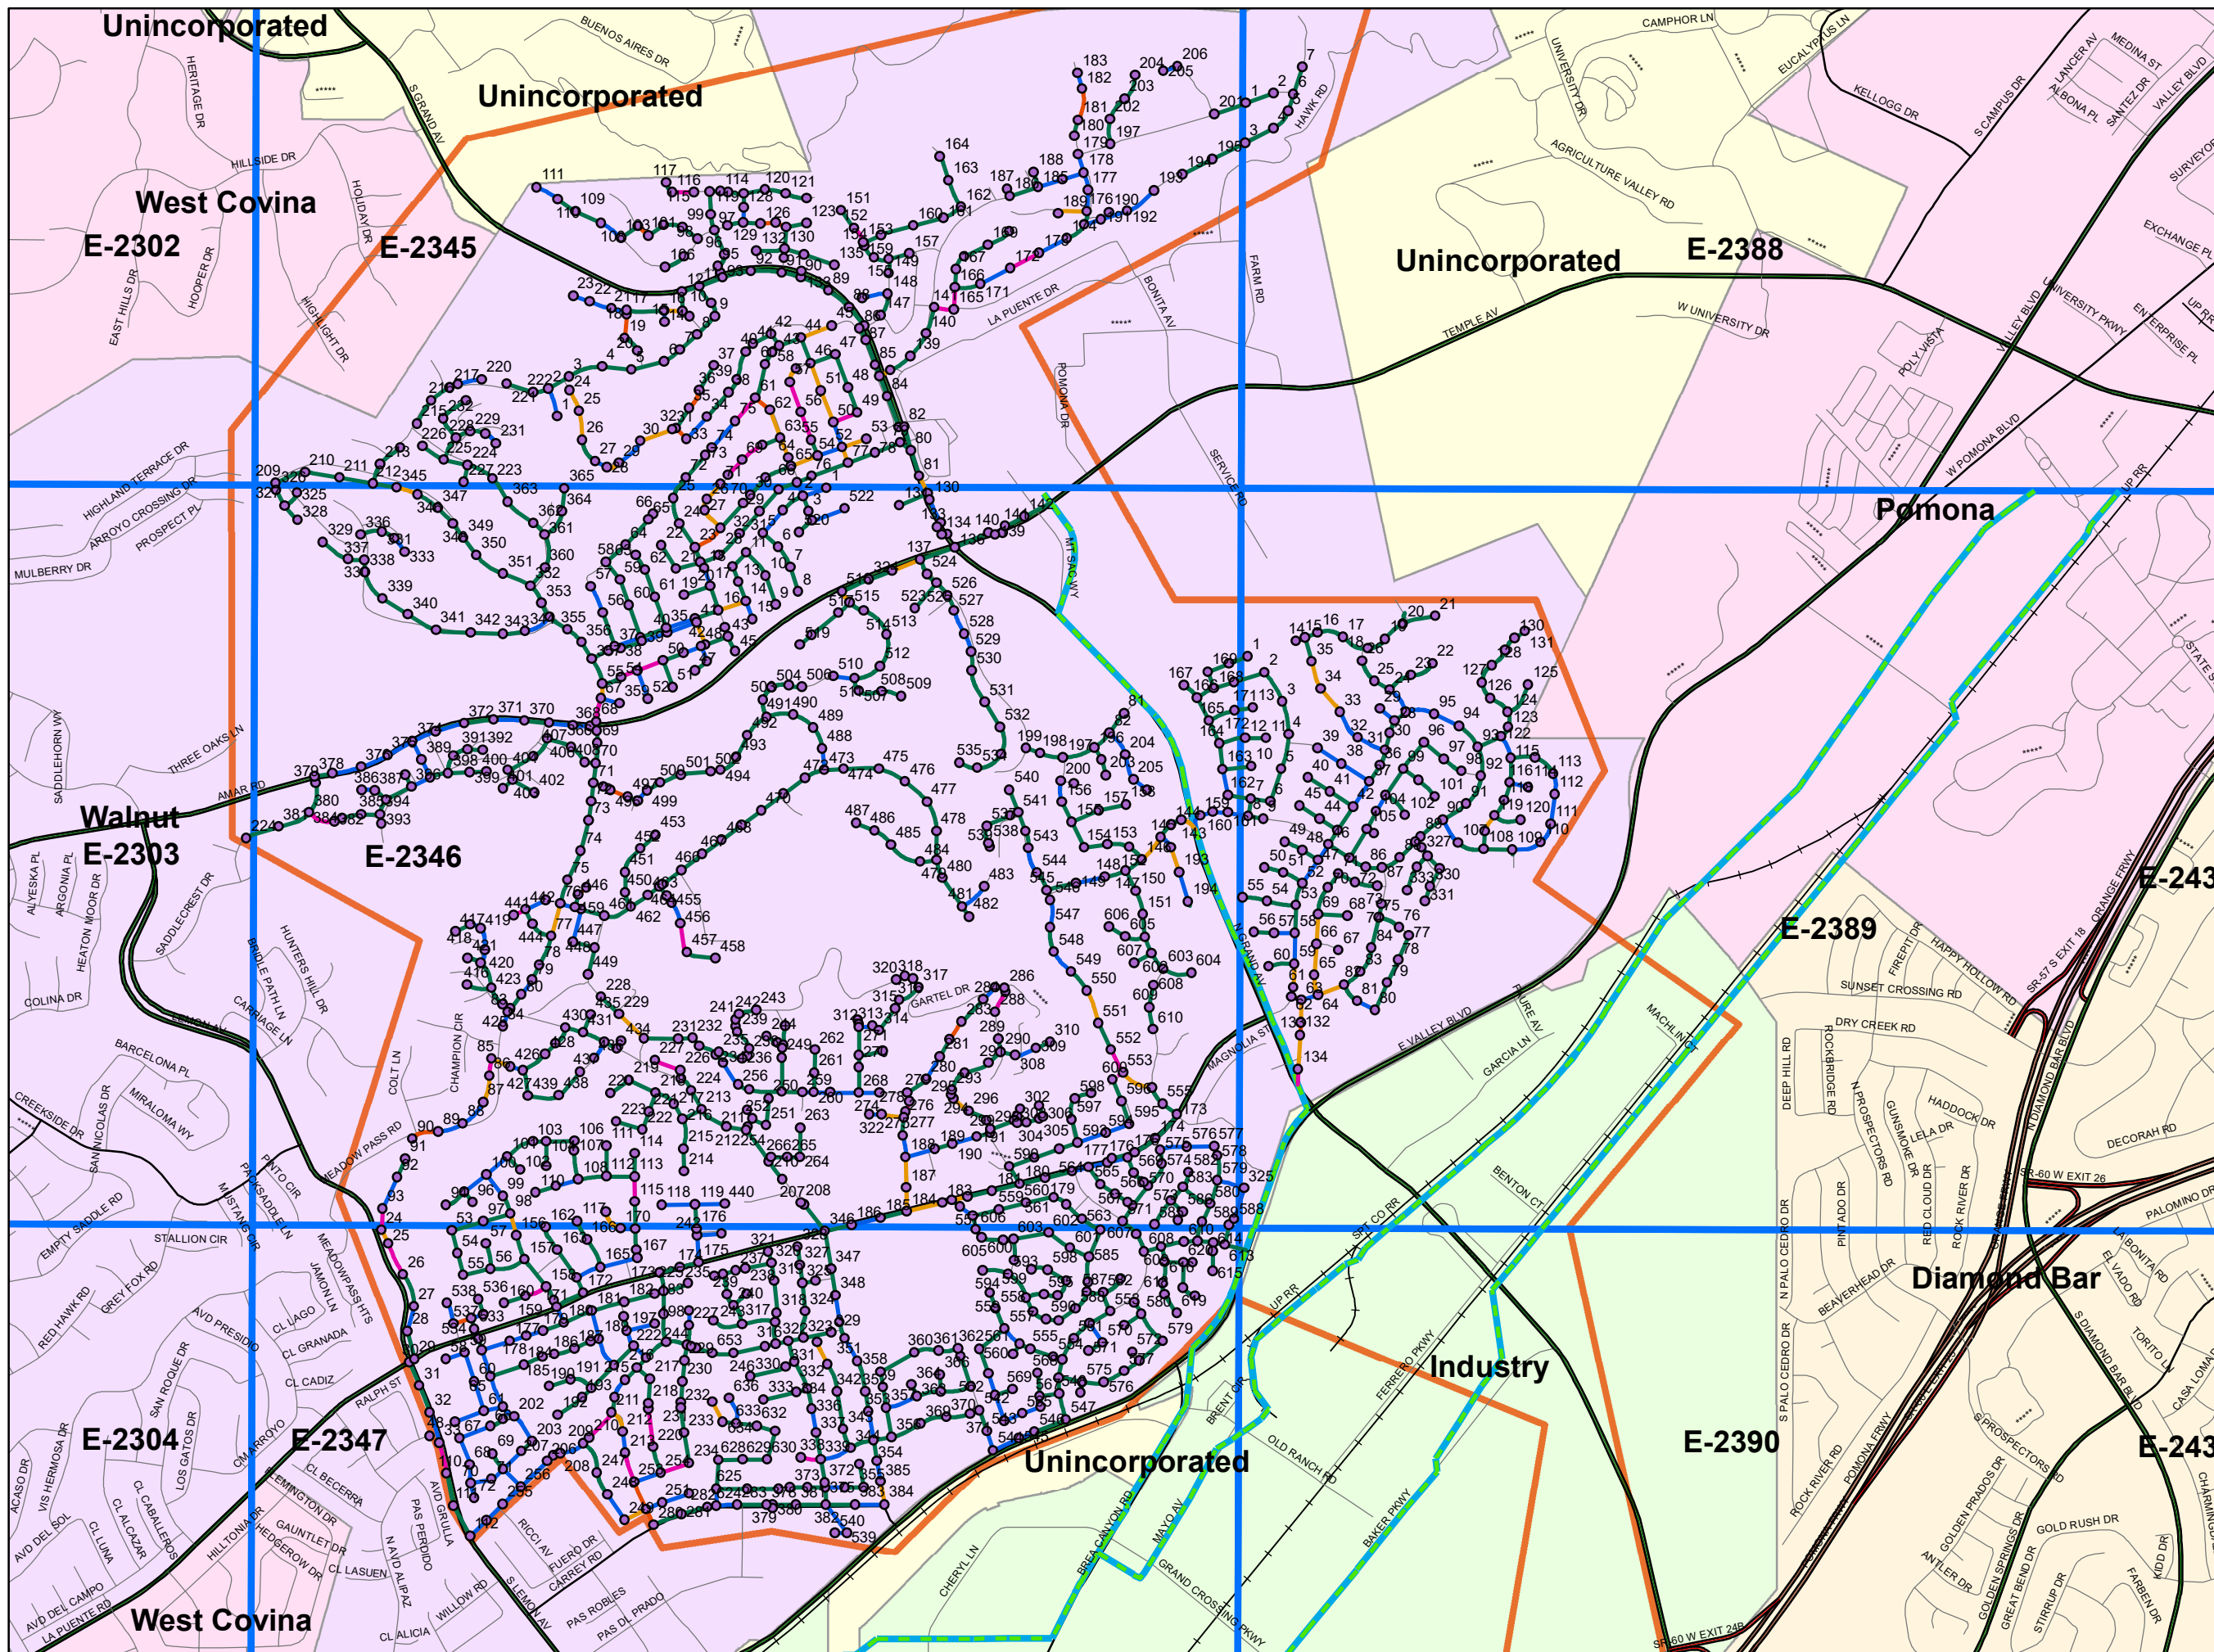
## WALNUT QUICK STRUCTURAL RATING (QSR)

Our inspection revealed that approximately 95.9 percent of the inspected pipe segments within the City were free of severe structural defects. The remaining 4.1 percent of the inspected pipe segments had a PACP structural grade of 4 or 5 as indicated in the Quick Structural Rating Table shown below. These segments have been placed on a priority list based on the severity and the need for action. For items 1 through 57 in the Quick Structural Rating Report Priority List (Enclosure 3), which warrant a corrective action, the proposed corrective action will be programmed in the next 24 months as part of the ongoing Accumulative Capital Outlay Program.

A color-coded map showing the Quick Structural Rating for each pipe segment is located in Enclosure 3.

ITEM NO.	START MH	END MH	STREET	OBSERVATION	PROPOSED CORRECTIVE ACTION
1	2345-0125	2345-0124	EASEMENT	Fractures, Broken	Lining
2	2347-0250	2347-0250A	CENTINARY DR	Broken	Emergency Point Repair (June 2019)
3	2345-0126	2345-0125	SAN GABRIEL VALLEY DR	Fracture, Broken	Lining
4	2346-0497	2346-0496	EASEMENT	Fractures, Broken	Lining
5	2345-0061	2345-0062	BOOKMAN AV	Fractures, Broken	Point Repair
6	2346-0089	2346-0090	MEADOWPASS RD	Broken	Point Repair
7	2389-0132	2389-0133	EASEMENT	Broken	No action needed*
8	2345-0019	2345-0018	EASEMENT	Fractures	Lining
9	2345-0036	2345-0035	CAMELBACK DR	Broken	No action needed*
10	2345-0032	2345-0033	CAMELBACK DR	Hole	Lining
11	2347-0250	2347-0280	CENTINARY DR	Hole	Emergency Point Repair (June 2019)
12	2345-0102	2345-0101	EASEMENT	Broken	Lining
13	2347-0537	2347-0534	SAN VICENTE CR	Broken	Point Repair
14	2346-0028	2346-0023	LOYALTON DR	Broken	Lining
15	2346-0283	2346-0282	FUERTE DR	Fractures	Lining

16	2346-0445	2346-0446	ANCIENT TITLE CT	Broken	Lining
17	2345-0069	2345-0068	VARSITY DR	Fracture	Lining
18	2346-0093	2347-0024	EASEMENT	Broken	Lining
19	2345-0070	2345-0069	VARSITY DR	Fracture	No action needed*
20	2345-0133	2345-0090	GRAND AV	Fracture	No action needed*
21	2346-0227	2346-0226	EASEMENT	Lining failure	No action needed*
22	2345-0057	2345-0056	LASSITER DR	Fracture	No action needed*
23	2347-0338	2347-0339	DIVONNE DR	Broken	Lining
24	2347-0213	2347-0253	CENTINARY DR	Fracture	No action needed*
25	2347-0033	2347-0110	LEMON AV	Fractures	Lining
26	2347-0025	2347-0026	EASEMENT	Fractures	Lining
27	2347-0253	2347-0250A	CENTINARY	Fractures	No action needed*
28	2346-0552	2346-0553	SILVER VALLEY TR	Collapsed	Point Repair
29	2346-0288	2346-0287	GARTEL DR	Fractures	Lining
30	2346-0050	2346-0053	YALE DR	Bulge	No action needed*
31	2345-0056	2345-0055	LASSITER DR	Fractures	No action needed*
32	2346-0053	2346-0054	YALE DR	Hole	No action needed*

33	2346-0278	2346-0277	SUZANNE RD	Broken	Lining
34	2347-0234	2347-0254	DIVONNE DR	Fractures	Lining
35	2345-0116	2345-0115	SETON HILL DR	Fractures	No action needed*

ITEM NO.	START MH	END MH	STREET	OBSERVATION	PROPOSED CORRECTIVE ACTION
36	2346-0425	2346-0083	MEADOWPASS RD	Fracture, Infiltration	Lining
37	2346-0113	2346-0115	LONE EAGLE RD	Fractures	No action needed*
38	2345-0075	2345-0061	COLLEGEWOOD DR	Fractures	Lining
39	2345-0166	2345-0165	STODDARD WELLS RD	Fractures	No action needed*
40	2346-0441	2346-0442	ROUNDTABLE CT	Fractures	No action needed*
41	2346-0085	2346-0086	MEADOWPASS RD	Fractures	Lining
42	2345-0049	2345-0050	CRANMER DR	Fracture	No action needed*
43	2347-0210	2347-0211	VEJAR RD	Fractures	Lining
44	2345-0152	2345-0153	WINONA DR	Broken	Lining
45	2345-0018	2345-0017	ALTA HACIENDA DR	Fractures	No action needed*
46	2346-0457	2346-0456	WENDI PL	Fractures	Lining
47	2347-0159	2347-0158	BURNT TREE LN	Fractures	Lining
48	2347-0219	2347-0220	MARYVILLE DR	Fractures	Lining
49	2347-0194A	2347-0195	JULLIARD DR	Fractures	Lining
50	2346-0146	2346-0145	SNOW CREEK DR	Corrosion	Lining

51	2347-0066	2347-0067	FERNDON ST	Joint offset	Point Repair
52	2346-0150	2346-0147	ARABIAN LN	Corrosion	Lining
53	2346-0207	2347-0346	PIERRE RD	Fracture, Infiltration	Lining
54	2346-0269	2346-0268	BRIDLE TRAIL RD	Tap Break-in Intruding	Point Repair
55	2347-0197	2347-0199	MARYVILLE DR	Fracture, Infiltration	Lining
56	2347-0355	2347-0385	PIERRE RD	Fracture, Infiltration	Lining
57	2345-0182	2345-0181	GRANITE WELLS DR	No structural issue	No action needed*
