CONSOLIDATED SEWER MAINTENANCE DISTRICT CONDITION ASSESSMENT PROGRAM REPORT PROJECT Y0TV0708B

**CONDITION ASSESSMENT REPORT
COUNTY OF LOS ANGELES DEPARTMENT OF PUBLIC WORKS
CONSOLIDATED SEWER MAINTENANCE DISTRICT**

PROJECT NAME	Y0TV0708B	PROJECT MGR:	Marzena Laskowska
PROJECT DATE	11/05/07-01/23/08	CONTACT NO:	(626) 300-3348
SUP DISTRICT(s):	1	MAP PAGE(S):	2024, 2025, 2077, 2078
Report By	Marzena Laskowska	Report Date:	03/31/09

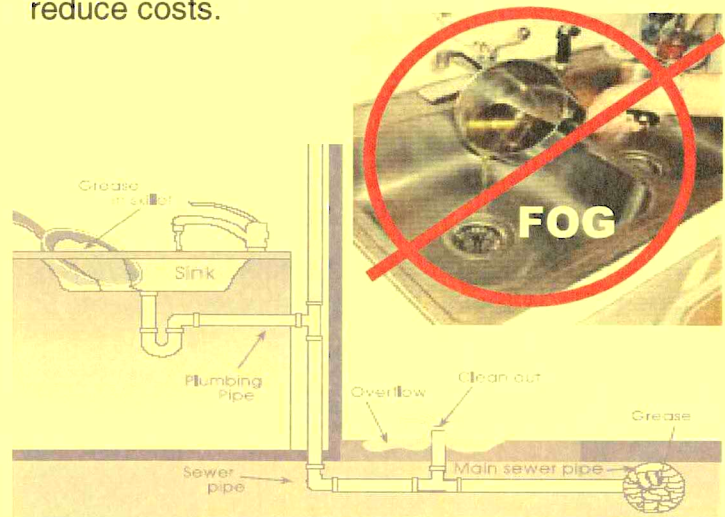
During a recent inspection of the mainline sewer on your street, our crews identified a heavy accumulation of grease in the sewer system.

- Do not pour FOG down the drain.
- Remember hot water does not prevent FOG from accumulating in the sanitary sewer system. It might not clog your plumbing, but may clog the sewer pipe and cause an overflow in your neighborhood.
- Place all FOG, once cooled, into a container with a lid. For example, use an empty coffee can and throw away in a trash can with a lid.
- Wipe pots and pans with absorbent material, like a paper towel, before cleaning.
