DEPARTMENT OF PUBLIC WORKS

CONSOLIDATED SEWER MAINTENANCE DISTRICT CONDITION ASSESSMENT PROGRAM REPORT PROJECT NO. Y0TV0809A

**CONDITION ASSESSMENT REPORT
COUNTY OF LOS ANGELES DEPARTMENT OF PUBLIC WORKS
CONSOLIDATED SEWER MAINTENANCE DISTRICT**

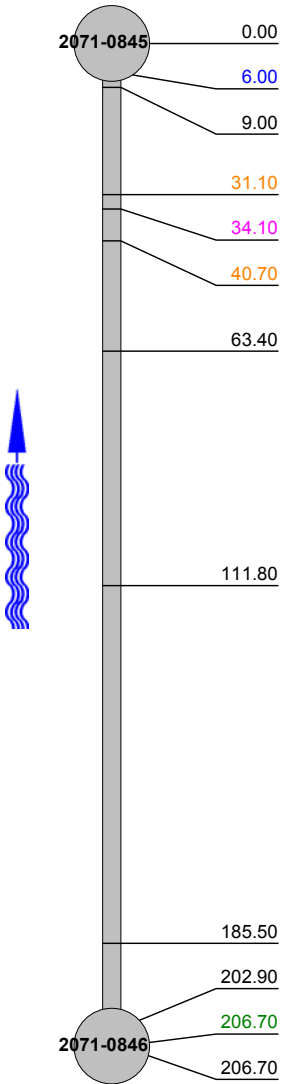
185.50	Tap Factory Active, at 9 o'clock, 6", within 8 inch: NO	00:09:57	2856	
	202.90	Tap Factory Active, at 10 o'clock, 6", within 8 inch: NO	00:10:42	2857

206.70	Vermin Cockroach, within 8 inch: NO	00:11:26	2858	M 1
	206.70	Manhole, within 8 inch: NO, Remarks: 2071-0846	00:11:37	2859

QSR	QMR	SPR	MPR	OPR	SPRI	MPRI	OPRI
4132	2111	10	3	13	3.33	1.5	2.6

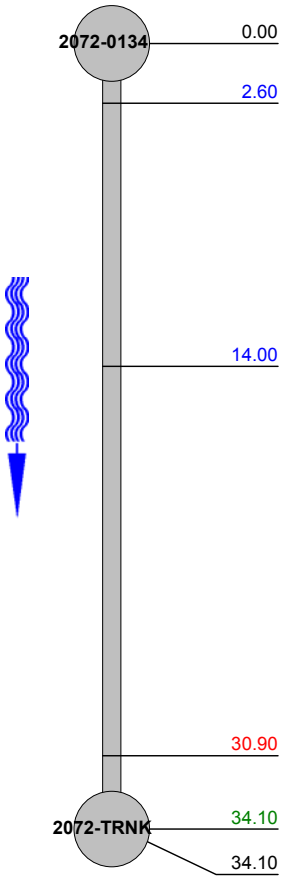
1:100	position	observation	MPEG	photo	grade
	0.00	Manhole, within 8 inch: NO, Remarks: 2072-0134	00:00:27	2931	
	2.60	Water Level, 5 %, within 8 inch: NO	00:04:27	2932	M 2
	14.00	Water Level, 15 %, within 8 inch: NO	00:04:53	2933	M 2
	30.90	Hole Void Visible, from 10 to 2 o'clock, within 8 inch: NO	00:06:16	2934, b	S 5
	34.10	Vermin Cockroach, within 8 inch: NO	00:07:02	2936	M 1
	34.10	Manhole, within 8 inch: NO, Remarks: 2072-TRNK	00:07:11	2937

QSR	QMR	SPR	MPR	OPR	SPRI	MPRI	OPRI
5100	2211	5	5	10	5	1.67	2.5

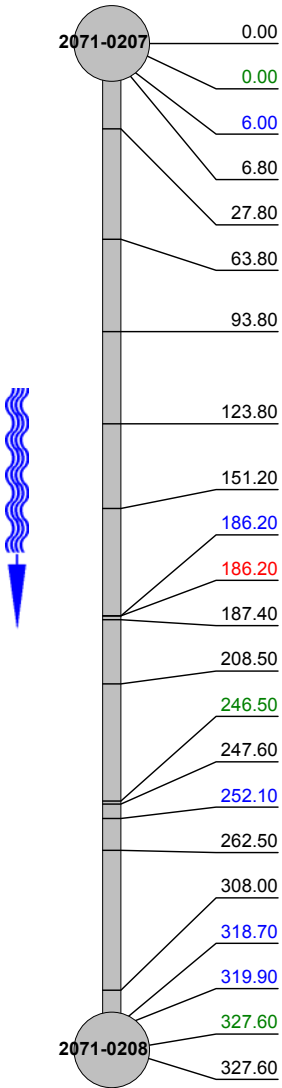
308.00	Tap Factory Active, at 3 o'clock, 6", within 8 inch: NO	00:15:42	1100	
	318.70	Crack Longitudinal, at 12 o'clock, within 8 inch: YES	00:16:30	1101, b	S 2

319.90	Tap Factory Defective, at 9 o'clock, 6", within 8 inch: NO	00:17:00	1103	M 2
	327.60	Vermin Cockroach, within 8 inch: NO	00:17:38	1104	M 1
	327.60	Manhole, within 8 inch: NO, Remarks: 2071-0208	00:17:49	1105

QSR	QMR	SPR	MPR	OPR	SPRI	MPRI	OPRI
5123	2212	12	6	18	2.4	1.5	2

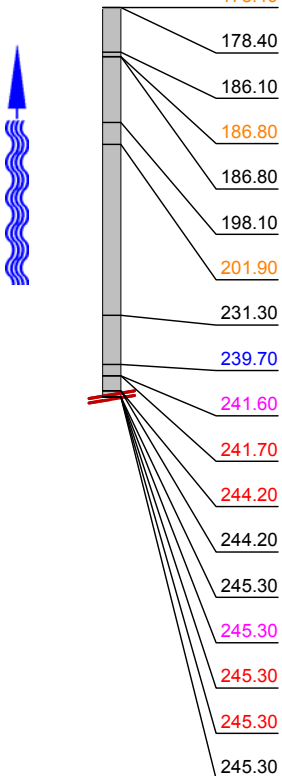
245.30 F2	Fracture Multiple, from 7 to 5 o'clock, within 8 inch: YES, End	00:23:09	3596	S 4
	245.30 F3	Deformed, 15 %, within 8 inch: NO, End	00:23:25	3597	S 5

245.30	Broken, from 3 to 9 o'clock, within 8 inch: YES	00:23:44	3598, b	S 5
	245.30	Abandoned Survey, within 8 inch: NO, Remarks: Completes inspection of e	00:24:08	3600
